TRIM MILLENNIUM PEDESTRIAN BRIDGE SCHEME

Cultural Heritage Assessment Report

Date: May 2024

TRA 12 10 08

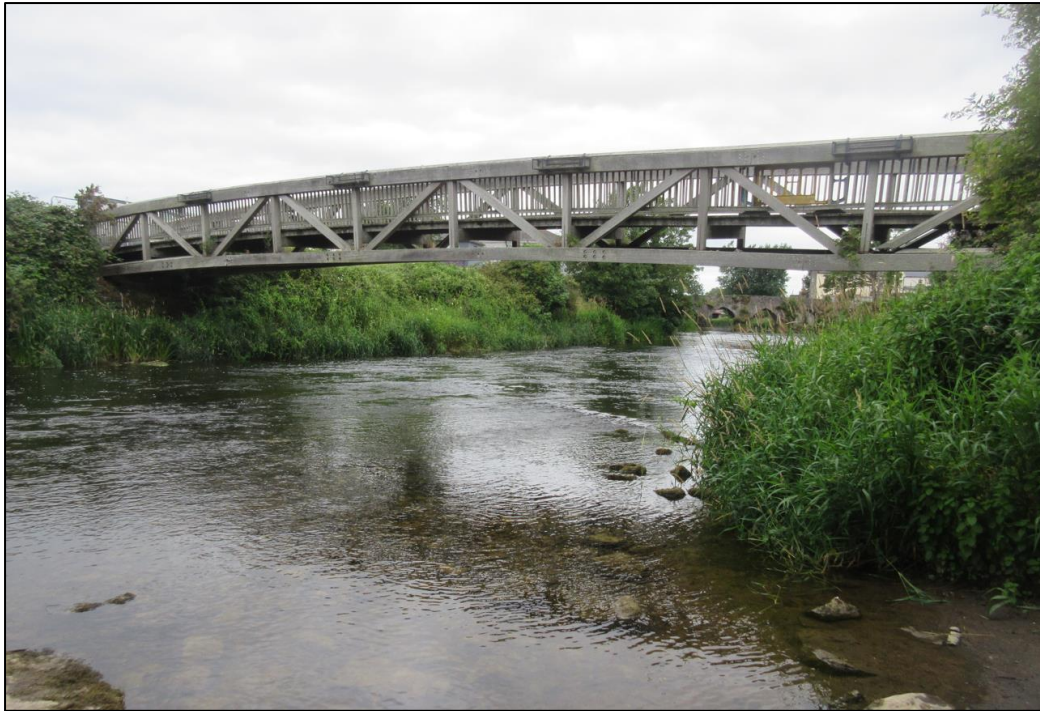
Bridge E face. The River is not very deep here, but the channel may be deeper elsewhere. Silts in the riverbed have probably accumulated since 1973, but there is potential for archaeological objects to occur in these silts across the riverbed. Should in-river works be proposed then a dive/wade metal detector survey should be completed.

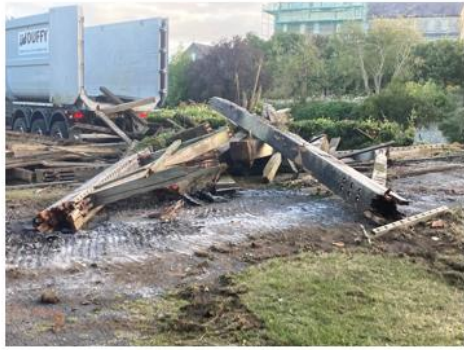
Photo 4

IMG_2481 Broken remains

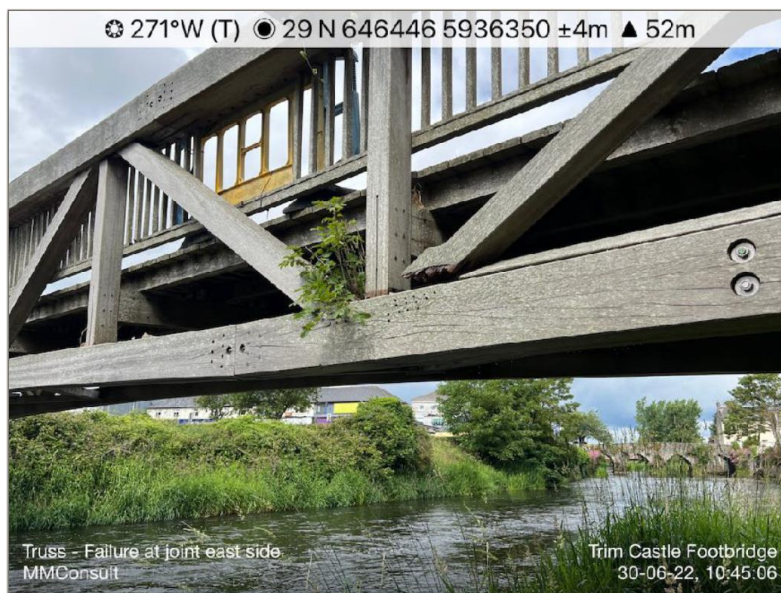
- The balustrade posts of the parapet are rotting and fragile with one section missing several together
- The parapet fixing battens are rotting
- There is significant cracking on the abutments masking walls
- Timber bearing plates are splitting
- The bridge deck and soffit has twisted / warped
- There is a failing splice section near the southern end
- There is a significant failed joint with an unattached diagonal member and a kink (see below)

Photo P25: View of failed joint, noting unattached diagonal member and kink at splice location

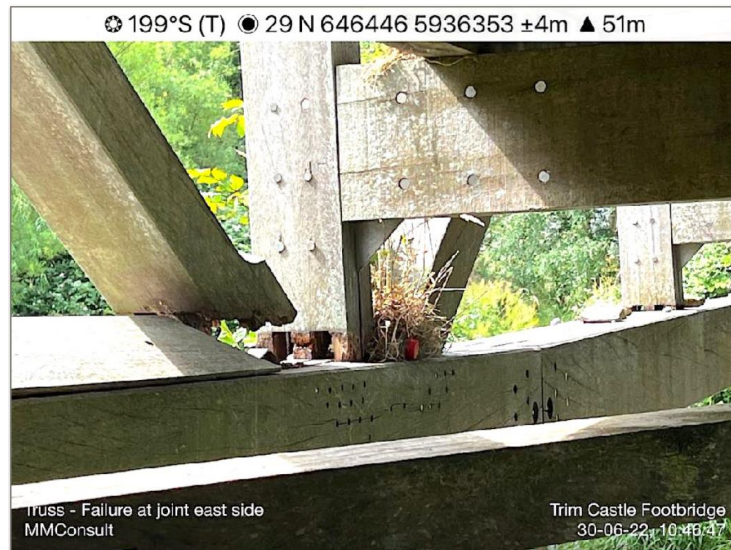
Photo P26: View of failed joint, noting unattached diagonal member and rotten ends of the members

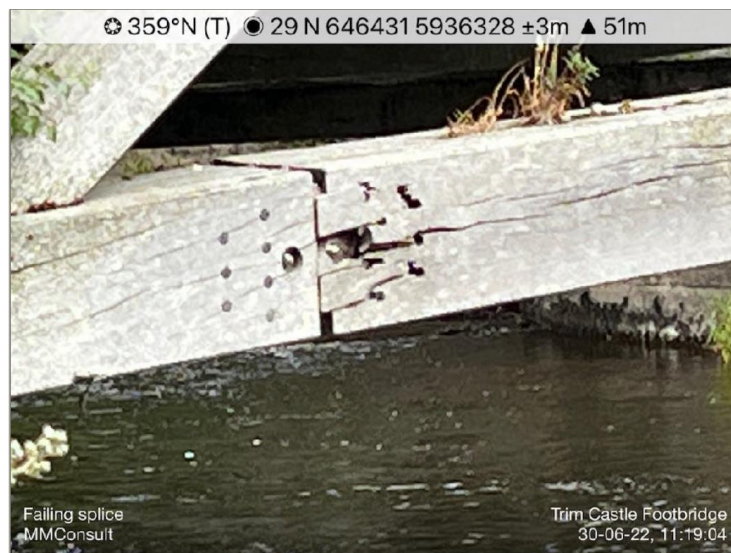
Photo P32: View of a failing splice connection to east truss at the south end

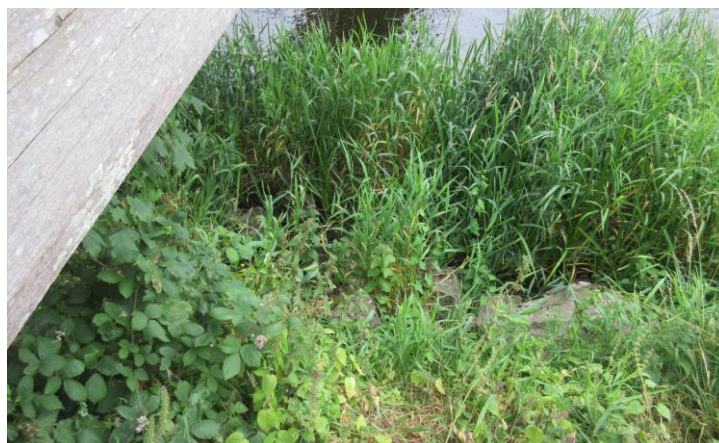
View of rock scour protection at base of abutment

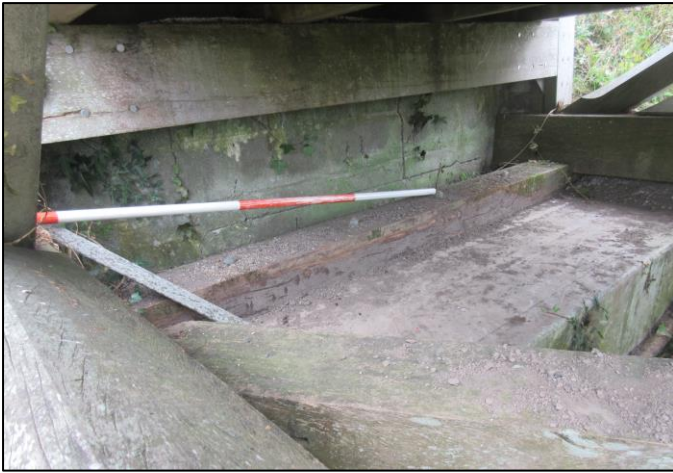
Cracking in Masking Wall on N abutment

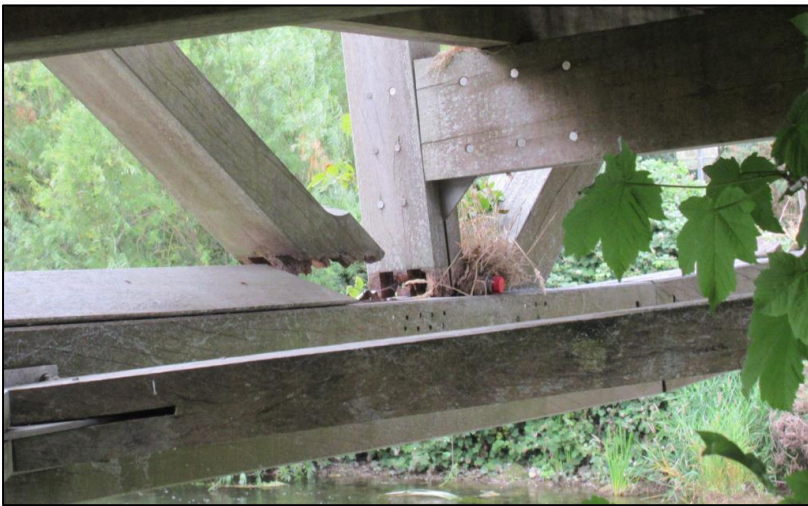
Broken joint on bridge E side
