# Old Johnstown Village

## **Draft** Public Realm and Regeneration Plan

## Mrs Butterly's Condition Survey

The following pages outline the condition survey report on the Mrs Butterly's Building completed by Hall Black Douglas in July 2024.

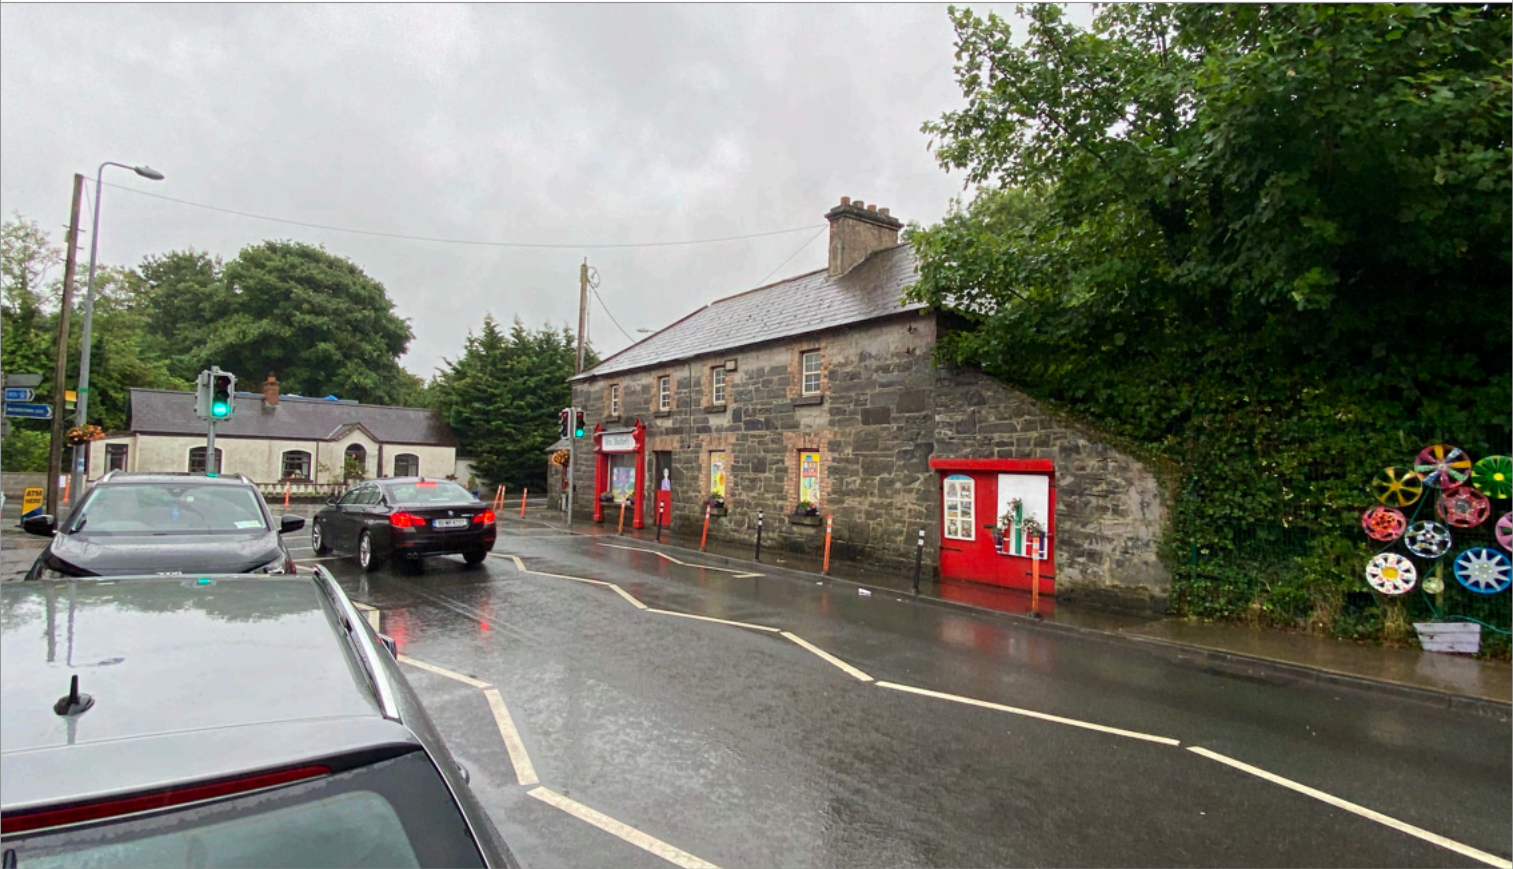
002	<p><b>North Elevation</b></p> <ul style="list-style-type: none"><li>- A single story outbuilding/store with a pitched roof is situated to the Eastern side and a lean-to store/garage with a mono-pitch roof sits to the West. Both are also of coursed rubble stone masonry construction, although the side structures appear to be a separate additions abutting the main 2 storey structure. This is evidenced by the large cornerstones visible at the intersections of the individual structures.</li><li>- The building has a further two-story, flat-roofed extension to the rear added in the early to mid 20<sup>th</sup> century, likely constructed of concrete blockwork.</li></ul>

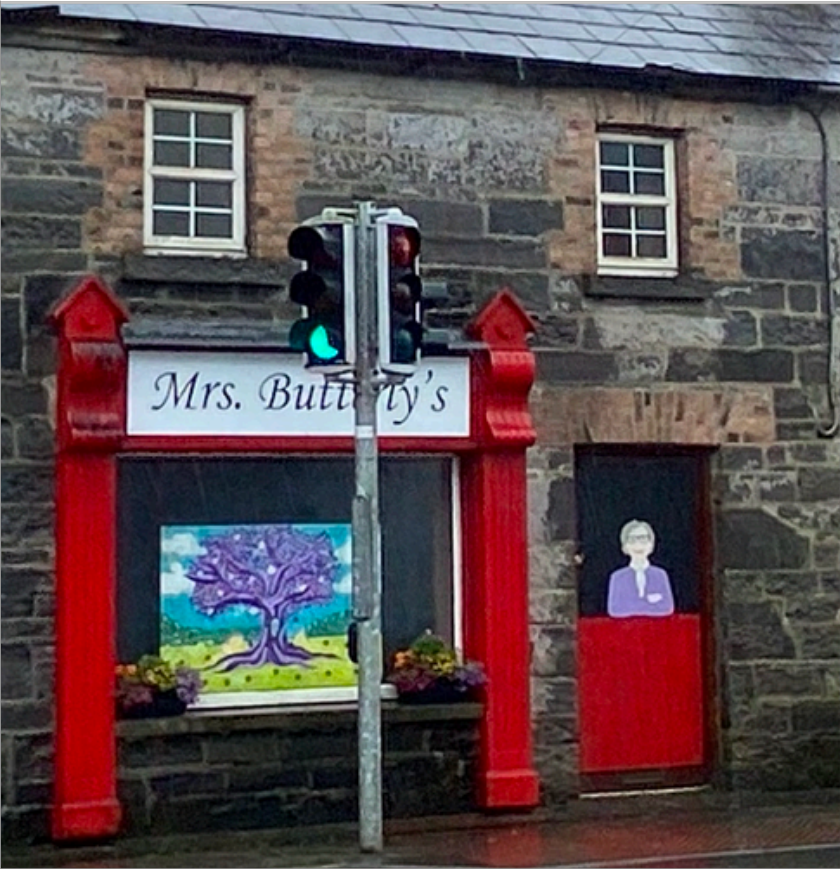
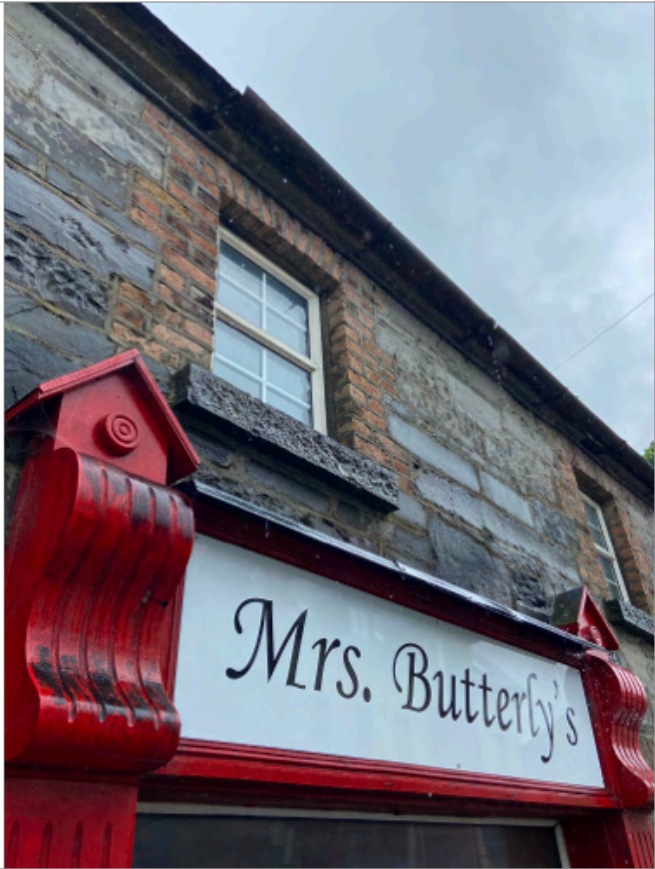
003	<p><b>2 Storey Cottage - North Elevation</b></p> <p>Traditional style timber decorative surround to shop front window in good condition.</p>

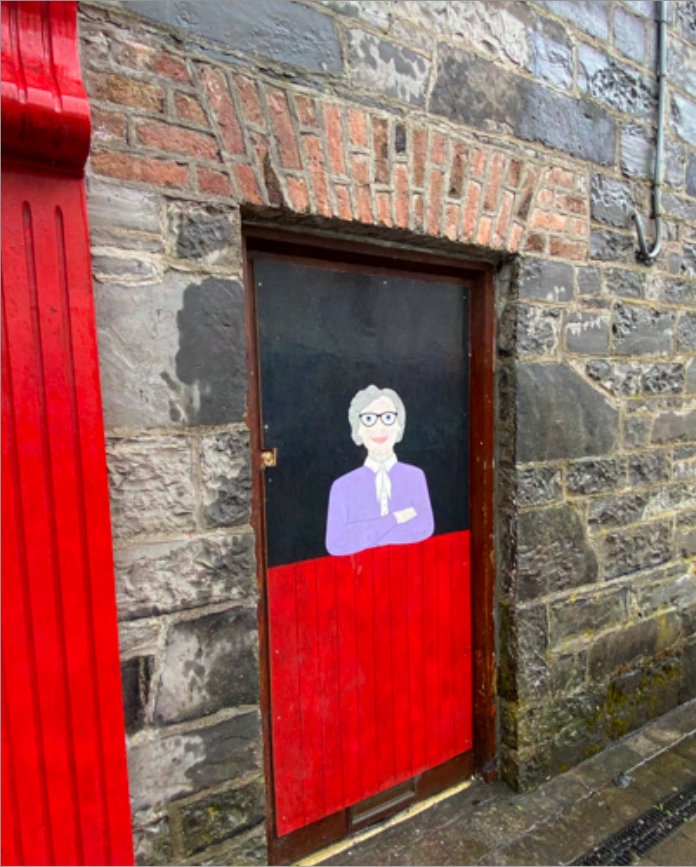
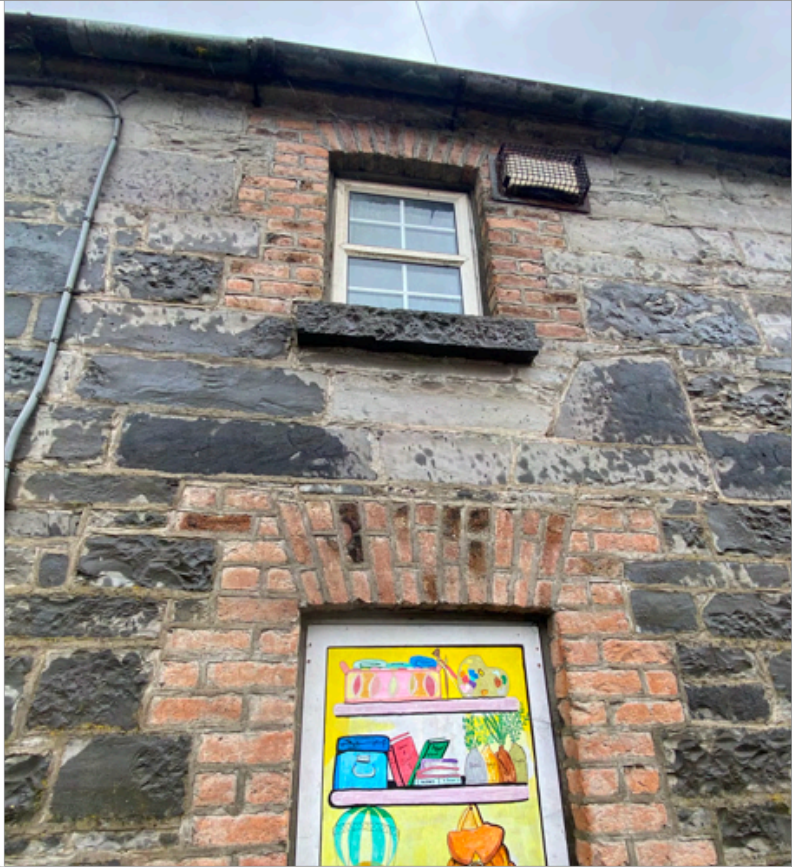
Fig. A	Fig. B
004	<p><b>2 Storey Cottage - North Elevation</b></p> <ul style="list-style-type: none"><li>- Timber front door with splayed brick head extending into stonework.</li><li>- Attractive brick details to window openings with natural stone cills. Generally in good condition, possibly recently re-pointed with sand/cement (mortar sitting proud of the face of the brickwork).</li><li>- Double glazed PVC windows fitted throughout. The ESB power supply cable enters the building to the right hand side of the front door with the meter box located directly inside.</li><li>-A redundant alarm box is fixed to the wall near the first floor window.</li></ul>

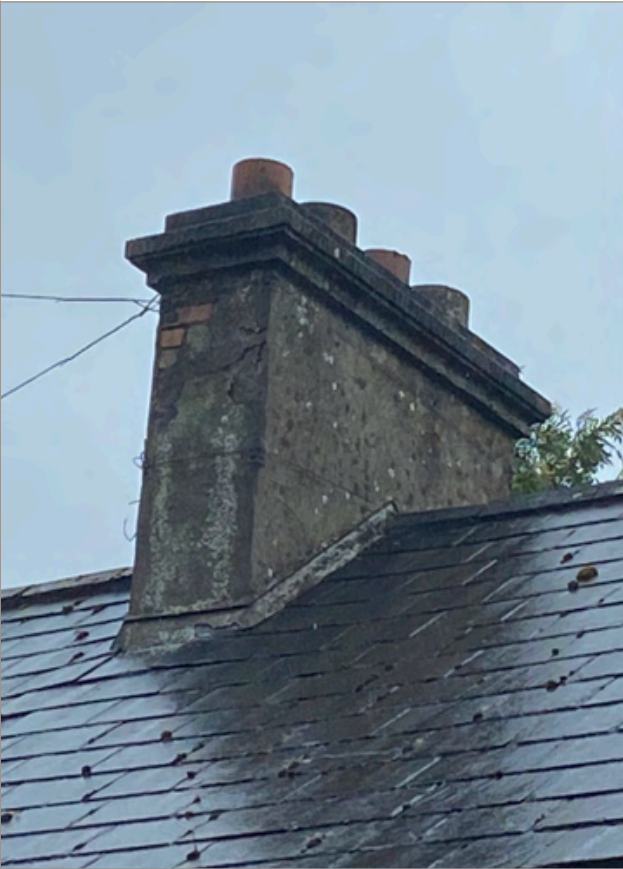
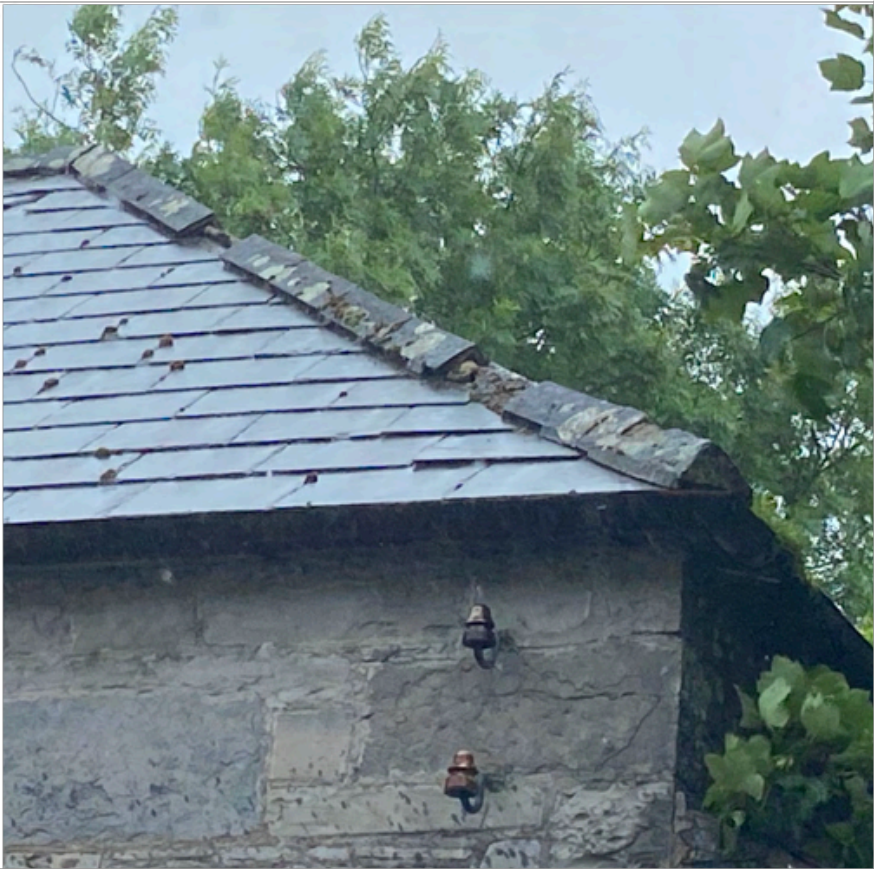
005	<p><b>2 Storey Cottage - Roof - Northern Slope</b></p> <ul style="list-style-type: none"><li>- Chimney stack constructed of brick with a render finish (likely sand/cement) with 4no. ceramic chimney pots.</li><li>- Visible damage / cracking to render finish with brick structure visible beneath. Damaged flashing / cement haunching around base.</li><li>- Damaged / missing ridge tiles to roof. Loose / slipped slates throughout. Remedial action required to prevent ingress of water.</li><li>- Cast-iron rainwater goods - damaged / missing / leaking in sections. Generally in poor condition.</li><li>- Redundant ceramic telephone pole insulators are located on the extreme right hand corner of the front elevation at high level.</li></ul>

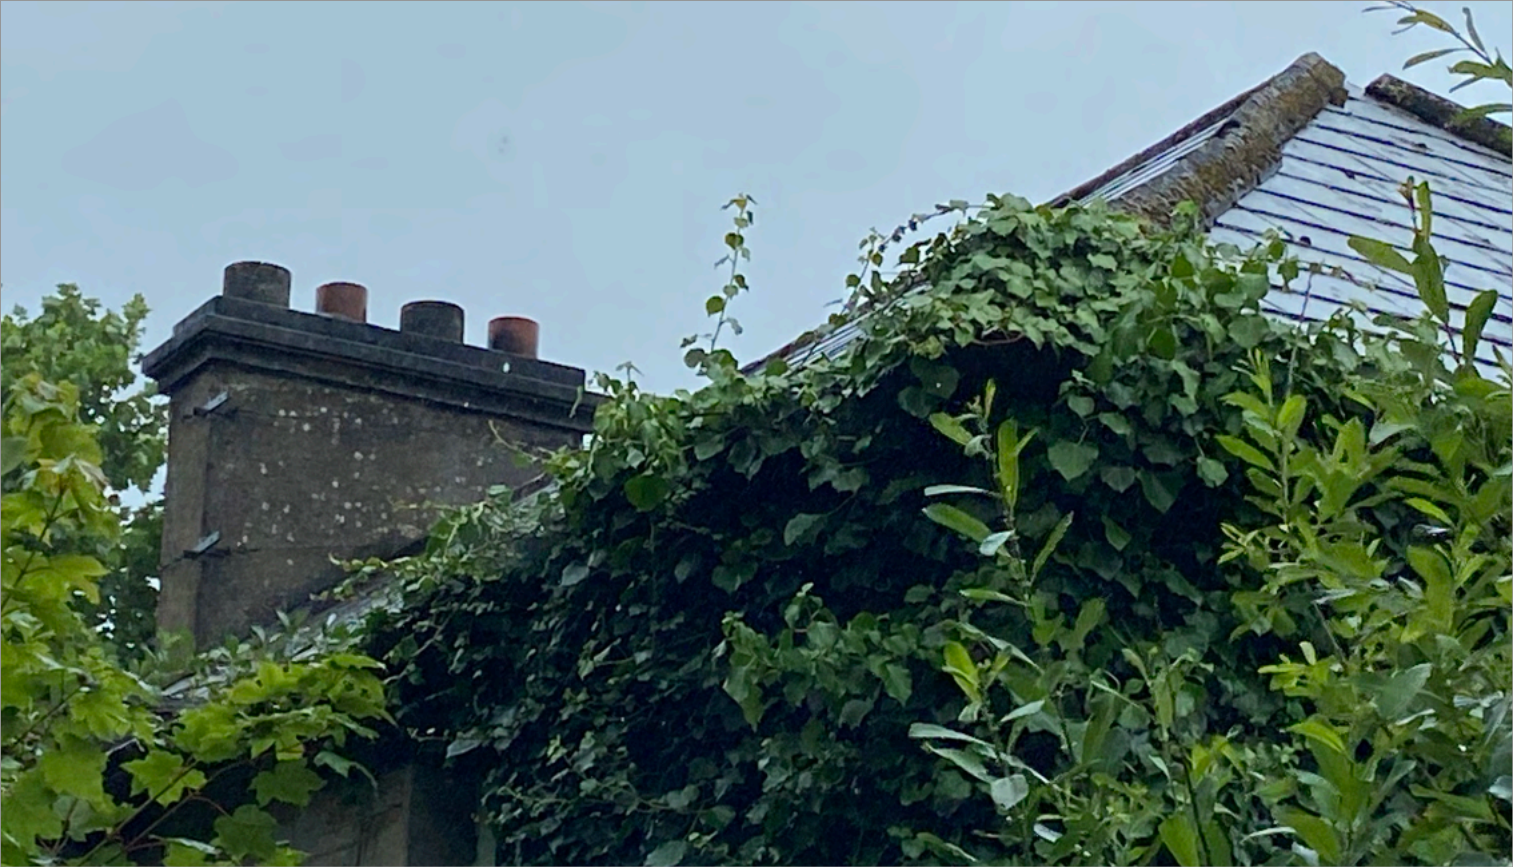
Fig. A	Fig. B
006	<p><b>2 Storey Cottage - Roof - Southern Slope</b></p> <ul style="list-style-type: none"><li>- Chimney stack constructed of brick with a render finish (potentially sand/cement) with 4no. ceramic chimney pots.</li><li>- Damaged / missing ridge tiles to roof. Loose / slipped slates. Remedial action required to prevent ingress of water.</li><li>- Cast-iron rainwater goods - damaged / missing / leaking in sections. Generally in poor condition. Significant ivy growth / vegetation.</li></ul>

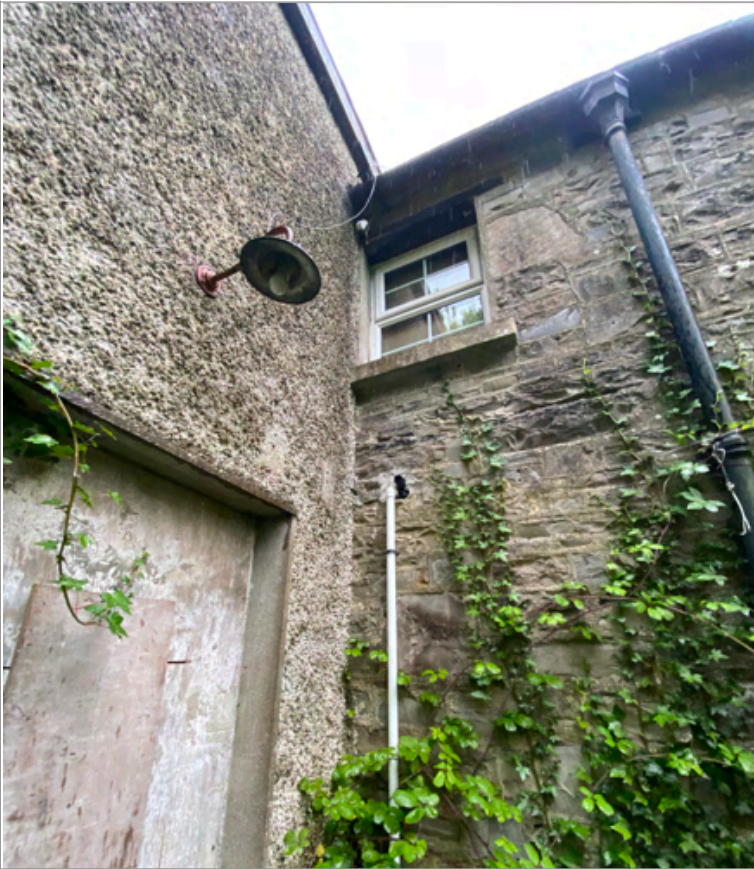
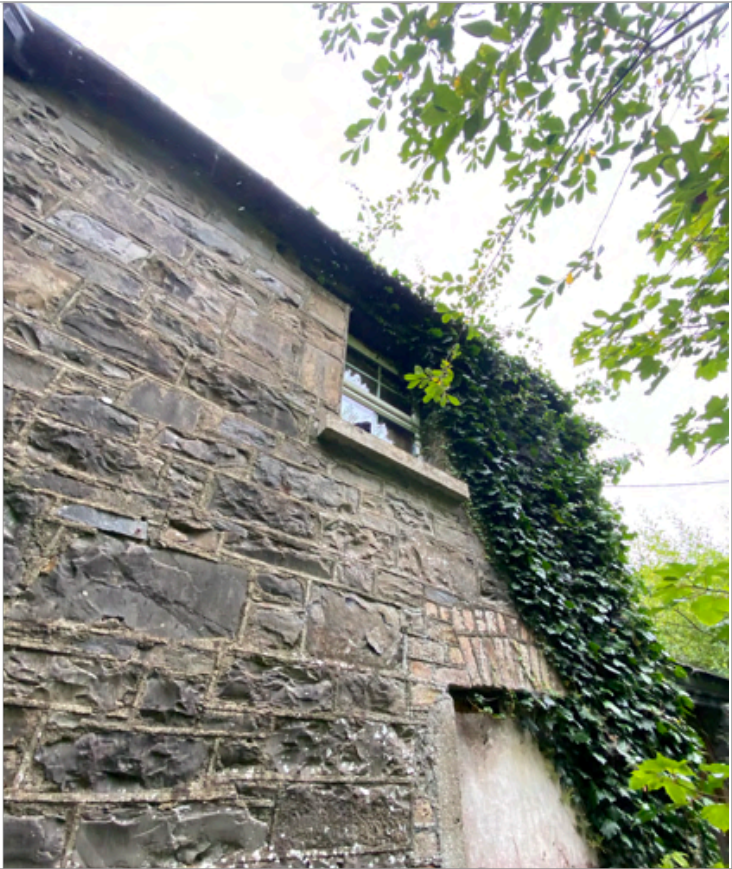
007	<p><b>2 Storey Cottage - South Elevation</b></p> <p><b>Fig. A</b> - Small PVC windows to first floor which appear to be similar in scale to those on the front elevation.</p> <ul style="list-style-type: none"><li>- Cast iron gutters are in poor condition.</li><li>- Door opening to eastern gable of two storey extension leading to kitchen interior. Vintage industrial style metal pipe wall light above.</li></ul> <p><b>Fig. B</b> - Arched / splayed brick detail above door opening leading to shop interior. Significant ivy growth / vegetation.</p>

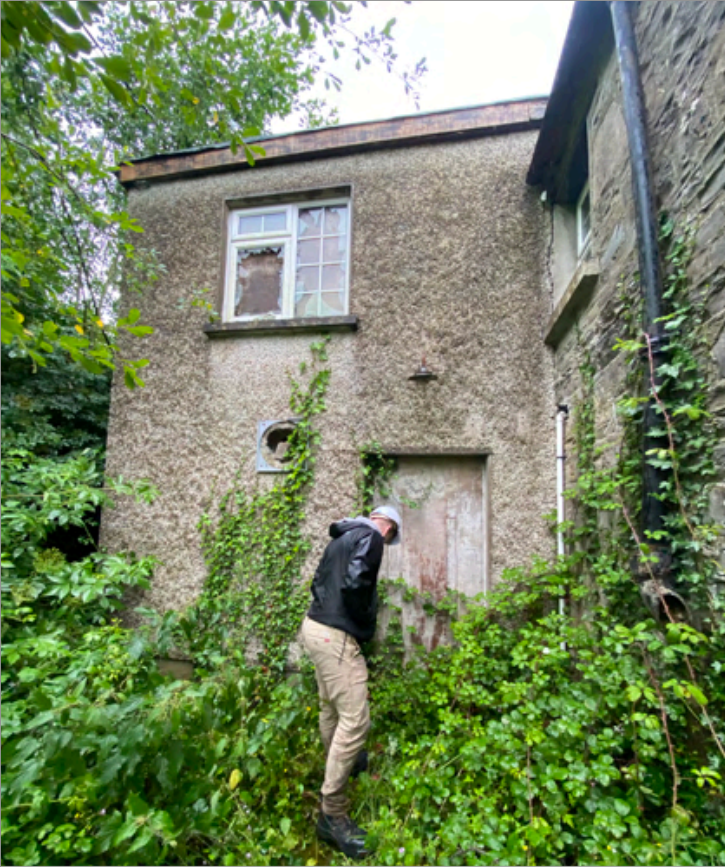
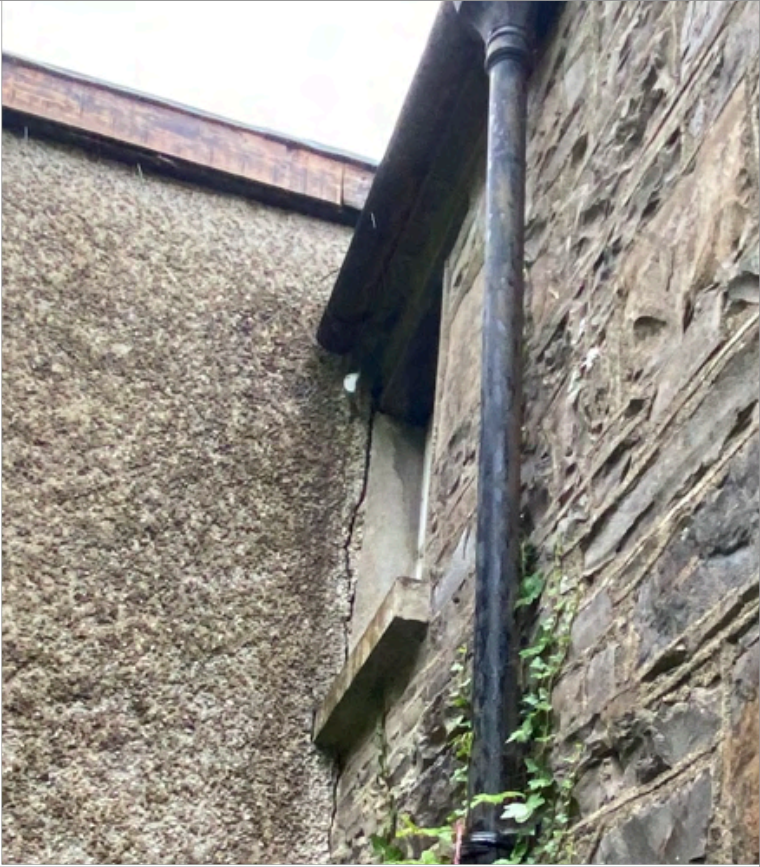
Fig. A	Fig. B
008	<p><b>Flat Roof Extension - East Elevation</b></p> <p><b>Fig. A</b> - Door opening to eastern gable of two storey extension leading to kitchen interior.</p> <ul style="list-style-type: none"><li>- First floor PVC window to bathroom has been smashed.</li><li>- Roughcast sand/cement render finish to two storey extension. Hole formed for extract vent.</li></ul> <p><b>Fig. B</b> - Significant visible cracking at intersection of two storey extension and stonework of original cottage. The extension appears to be decoupling / pulling away from original building as width and depth of crack increases with height.</p>

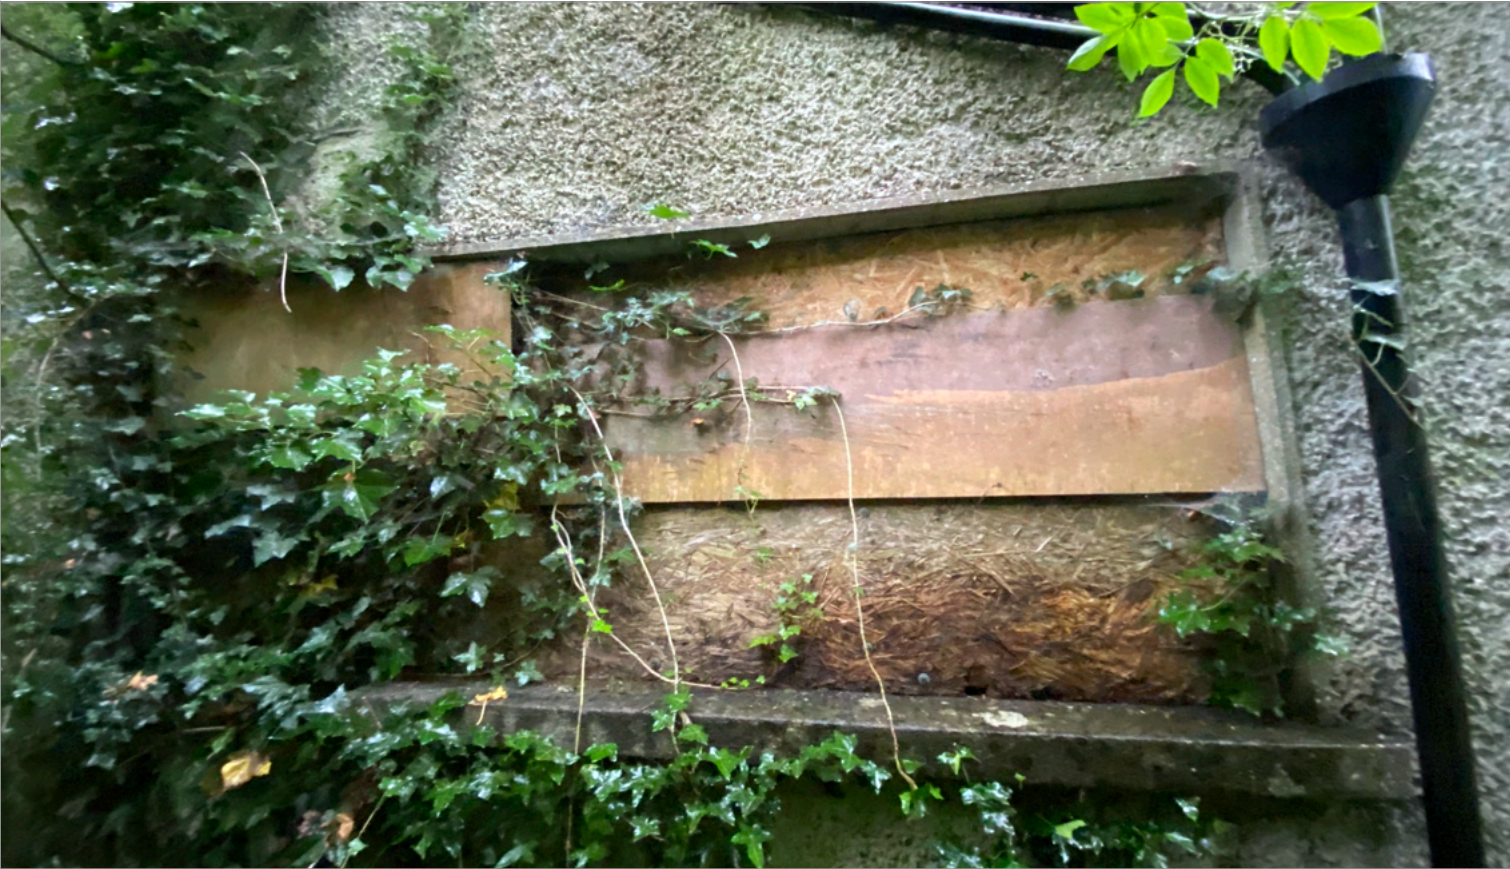
009	<p><b>Flat Roof Extension - South Elevation</b></p> <ul style="list-style-type: none"><li>- Window opening to kitchen with precast concrete cill overgrown with ivy.</li><li>- PVC waste pipes from first floor bathroom visible.</li></ul>

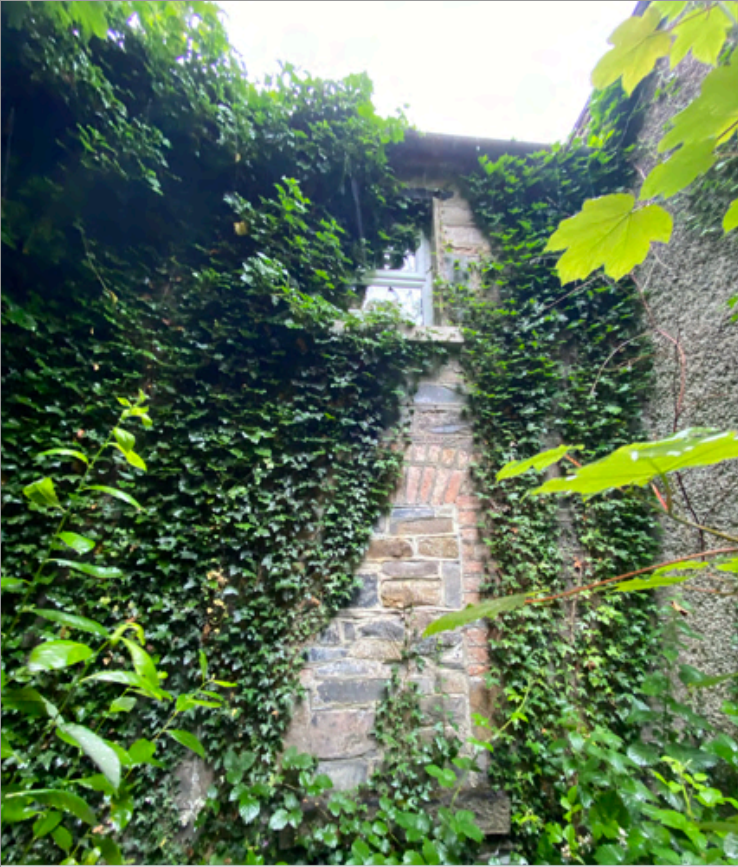
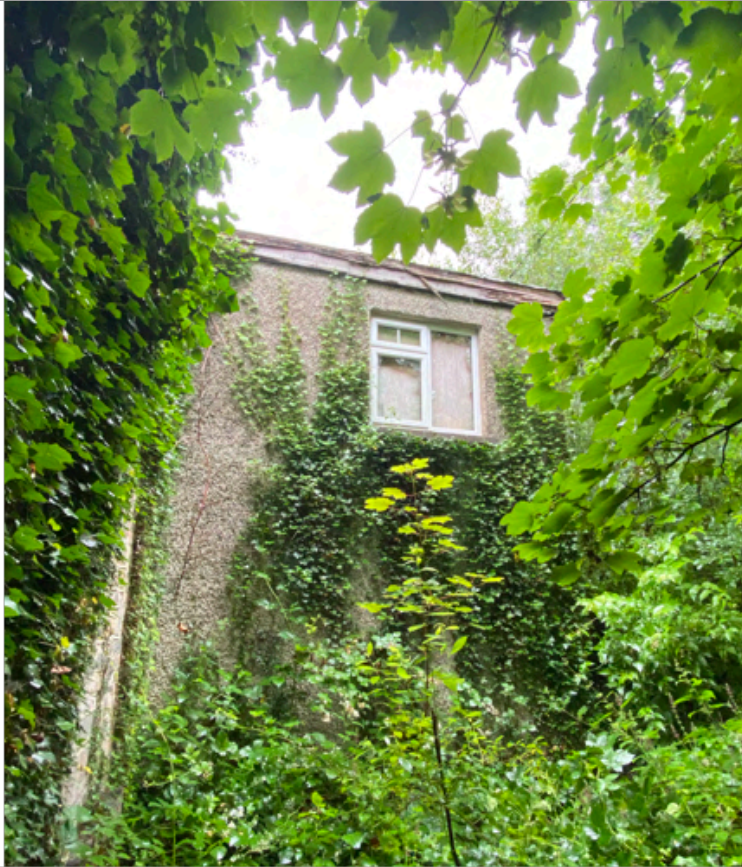
</div> <div>Fig. A</div> <div>Fig. B</div>

010	<p><b>2 Storey Cottage - South Elevation</b></p> <p><b>Fig. A</b> - Significant ivy growth to south elevation of cottage. Larger ground floor window opening formed with splayed brick head / surround and natural stone cill which has been blocked up with stone work.</p> <ul style="list-style-type: none"><li>- Small window similar to front elevation visible at first floor level.</li></ul> <p><b>Flat Roof Extension - West Elevation</b></p> <p><b>Fig. B</b> - Significant ivy / vegetation growth to rear elevations generally.</p> <ul style="list-style-type: none"><li>- Timber fascia to flat roof extension is rotten.</li><li>- PVC window frame with broken glazing (located at top of stairs).</li></ul>	<div>

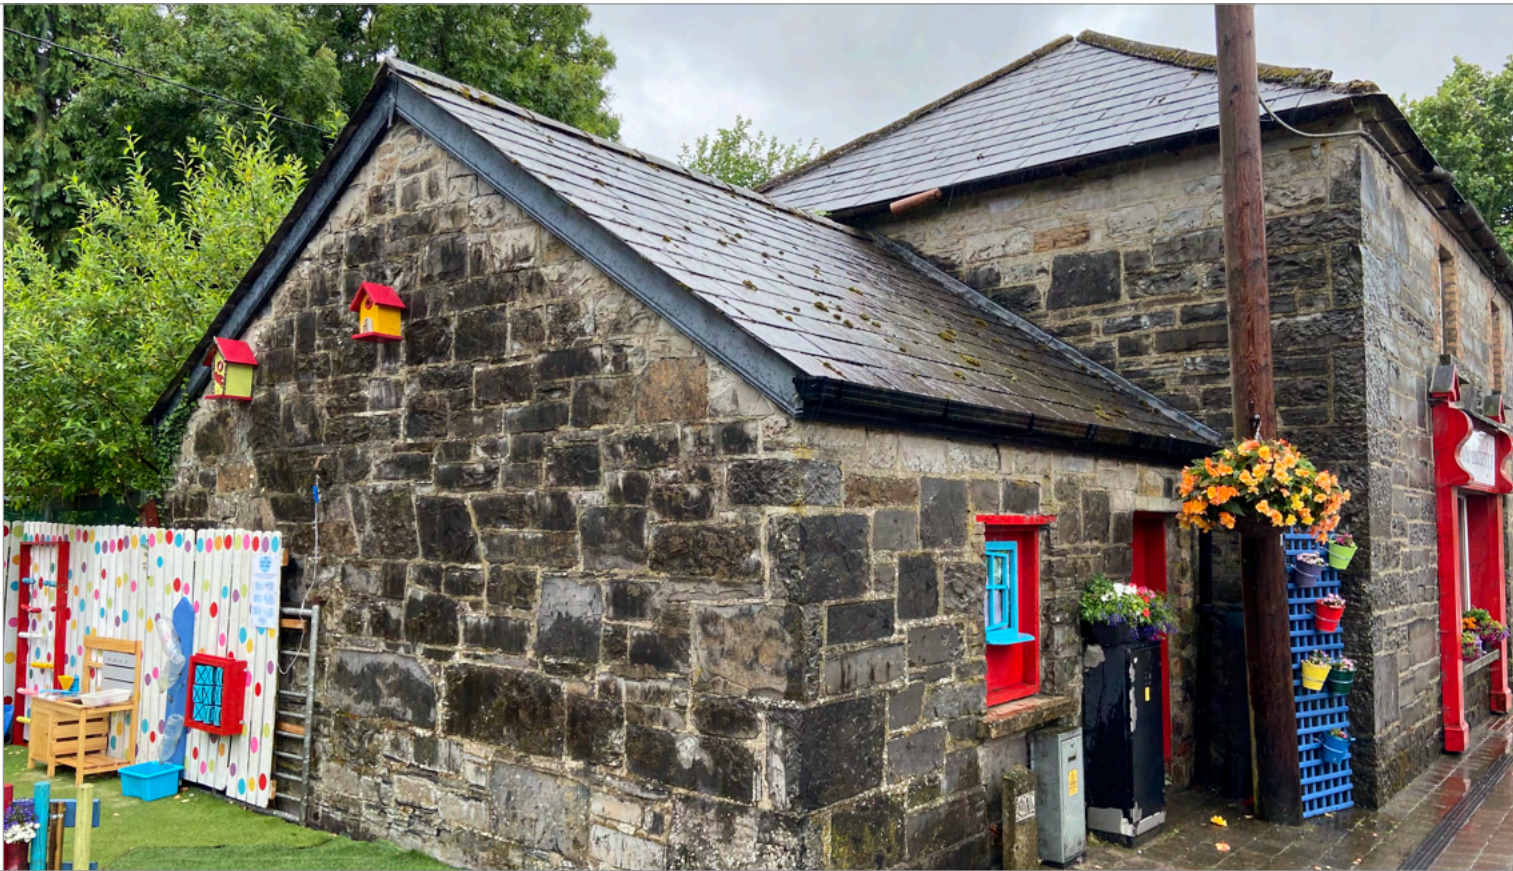
- Single story outbuilding with a slated, pitched roof situated to the eastern side of the main 2 storey building.
- Modern PVC fascia & aluminium rainwater goods.
- Flashing to roof slopes which abut 2 storey gable appear to be in fair condition with no visible water ingress internally.
- Coursed stone masonry construction in similar style to main 2 storey block.
- Note the lack of red brick details to window and door openings. Cill profile differs from traditional large stone cills featured on 2 storey block and appears to be more modern, matching large shop window opening to front elevation.
- Door and window opening feature on external elevation only and are blocked up / not visible from the interior.
- Various infrastructure including a telegraph pole, ESB box are positioned immediately adjacent to the front elevation.

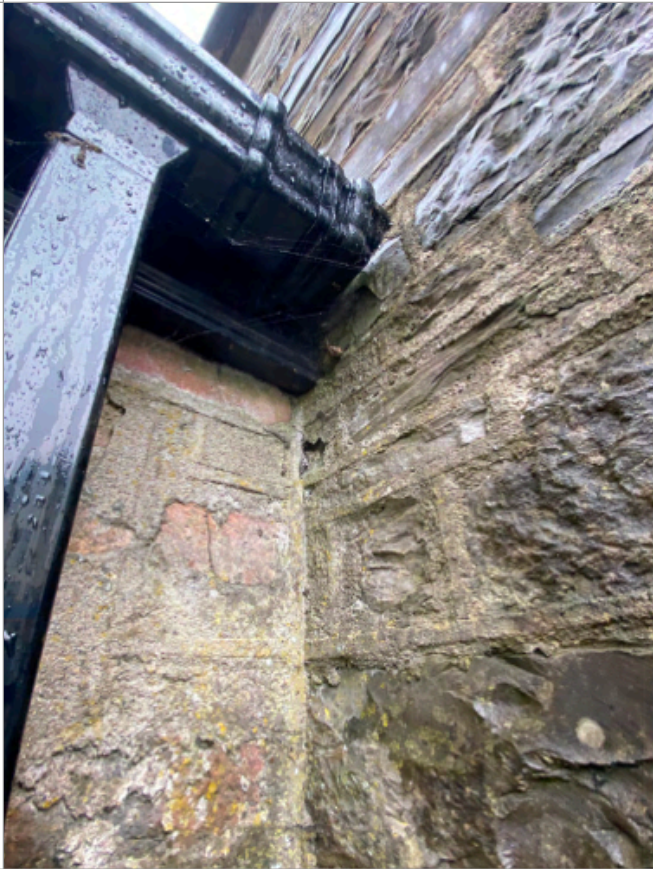
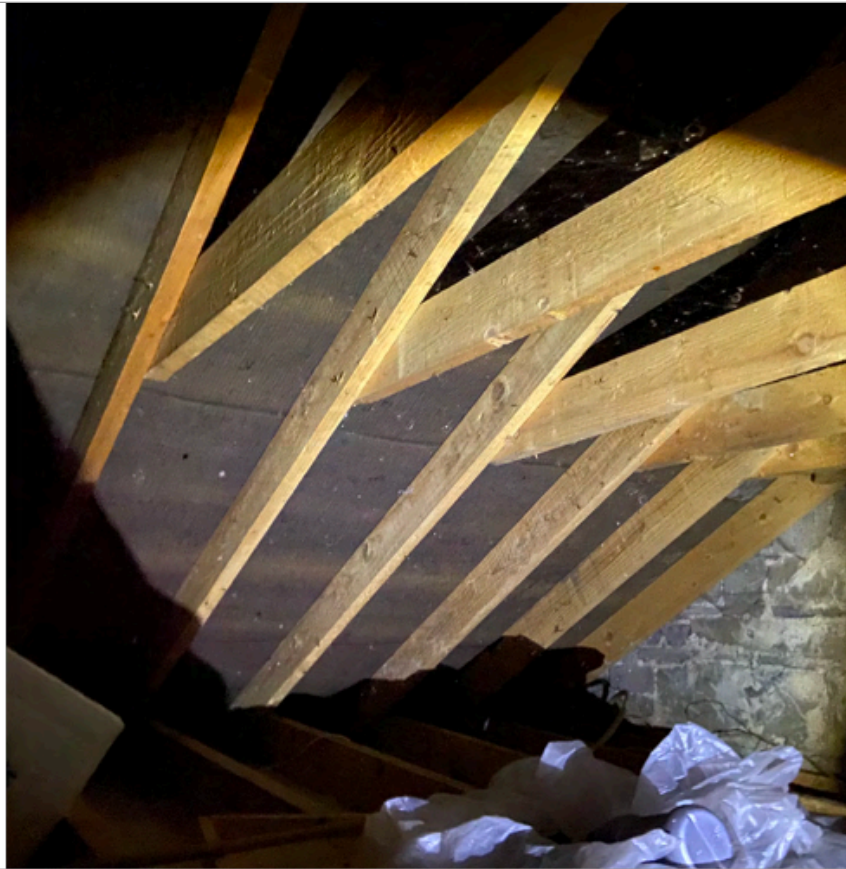
Fig. A

- Detail image illustrates that the single storey outbuilding abutting the gable of the 2 storey building.
- Modern timbers and roof construction internally in good condition with plasterboard ceiling below. Roof void appears to be uninsulated.
- The shop floor extends into the outbuilding internally.

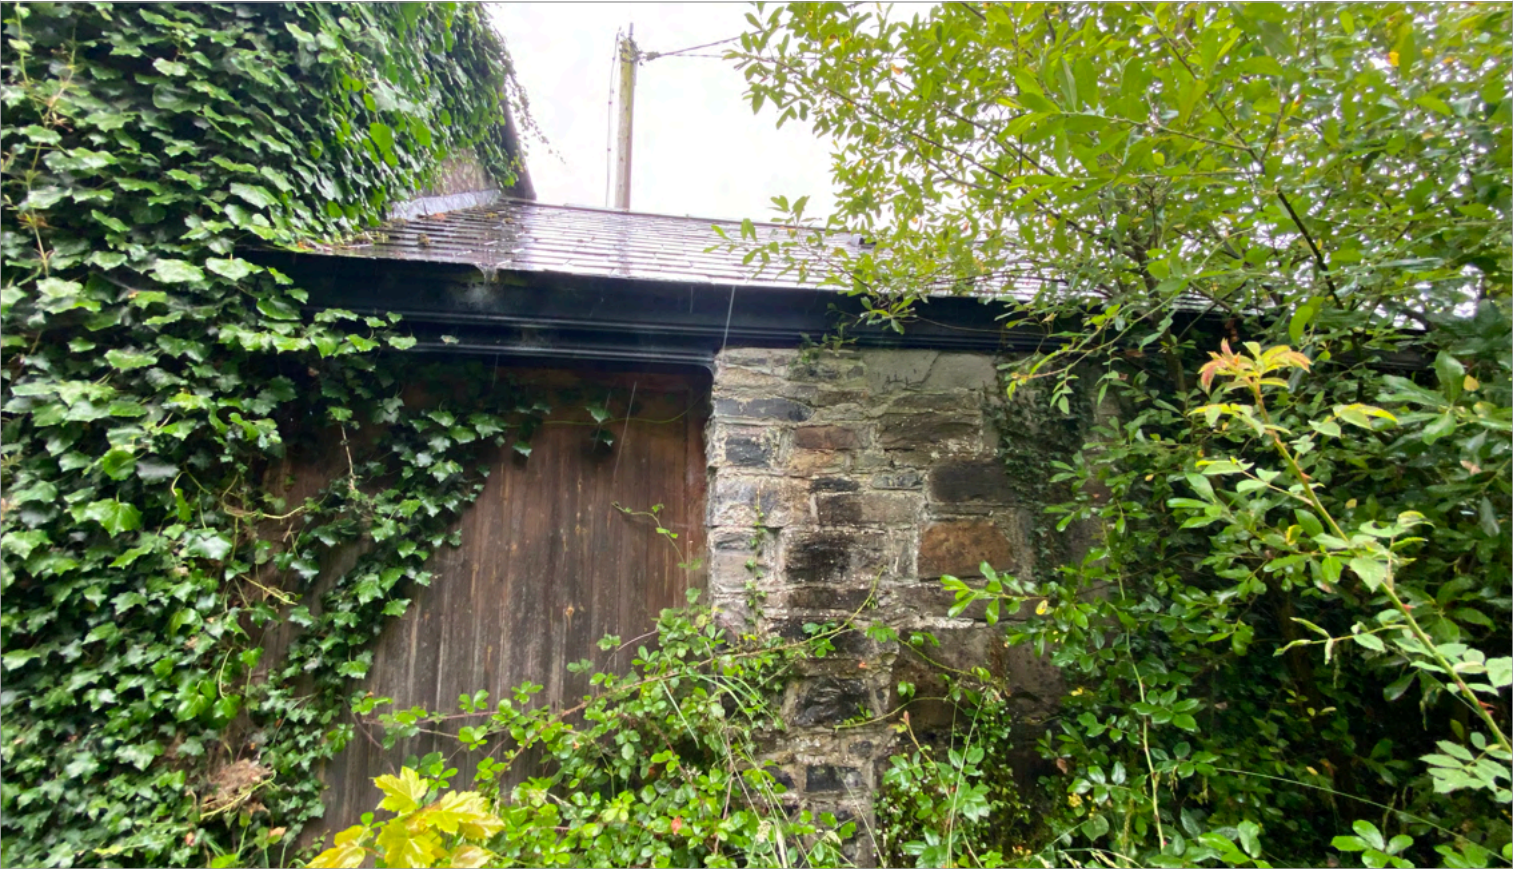
015	<p><b>Single Storey Outbuilding (East)</b></p> <p>South facing rear elevation of the single storey extension features a large door opening which is hinged off the gable of two storey building. Significant ivy growth / vegetation.</p>

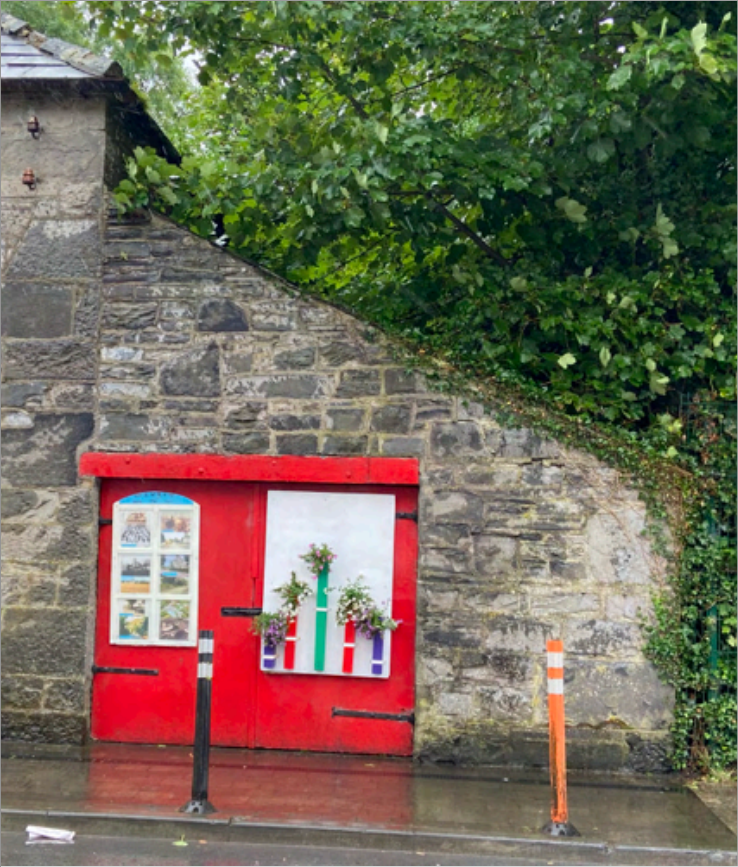
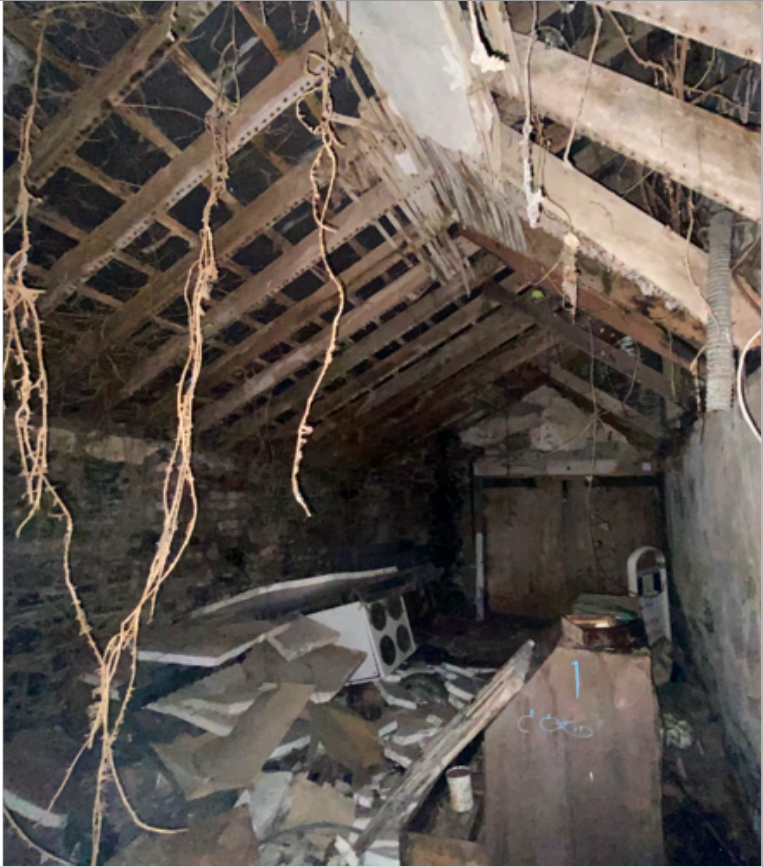
</div> <div><div>Fig. A</div><div>Fig. B</div></div>

016	<p><b>Lean-to Store (West)</b></p> <ul style="list-style-type: none"><li>- Single story, lean-to store with a mono-pitch roof.</li><li>- Coursed rubble stone masonry construction which abuts the main two storey building. Stonework does appear to form part of the original wall construction - not keyed in.</li><li>- Timber beam over two outward opening timber gates.</li><li>- Significant vegetation and ivy growth to west side and rear with roots penetrating the interior. Large tree in close proximity.</li><li>- Internally, the roof is in very poor condition. Evidence of significantly deteriorated lath and plaster ceiling and large amount of debris on the ground.</li><li>- Brick wall finished in plaster built against 2 storey gable wall to provide support for roof structure.</li></ul>	<div>

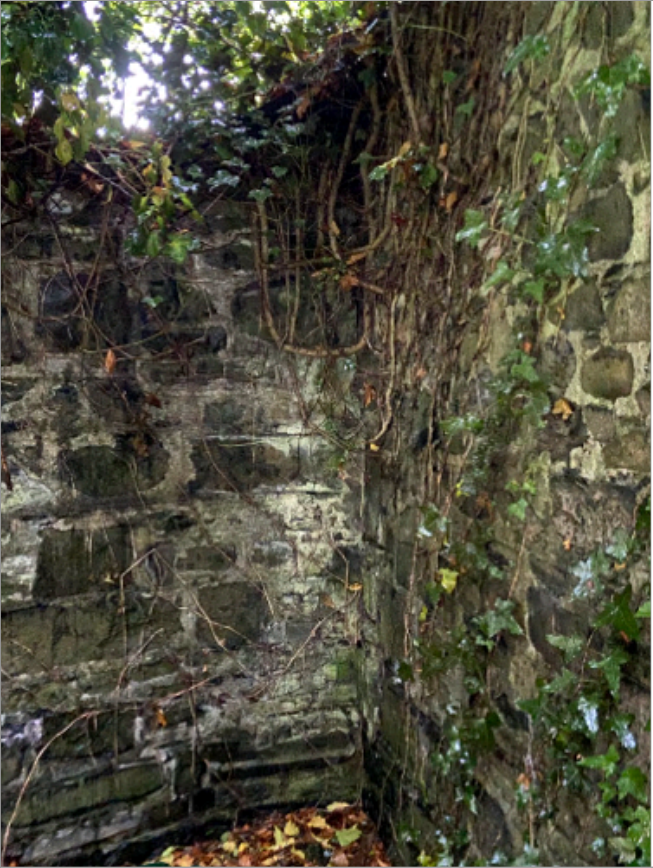
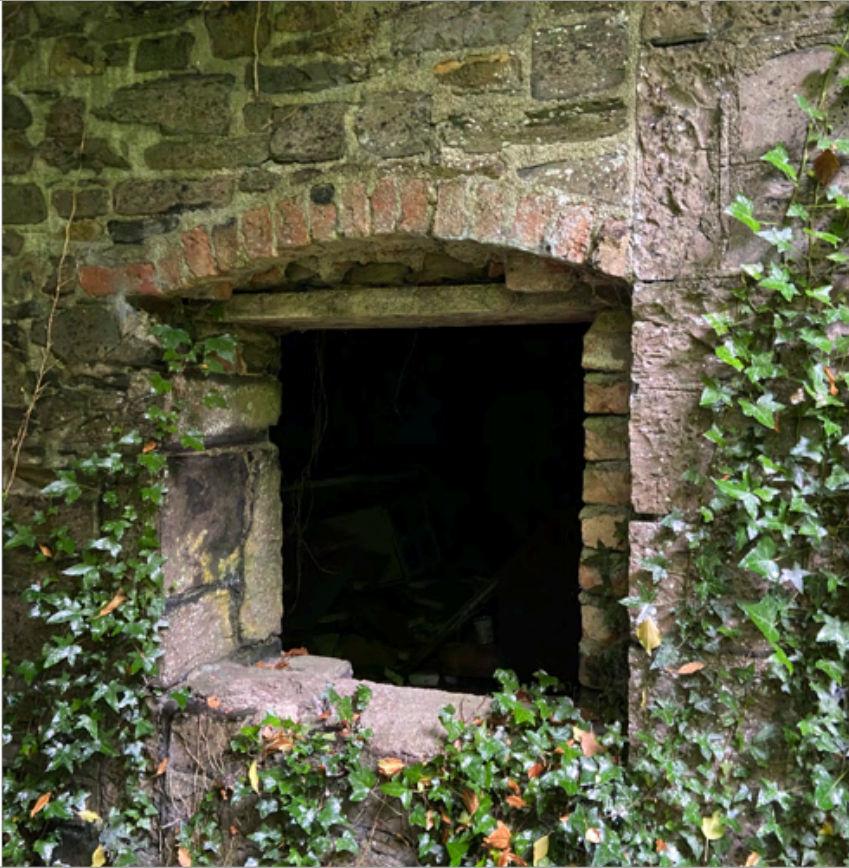
Fig. A	Fig. B
016	<p><b>Lean-to Store (West)</b></p> <p>- Small window opening with arched brick construction to rear provides some access to the interior. Upper section of rear elevation appears to be rubble stone masonry - further evidencing later stage of construction.</p> <p>- Curving stone wall approx. 1.8m-2.0m high abuts the rear elevation of the lean-to. West elevation extremely overgrown / in-accessible for survey.</p>

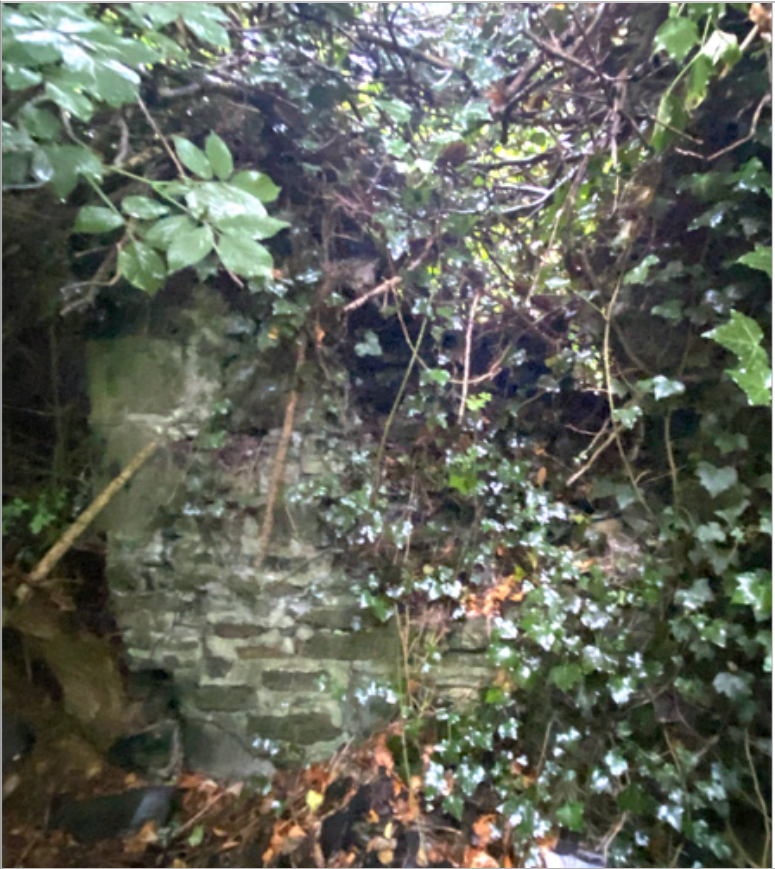
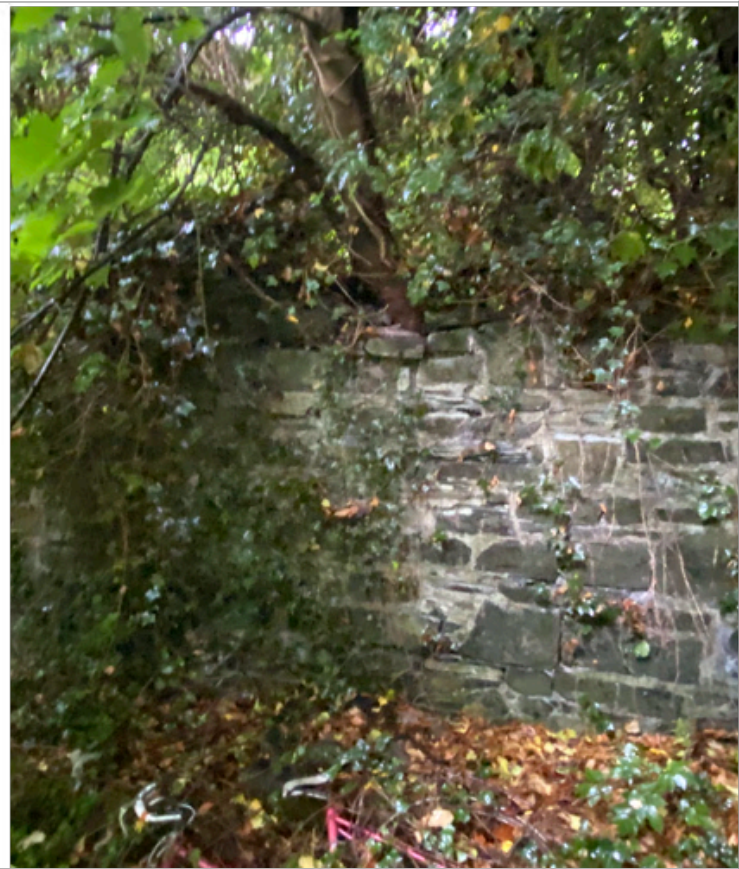
017	<p><b>Stone boundary wall to rear</b></p> <p>Curving stone wall approx. 1.8m-2.0m high.</p> <p><b>Fig A</b> - Short section at end of stone wall which returns at right angle. In poor condition / partially collapsed and heavily overgrown.</p> <p><b>Fig B</b> - Longer section of stone wall with large trees growing in close proximity. This section generally appears to be stable / mostly intact with some majority of damage to top section. Removal of trees could cause further damage to wall due to proximity of root systems.</p>
