# Old Johnstown Village

## **Draft** Public Realm and Regeneration Plan

## Mrs Butterly's Condition Survey

The following pages outline the condition survey report on the Mrs Butterly's Building completed by Hall Black Douglas in July 2024.

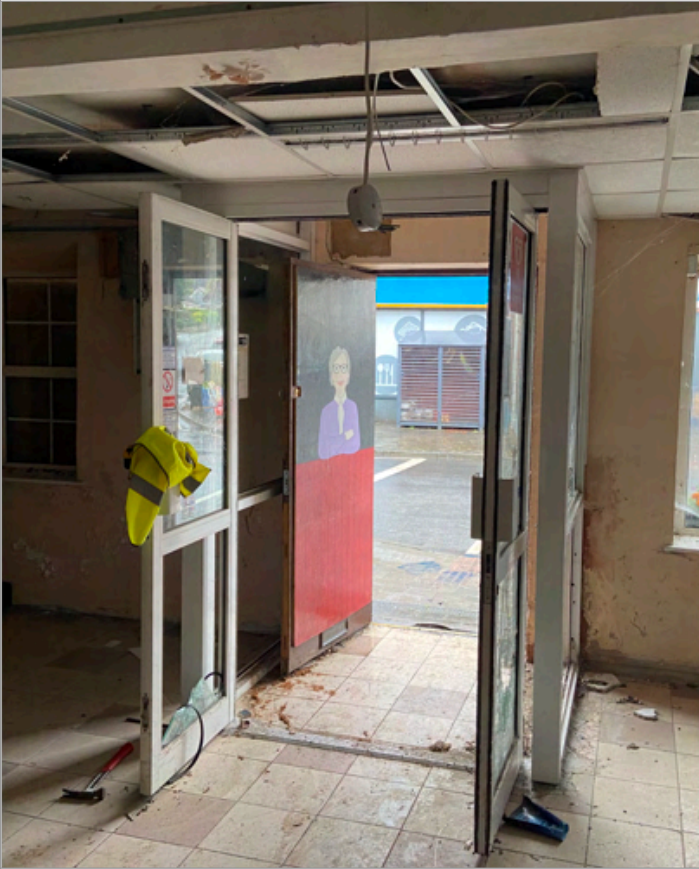
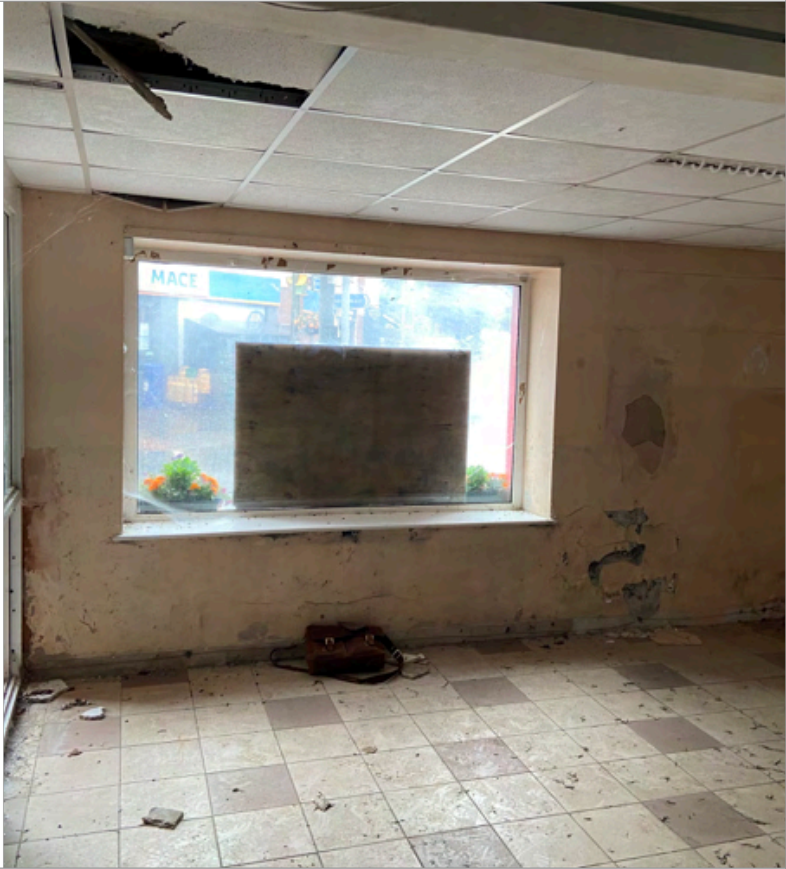
Fig. A	Fig. B
018	<p><b>2 Storey Cottage - Interior - Ground Floor - Shop Floor</b></p> <p><b>Fig A</b> - Glazed PVC draft lobby inside main front door with broken glass panes. Suspended ceiling above in poor condition.</p> <p><b>Fig B</b> - Large double glazed shop window opening with timber cill internally. Evidence of damage / localised dampness to internal plasterwork.</p> <ul style="list-style-type: none"><li>- Generally dry with no obvious water ingress from above.</li><li>- Ceramic tiled floor.</li></ul>

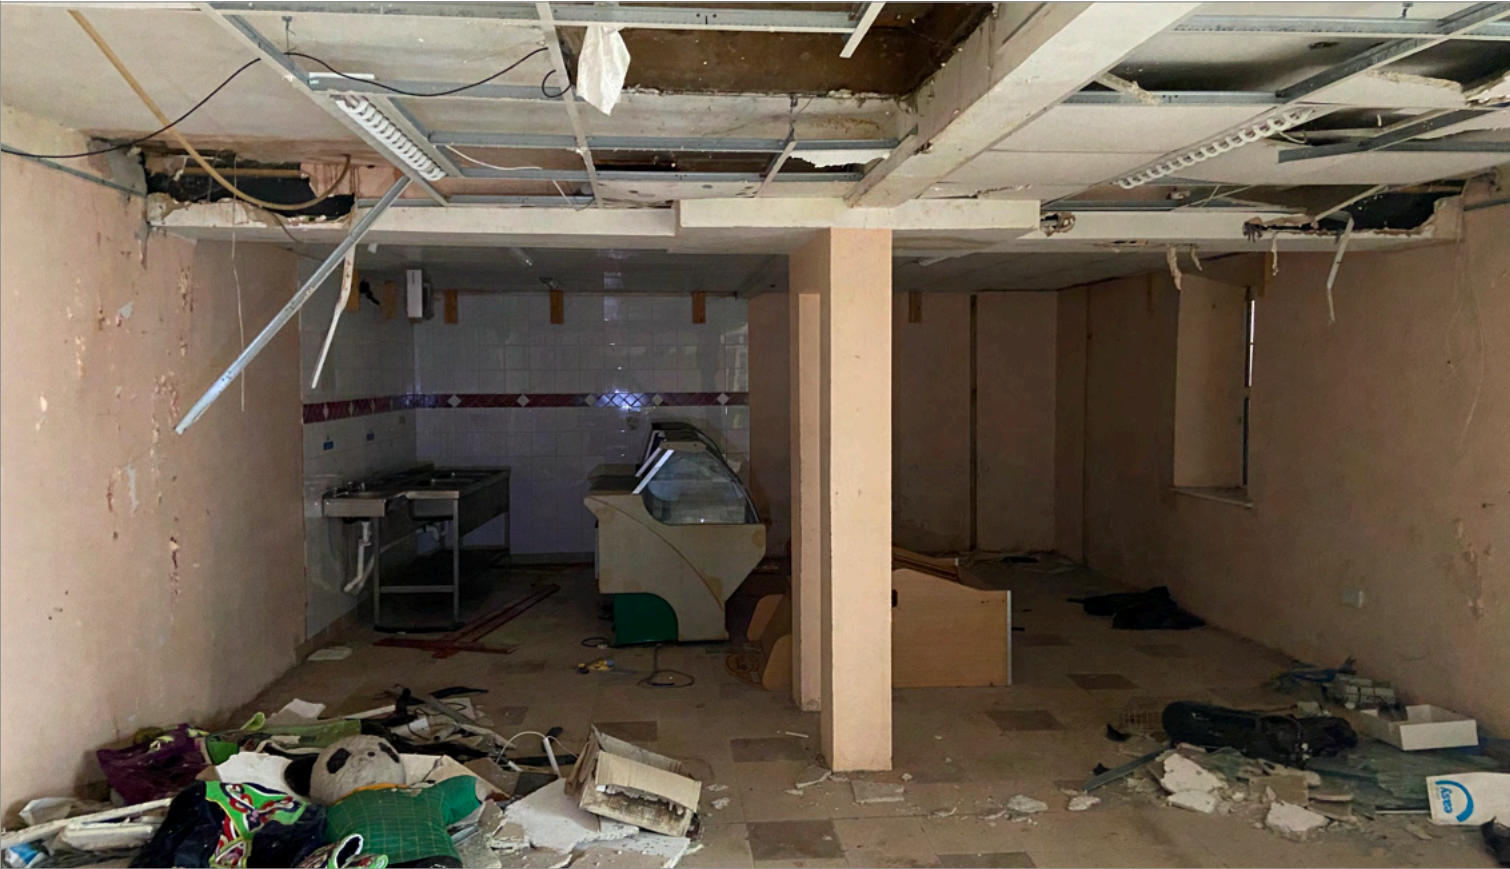
019	<p><b>2 Storey Cottage - Interior - Ground Floor - Shop Floor</b></p> <p>Two steel columns and steel beam structure supporting timber first floor above. Position of steel columns within the space indicate they are likely supporting chimney structure above. Columns and beams boxed out in plasterboard.</p> <ul style="list-style-type: none"><li>- Suspended ceiling partially removed and in poor condition.</li><li>- Generally dry with no obvious water ingress from above.</li></ul>

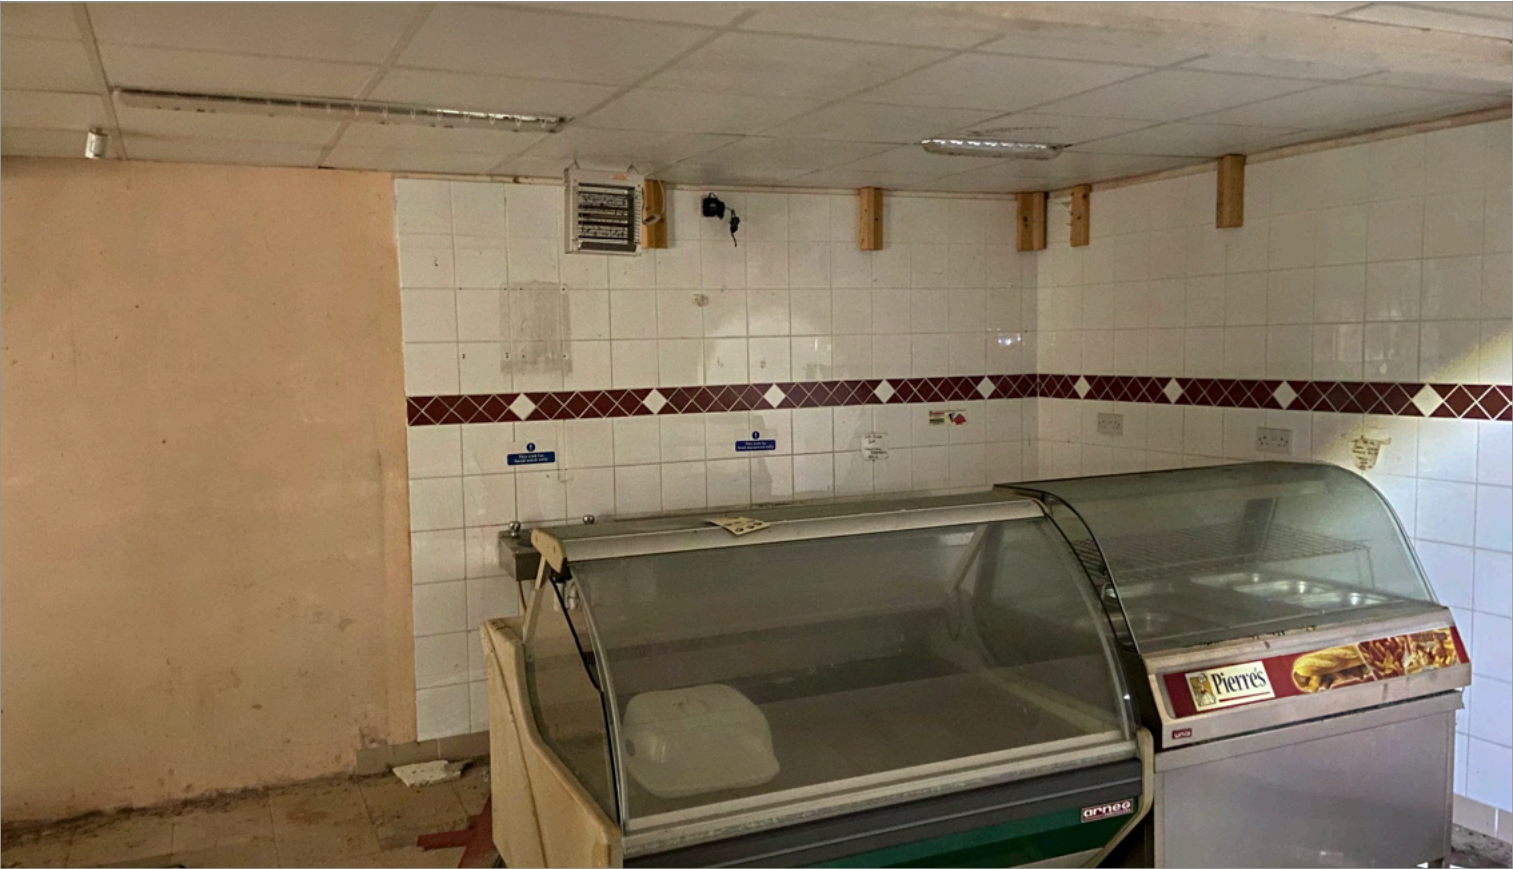
021	<p><b>2 Storey Cottage - Interior - Ground Floor - Shop Floor</b></p> <ul style="list-style-type: none"><li>- Tiled wall surface to corner of shop floor used as deli.</li><li>- Blocked up window opening identified on rear elevation located in this area.</li></ul>

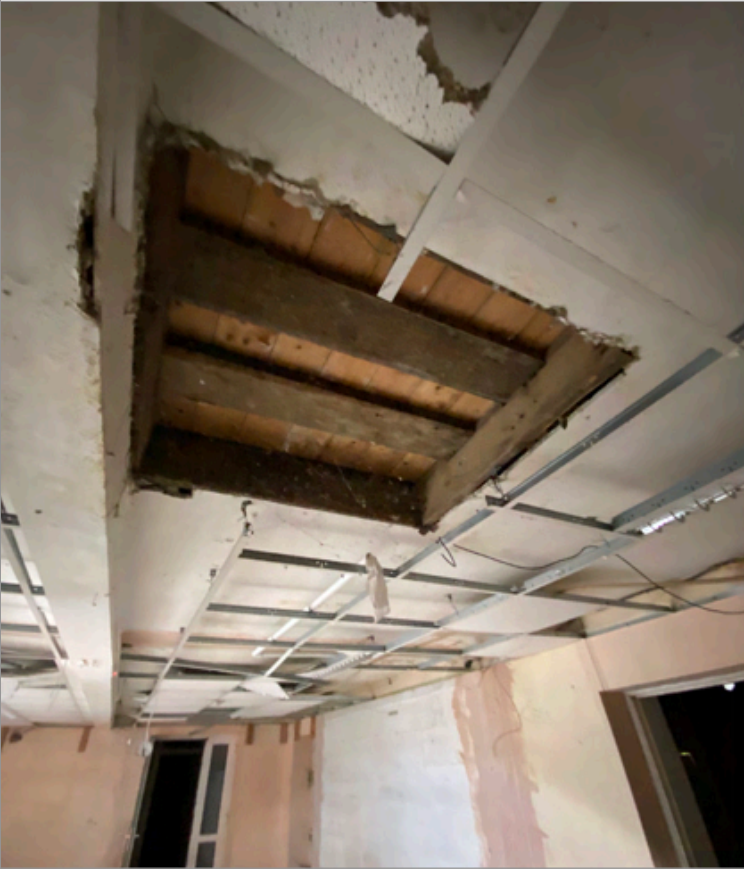
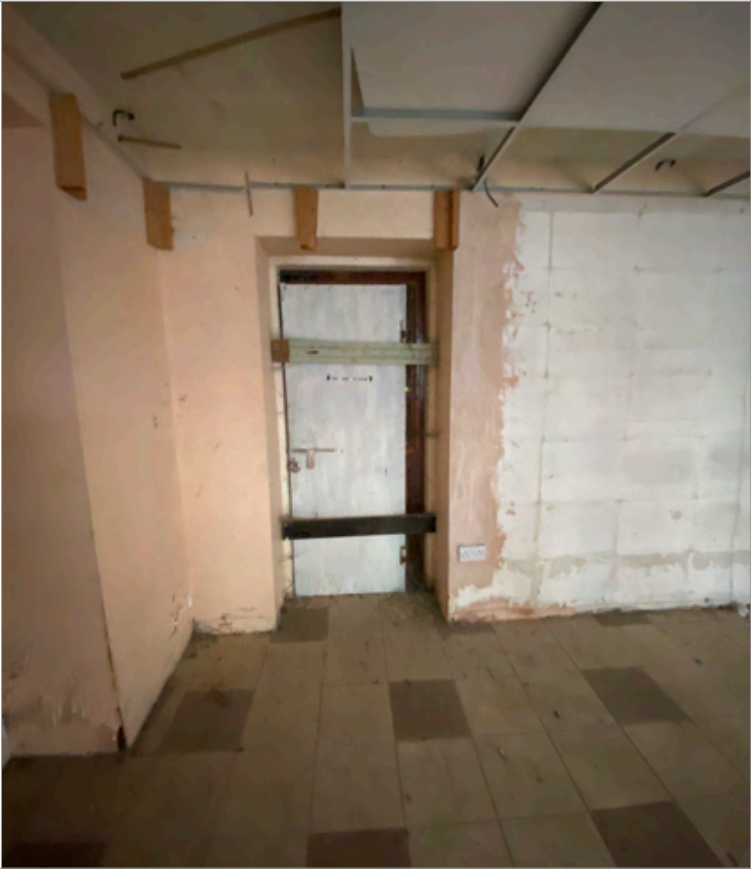
</div> <div><p>Fig. A</p><p>Fig. B</p></div>

022	<p><b>2 Storey Cottage - Interior - Ground Floor - Shop Floor</b></p> <p><b>Fig. A</b> - First floor timber floor structure visible above suspended ceiling. Appears to be in fair condition.</p> <p><b>Fig. B</b> - Rear door opening leading to back yard area.</p>	<div>

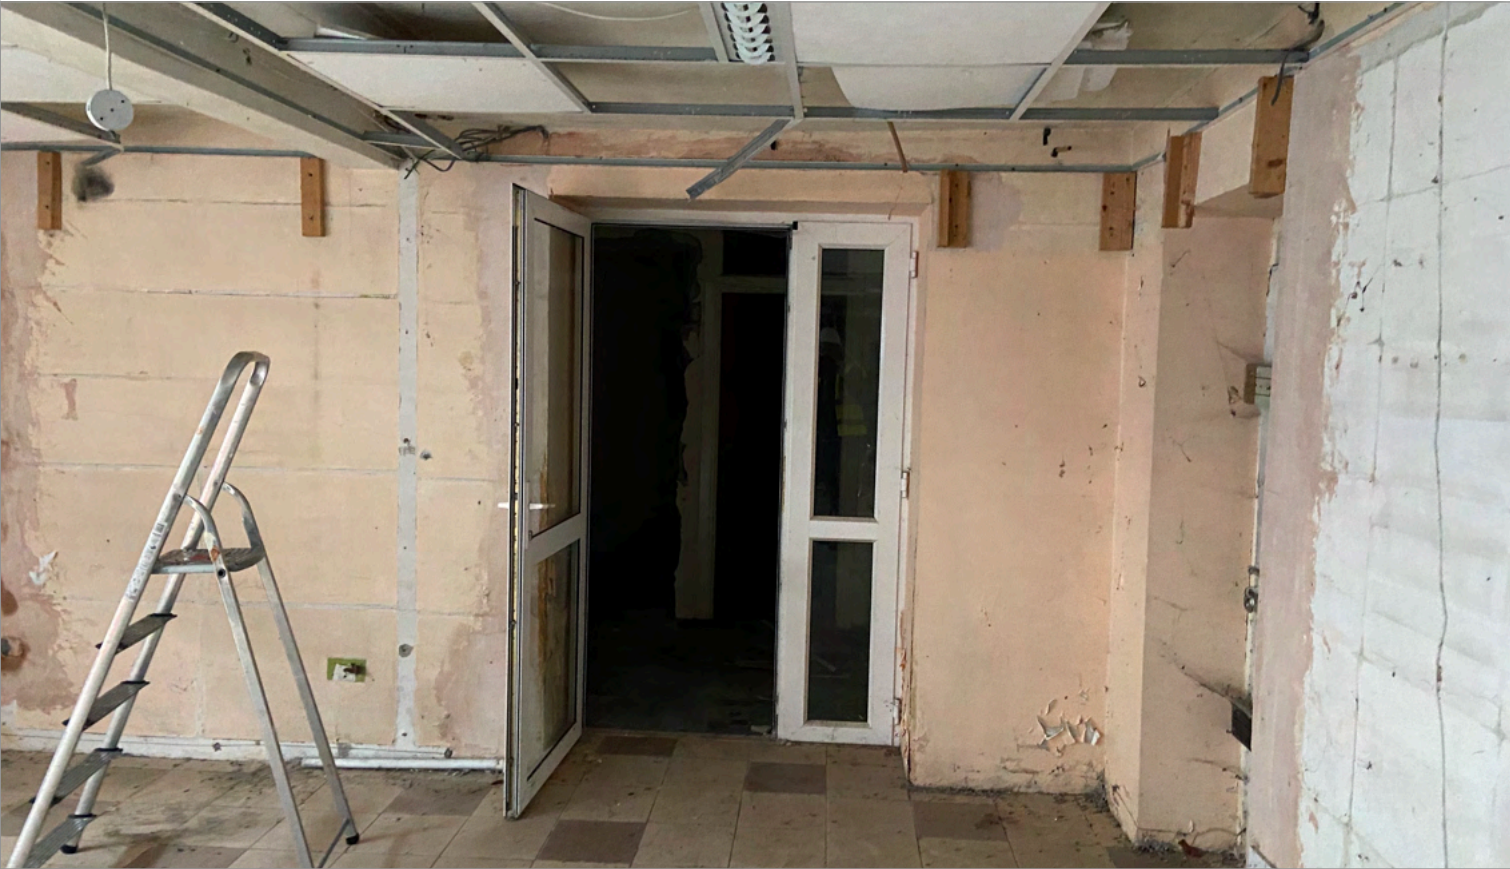
023	<p><b>2 Storey Cottage - Interior - Ground Floor - Shop Floor</b></p> <ul style="list-style-type: none"><li>- Door opening formed within eastern gable wall of 2 storey cottage leading to <b>Single Storey Extension (East)</b>.</li><li>- Glazed PVC door and side light. Plaster finish to wall in generally in poor condition with evidence of shelving / fixings now removed.</li></ul>

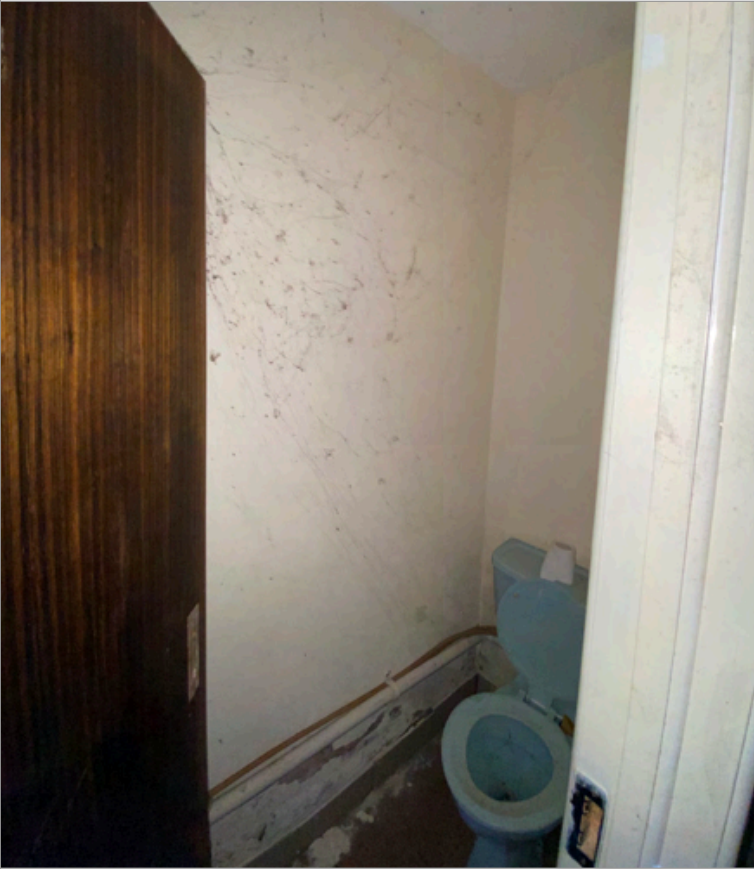
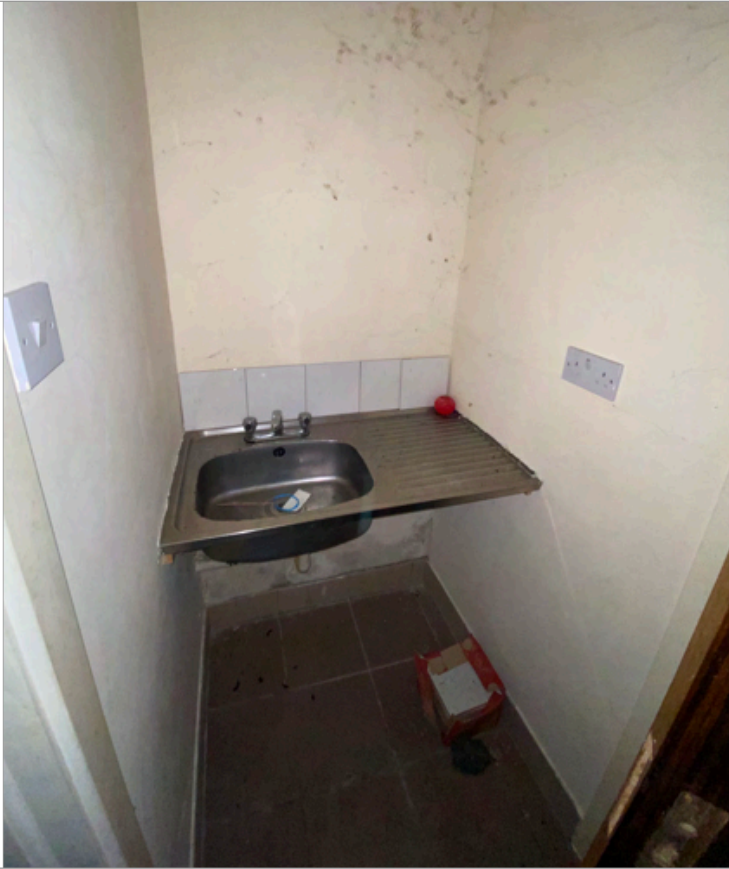
</div> <div>Fig. A</div> <div>Fig. B</div>

024	<p><b>Single Storey Extension (East) - Interior</b></p> <p>Small WC and washbasin formed of modern single skin concrete blockwork within single storey outbuilding. Evidence of possible rising damp issues at low level.</p> <ul style="list-style-type: none"><li>- Generally dry with no obvious water ingress.</li><li>- Plasterboard ceiling above.</li></ul>	<div>

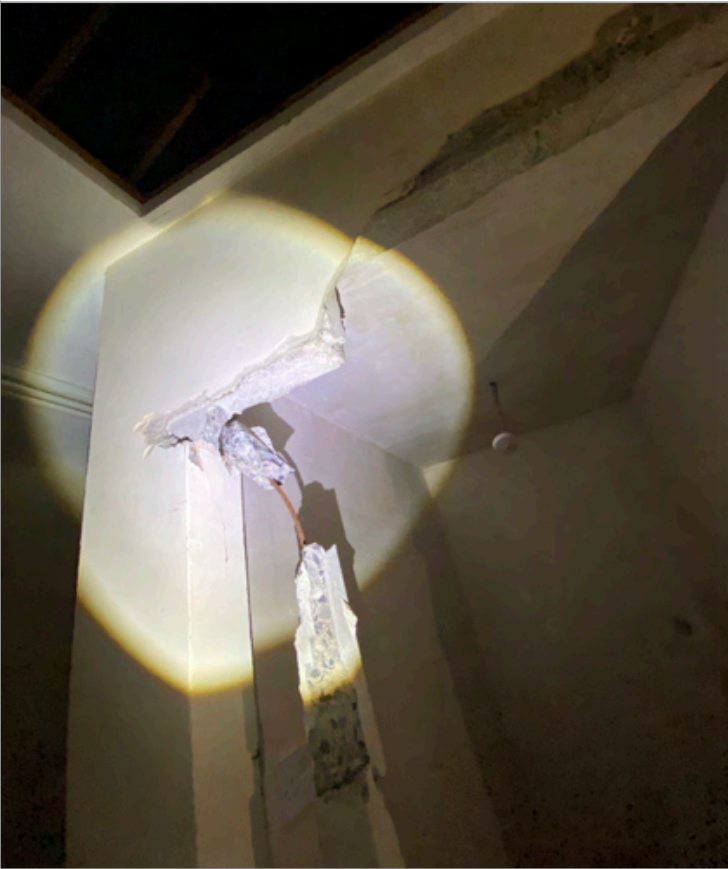
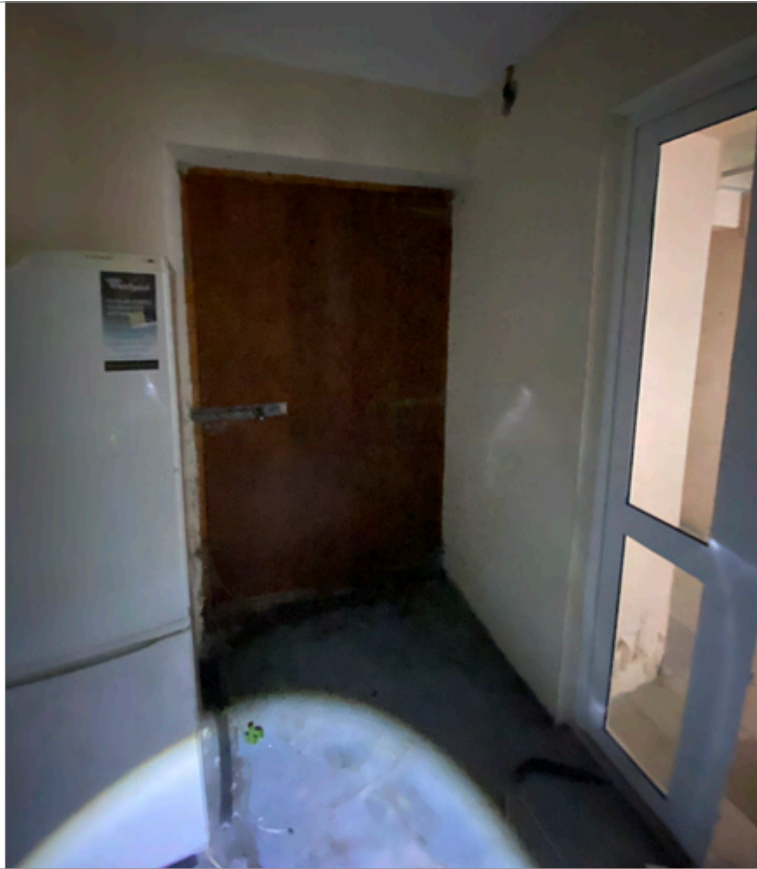
025	<p><b>Single Storey Outbuilding (East) - Interior</b></p> <p><b>Fig. A</b> - Storage area formed of modern single skin concrete blockwork. Damaged concrete lintel over opening. Possibly former location of refrigeration unit now removed.</p> <p>- Access hatch formed in plasterboard ceiling above.</p> <p><b>Fig. B</b> - Wide door leading to rear yard. Condition of structure generally sound. Relatively modern materials and finishes further indicate the single storey outbuilding has been recently refurbished with a new roof and internal fit out.</p>

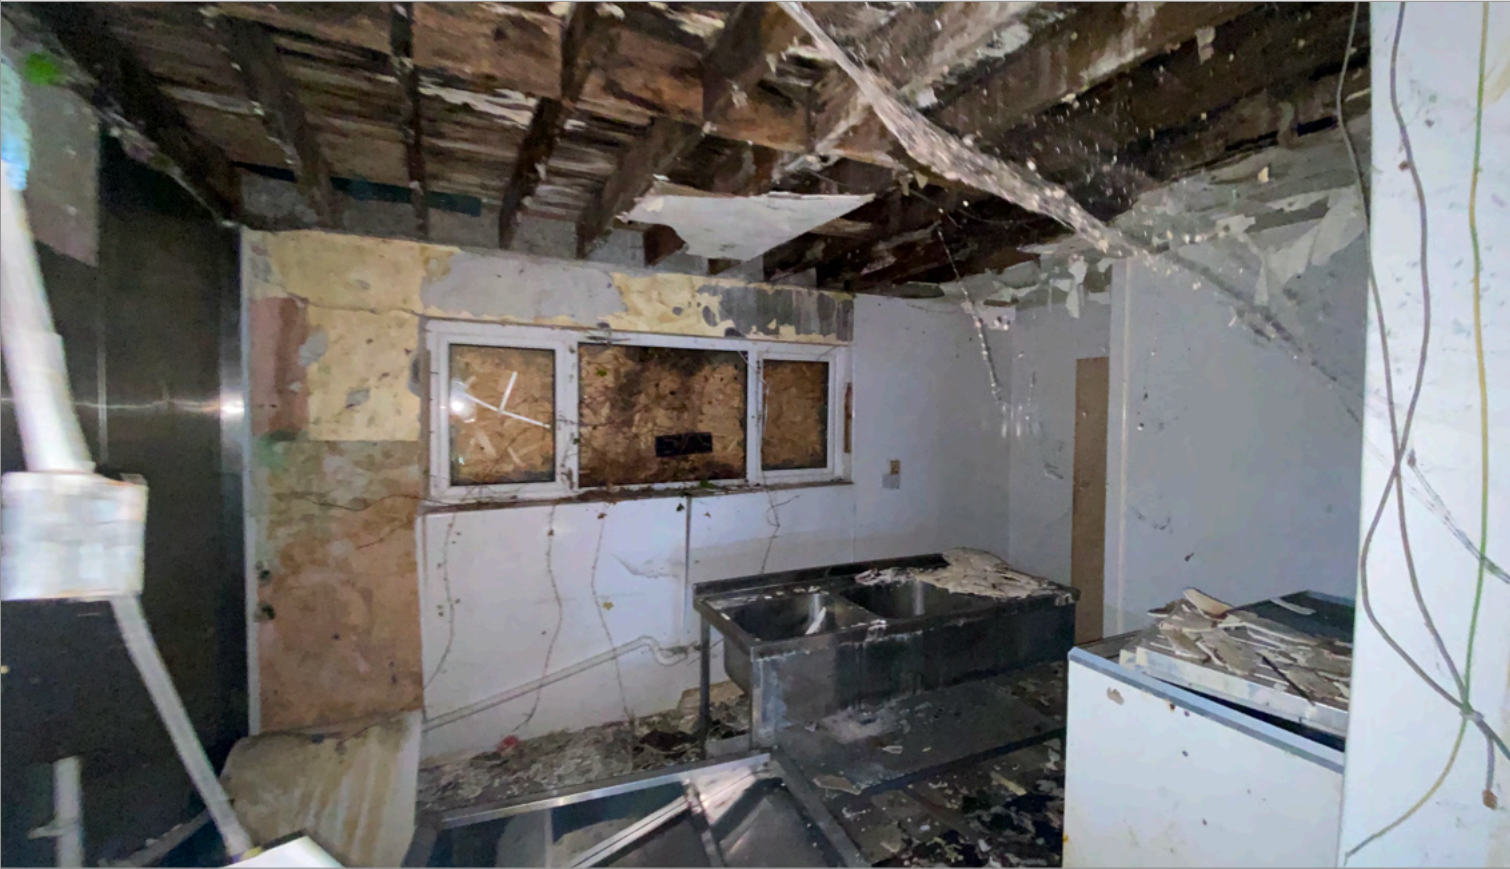
Fig. A	Fig. B
026	<p><b>Two Storey Extension (South) - Ground Floor -Interior</b></p> <p>- Walls of extension appear to be formed of concrete blockwork.</p> <p>- Significant water ingress has created severely damp conditions leading to decay of first floor timber structure above.</p> <p>- Plasterboard ceiling collapsed entirely. Entire first floor structure in dangerous condition and at risk of collapse.</p> <p>- South facing PVC window opening with roots of vegetation growing from outside.</p>

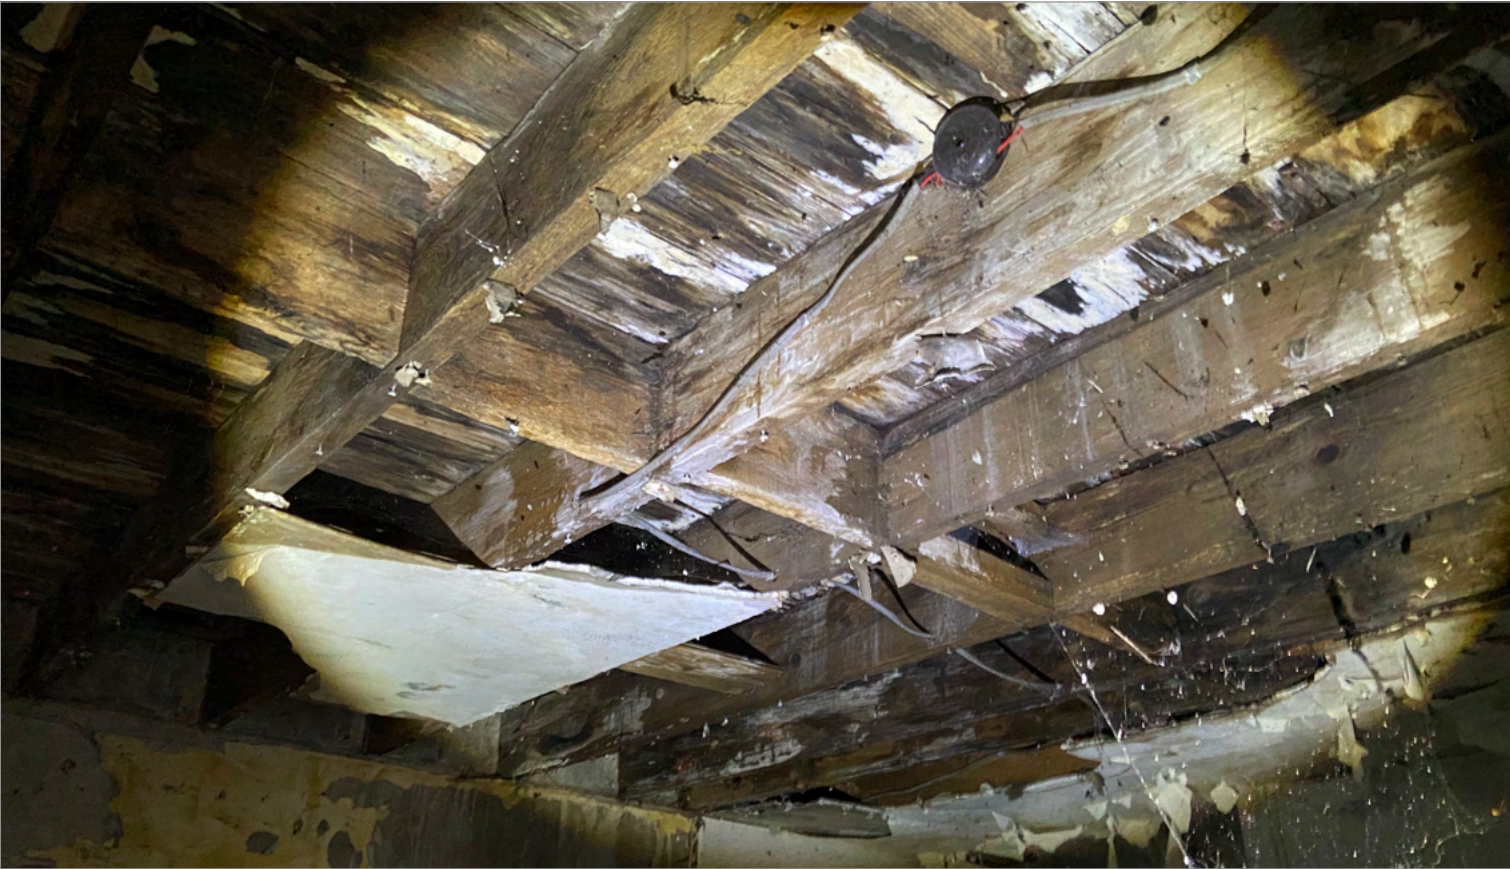
027	<p><b>Two Storey Extension (South) - Ground Floor - Interior</b></p> <ul style="list-style-type: none"><li>- Significant water ingress has created severely damp conditions leading to decay of first floor timber structure above.</li><li>- Plasterboard ceiling collapsed entirely. Entire first floor structure in dangerous condition and at risk of collapse.</li><li>- Dated electrical installations evident.</li><li>- Infestation of insects throughout.</li></ul>

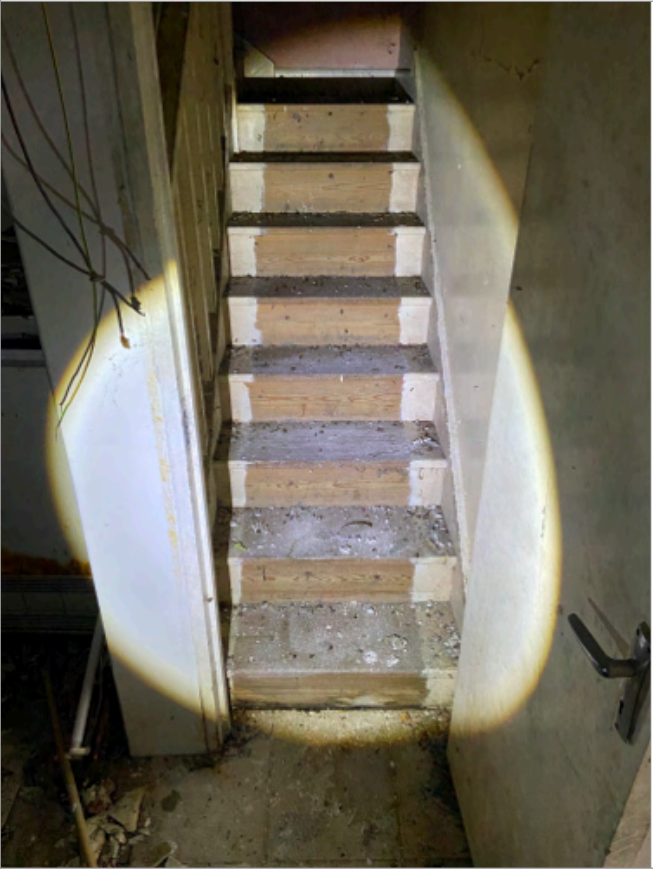
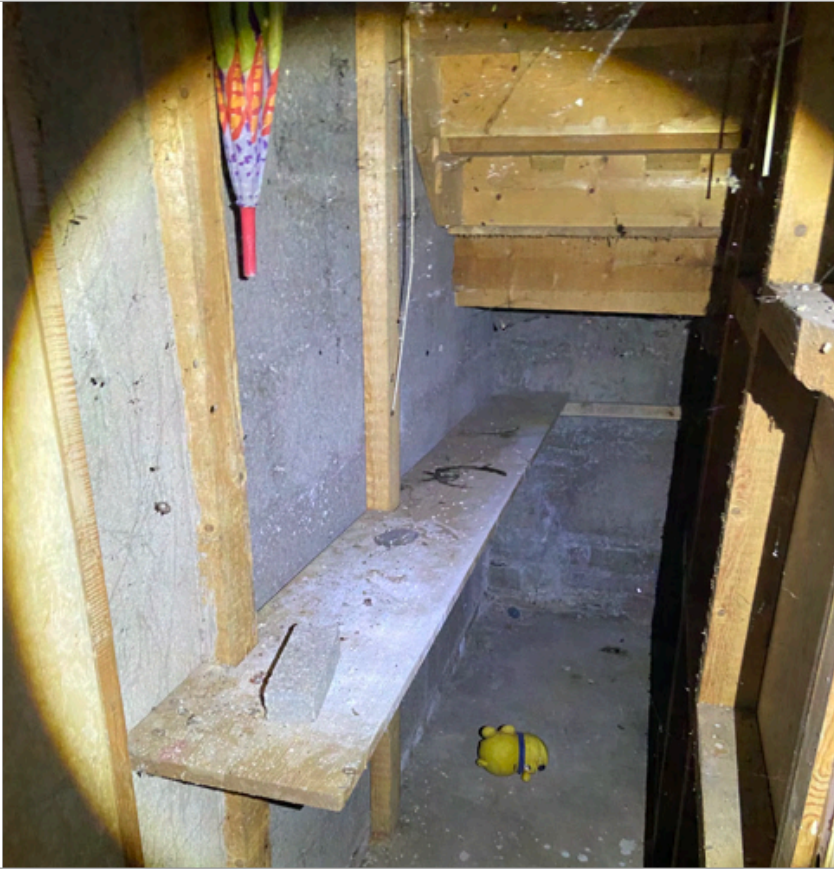
028	<p><b>Two Storey Extension (South) - Ground Floor - Interior</b></p> <p><b>Fig. A</b> - Stairs leading to first floor appear to be in fair condition. Considerable amount of bird droppings on stairs.</p> <p><b>Fig. B</b> - Stud wall formed with timber and finished in plasterboard creates partition between stairwell and the kitchen area with a small storage space beneath.</p>	<div>

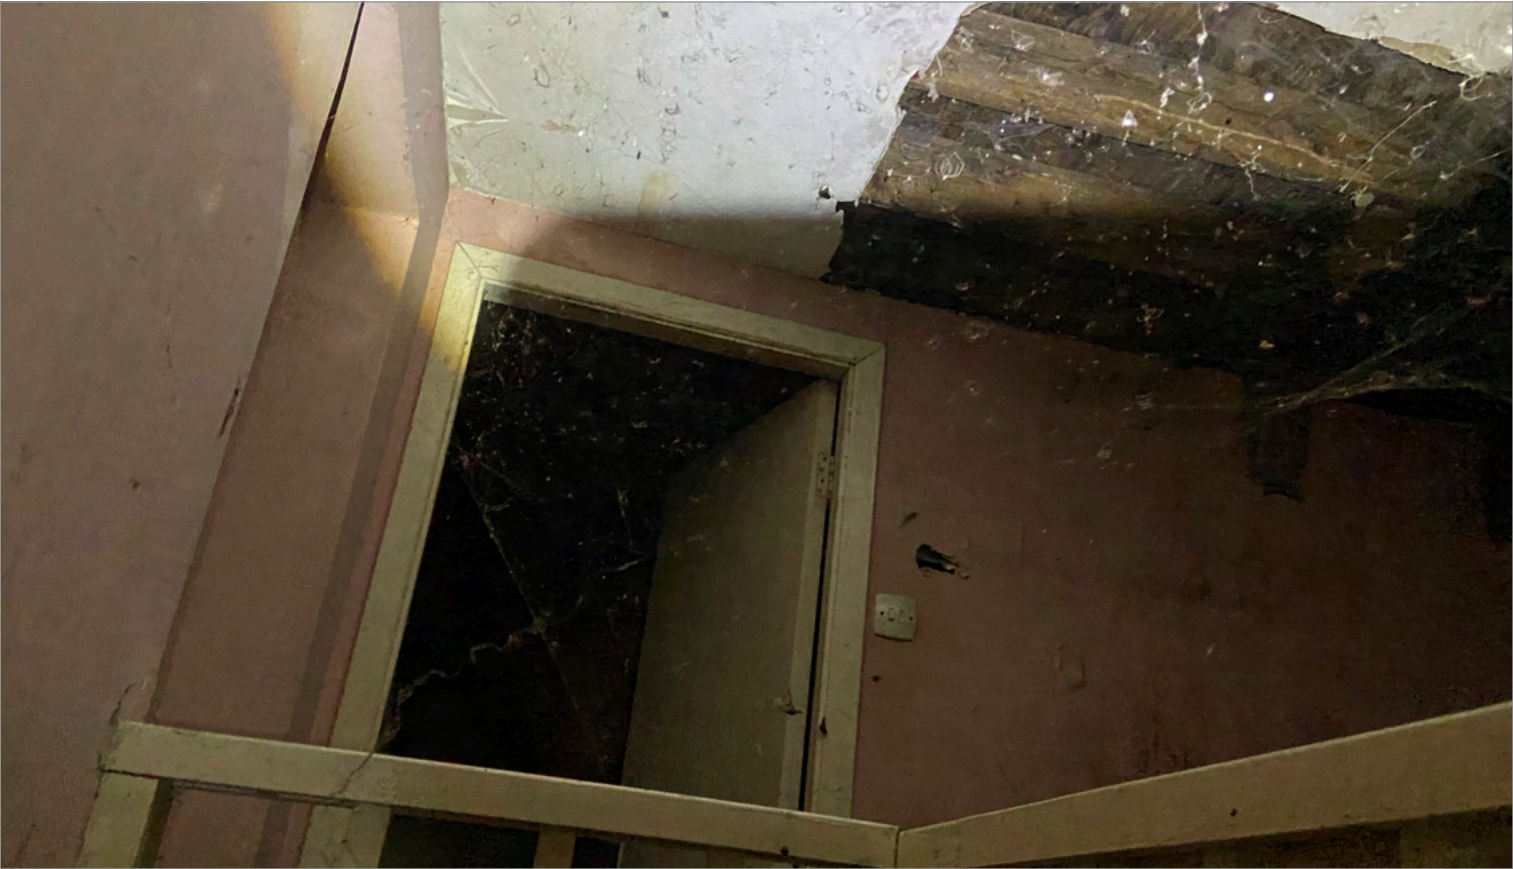
029	<p><b>Two Storey Extension (South) - First Floor - Interior</b></p> <ul style="list-style-type: none"><li>- Image taken from stairs leading to first floor looking towards what appears to be first floor bathroom.</li><li>- Ceiling / underside of flat roof above in extremely poor condition with significant water ingress and rotted timbers.</li><li>- Plasterboard ceiling above has partially collapsed.</li></ul>

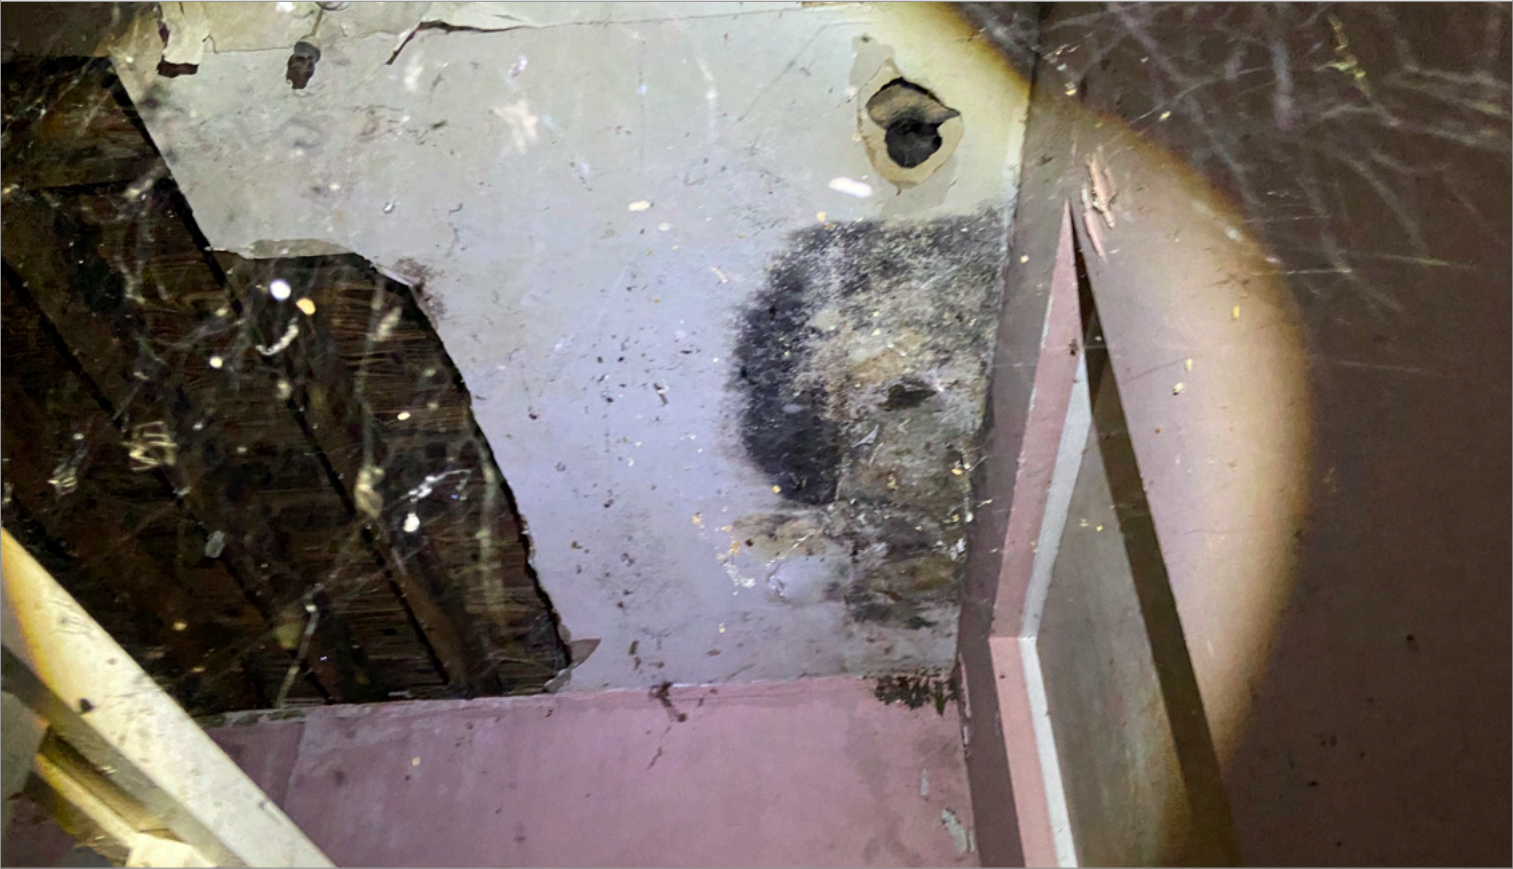
030	<p><b>Two Storey Extension (South) - First Floor - Interior</b></p> <ul style="list-style-type: none"><li>- Image taken from stairs leading to first floor. Ceiling / underside of flat roof above in extremely poor condition with significant water ingress and rotted timbers.</li><li>- Plasterboard ceiling above has partially collapsed.</li><li>- Significant damp conditions with black mould evidenced on the remaining ceiling.</li></ul>

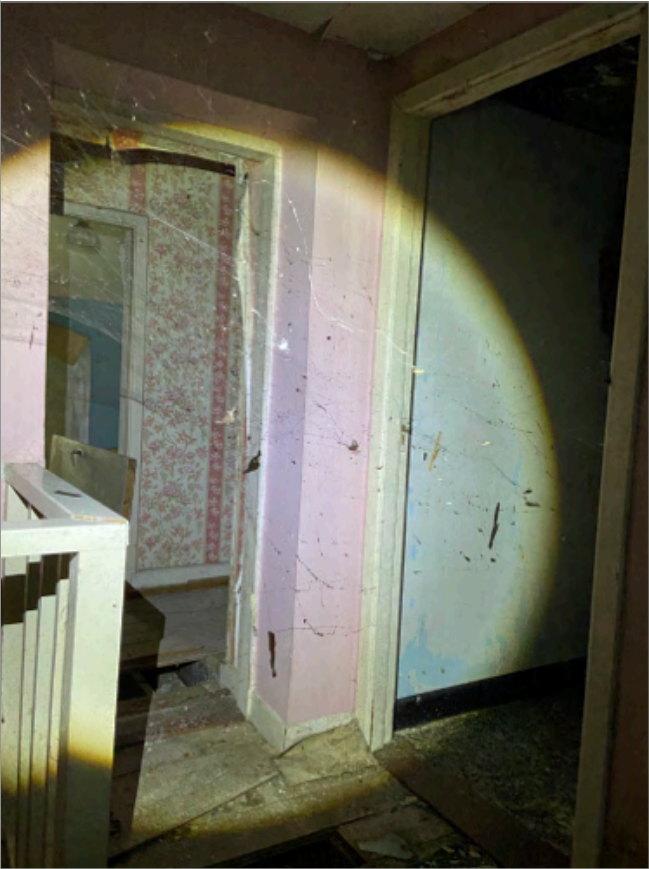
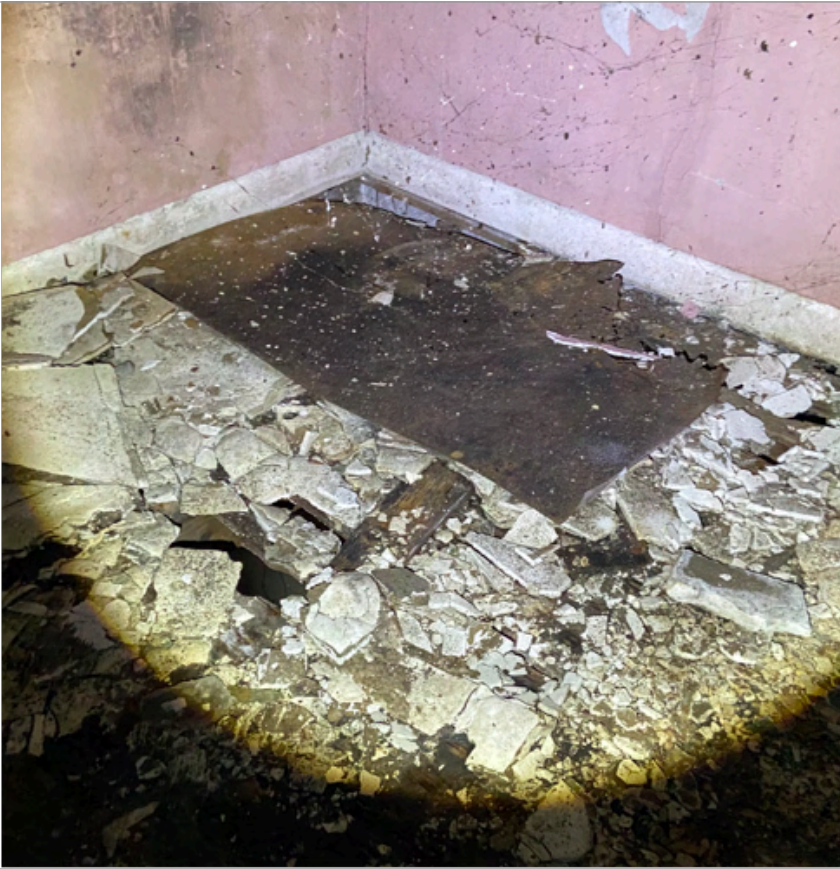
031	<p><b>Two Storey Extension (South) - First Floor - Interior</b></p> <p><b>Fig. A</b> - Taken from top of stairs, looking back into first floor of 2 storey cottage with door to bathroom on right hand side.</p> <p><b>Fig. B</b> - Significant deterioration of floor structure due to damp conditions and water ingress. Deemed too dangerous to proceed further into first floor due to risk of collapse. Holes clearly visible in floor structure beneath debris.</p>

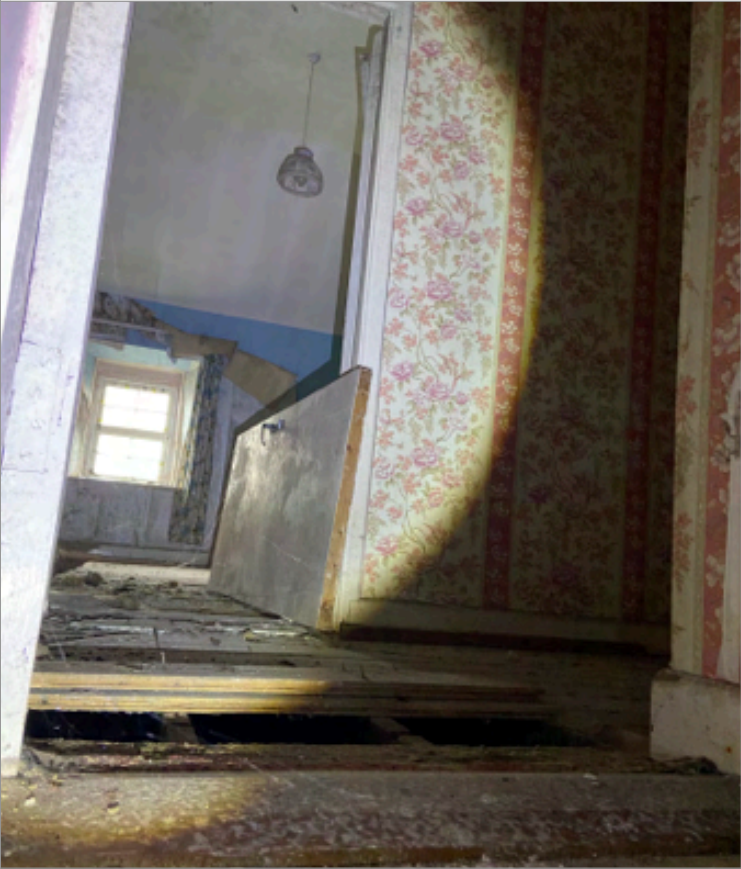
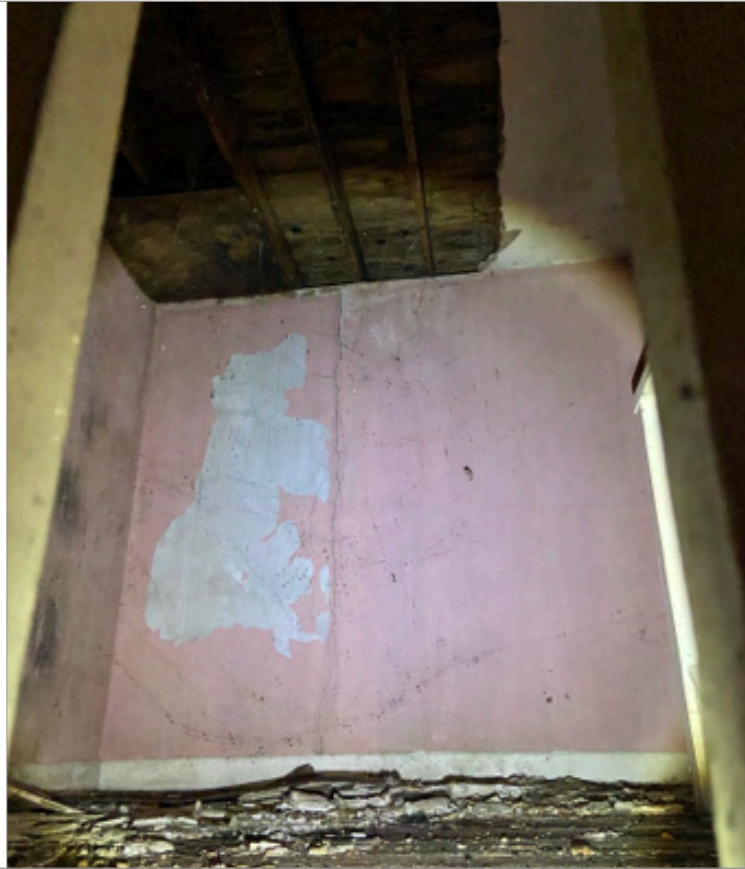
Fig. A	Fig. B
031	<p><b>Two Storey Extension (South) - First Floor - Interior</b></p> <p><b>Fig. A</b> - Photo taken from stairs, looking back into first floor of 2 storey cottage. It was possible to see through the hallway into bedroom area which features low level windows below eaves height. These are the first floor windows which appear on the front elevation. Note splayed reveal similar to that featured on the ground floor windows.</p> <p>- First floor of two storey cottage appears to be in fair condition with no obvious signs of water ingress from this vantage. Deemed too dangerous to proceed further into first floor of cottage due to risk of collapse. <b>First floor area to be made safe before further surveys can be undertaken.</b></p> <p><b>Fig. B</b> - Photo taken from stairs illustrates extent of ceiling collapse and damp conditions within first floor of rear extension.</p>
