Ratoath Pedestrian and Cycle Scheme

Part 8 Report

Meath County Council

February 2020

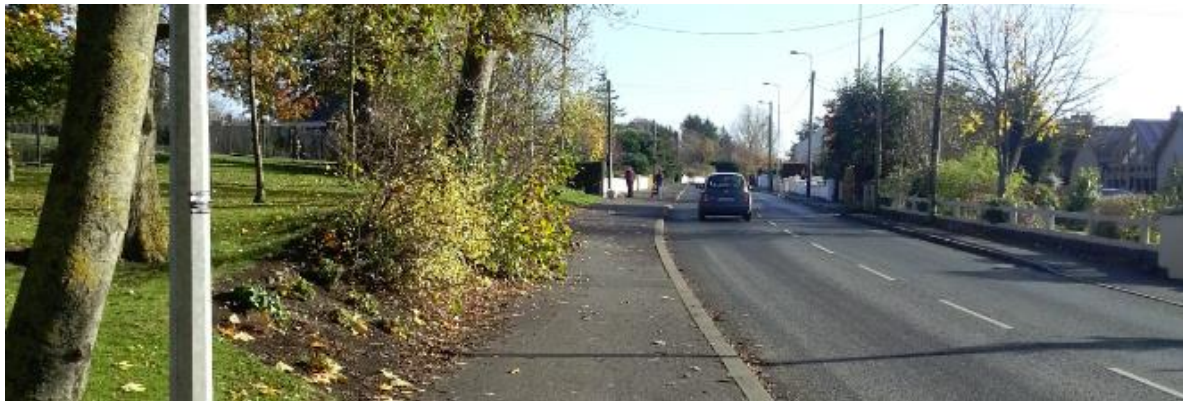
Figure 4-2: R125 Dunshaughlin Road

R125 Dunshaughlin Road: This is the western approach to Main Street. The street is generally 6.5m wide with footpaths on both sides of the road and public lighting generally provided along the southern street side.

Traffic volumes are in the order of 5600 AADT and traffic speeds are in the order of 60kmh as indicated by the 85th percentile speed. The street provides access to a number of private dwelling directly fronting the street edge and some small housing estates such as the Streamstown and Parkview and the Supervalu car park. The eastern extent of the street is formed by the intersection of the R125 and R155 regional routes. The street facilitates access by bus routes and caters for associated bus stops.

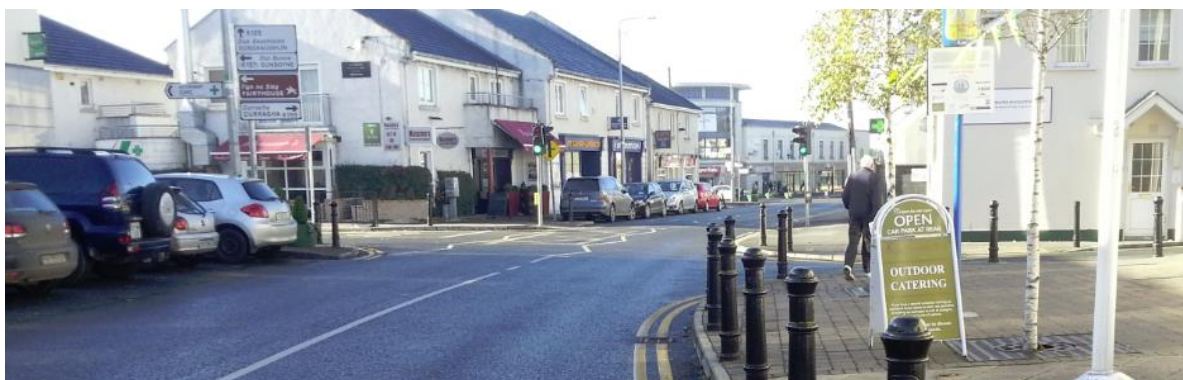
Figure 4-3: Main Street

Main Street: The Main Street forms the main commercial centre in Ratoath and extends from the R125 / R155 junction to the R125 / Skryne Road junction. The street is generally 6.5m wide with some narrow and wider locations. Footpaths and parking are generally provided along the extent of the street with public lighting generally provided along the southern street side.

Traffic volumes are moderate to high in the order of 8150 AADT and traffic speeds are in the order of 42kmh as indicated by the 85th percentile speed. The street provides access to a number of on street commercial and residential developments, a petrol filling station and garage. The street facilitates access by bus routes and caters for associated bus stops.

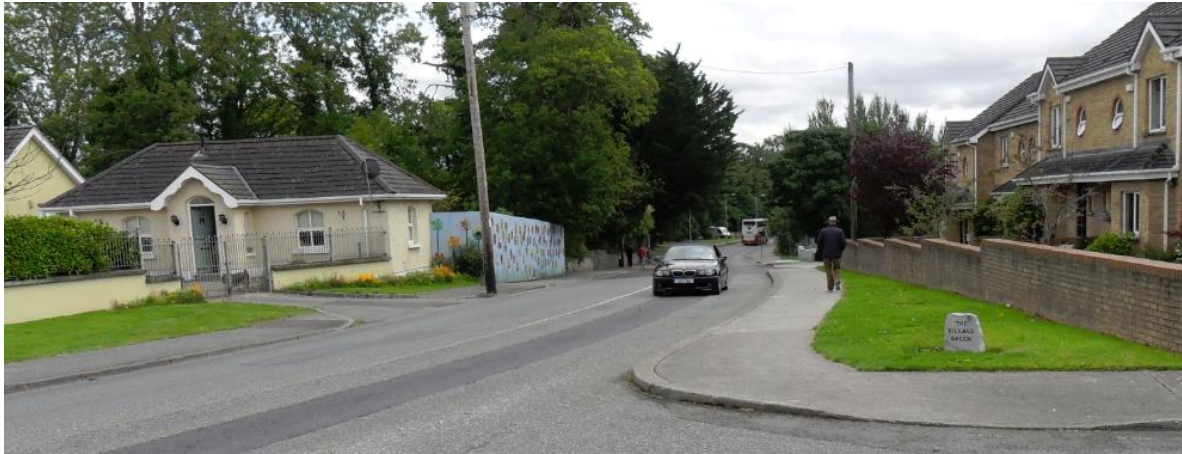
Figure 4-4: East of Main Street

East of Main Street: This is the eastern approach to Main Street and extends from the R125 / Skryne Road junction to the Foxlodge housing estate. The street is generally 6.5m wide with footpaths on both sides of the road and public lighting generally provided along the southern street side.

Traffic volumes are in the order of 11000 AADT and traffic speeds are in the order of 44kmh as indicated by the 85th percentile speed. The street provides access to a number of on street commercial and residential developments, the local church, Corballis Shopping Centre, Silverstream Nursing Home and the Village Green housing estate. The street facilitates access by bus routes and caters for associated bus stops.

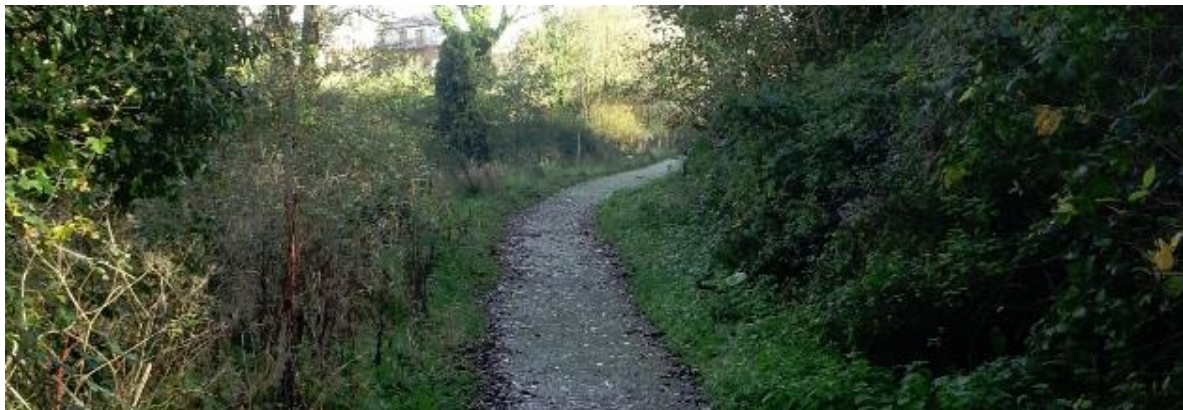
Figure 4-5: Existing Path adjacent Broadmeadow

There are a number of existing routes which extend along the Broadmeadow River in a west to east orientation. At the western extent of these paths, an existing path commences at the Meadowbank Hill in vicinity of its junction with the R155 Fairyhouse Road. The path proceeds along the southern river bank adjacent the back of the Meadowbank Hill housing estate, for approximately 150m where intersects with an alternative path choice. This alternative path crosses the river via a small masonry bridge and proceeds northeast uphill for approximately 250m before terminating at footpaths associated with the R125 Main Street. The original path (as per Figure below) proceeds past the bridge for approximately 280m along the river before coming upon another small masonry bridge. At this point the formal path ends.

These existing paths are of varying surfacing, width and gradients. The Broadmeadow River itself is modest in channel width and the overall topography of the surrounding area slopes noticeably downwards to the river banks from the north and south.

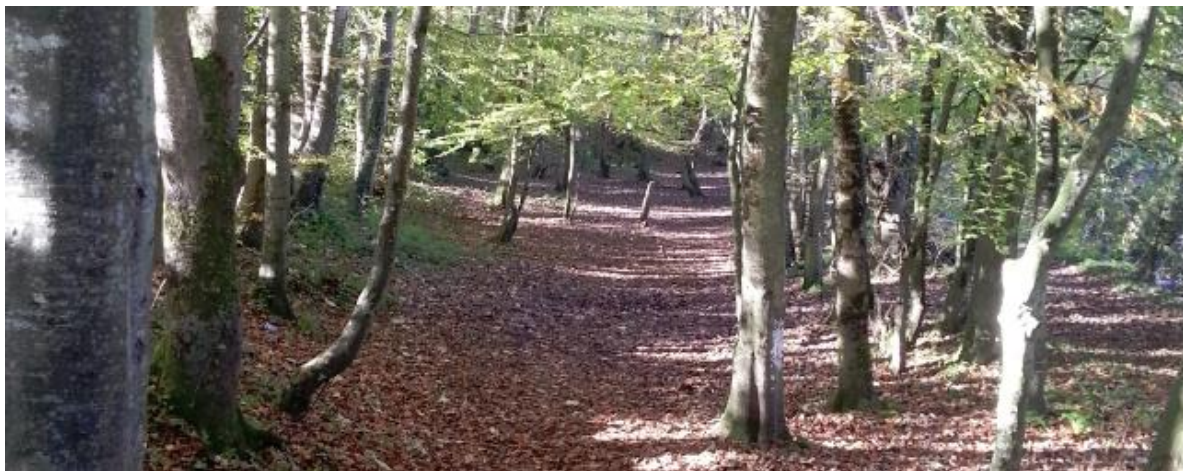
Figure 4-6: Route through Woodland Area

There are two informal paths which proceed east from where the formal path ends. One proceeds south of the river through a wooded area for approximately 200m (as per Figure below) before joining up with the footpath network associated with the Jamestown Park housing estate with a route available through the estate to gain access back out onto Meadowbank Hill, in vicinity of its roundabout junction with the R125 Swords Road.

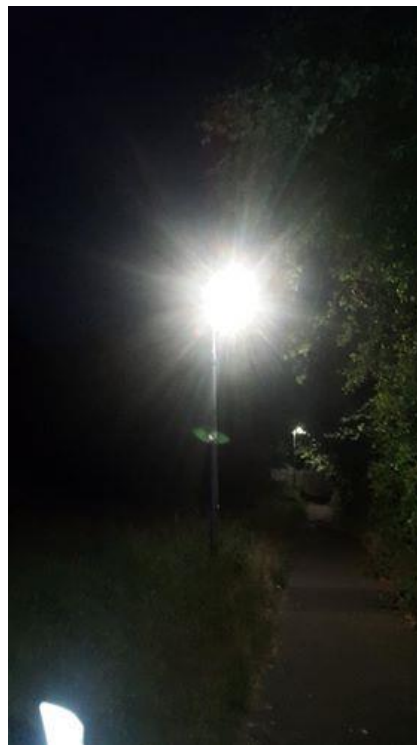
There is considerable light pollution, particularly along the western entrance at Meadowbank.

Light pollution with spillage into the sky at the western entrance

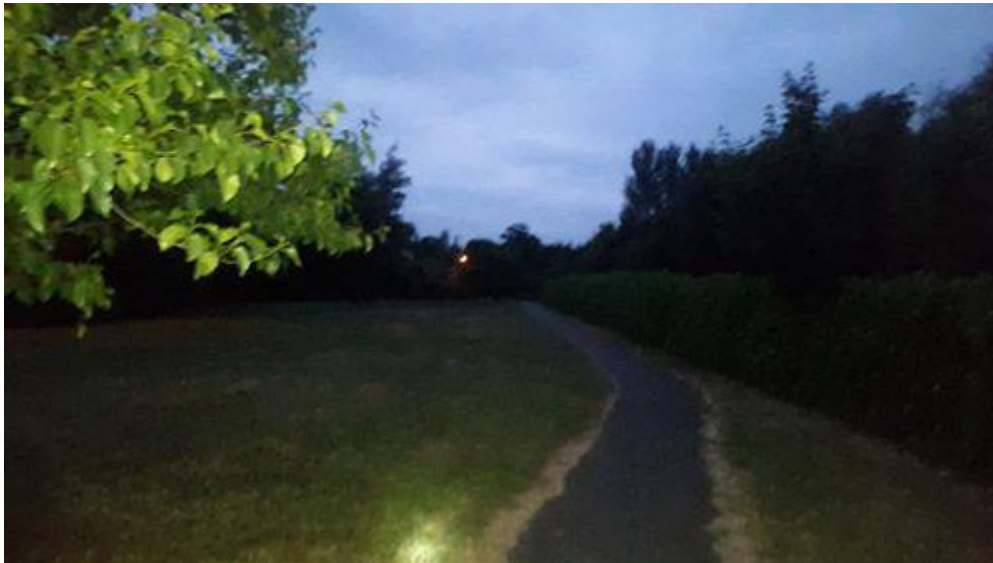
Some areas beside the river are intensively sprayed and cut and planted with laurel – which is toxic to both people and wildlife.

This area near the Jamestown estate is very poor for wildlife.

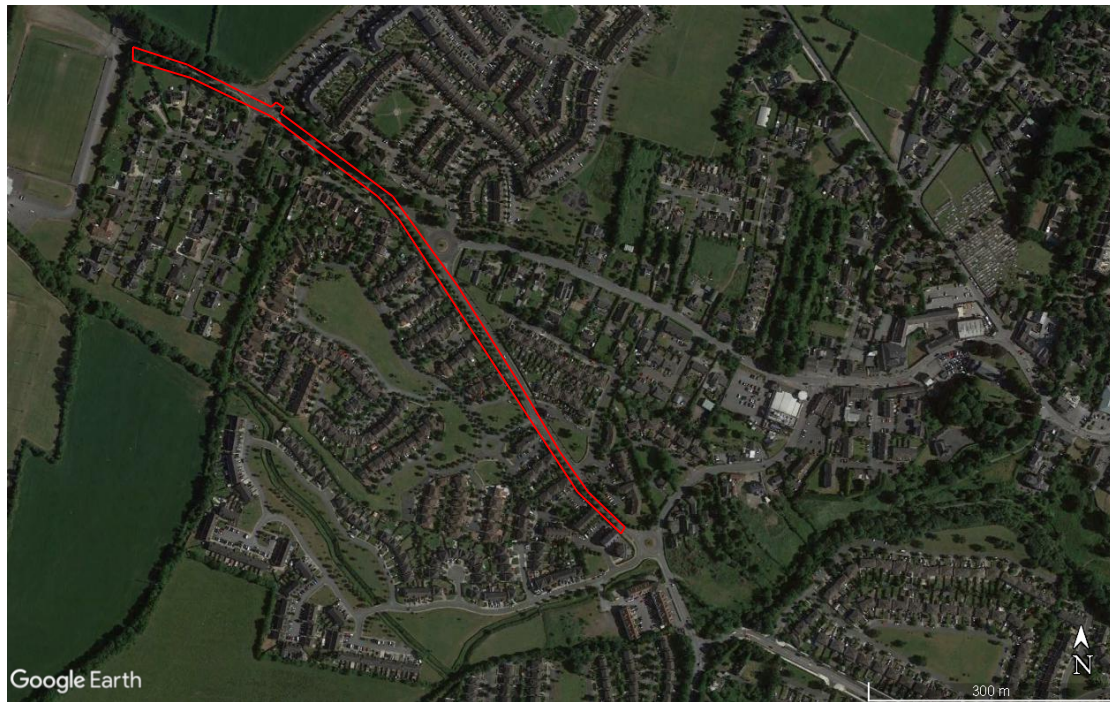
Figure 1: Low resolution satellite image of approximate tree survey area (courtesy of Google Earth).

2.1 The tree survey area (approximate area highlighted red – Fig 1) is an existing public roadway and footpaths located on the western side of Ratoath.

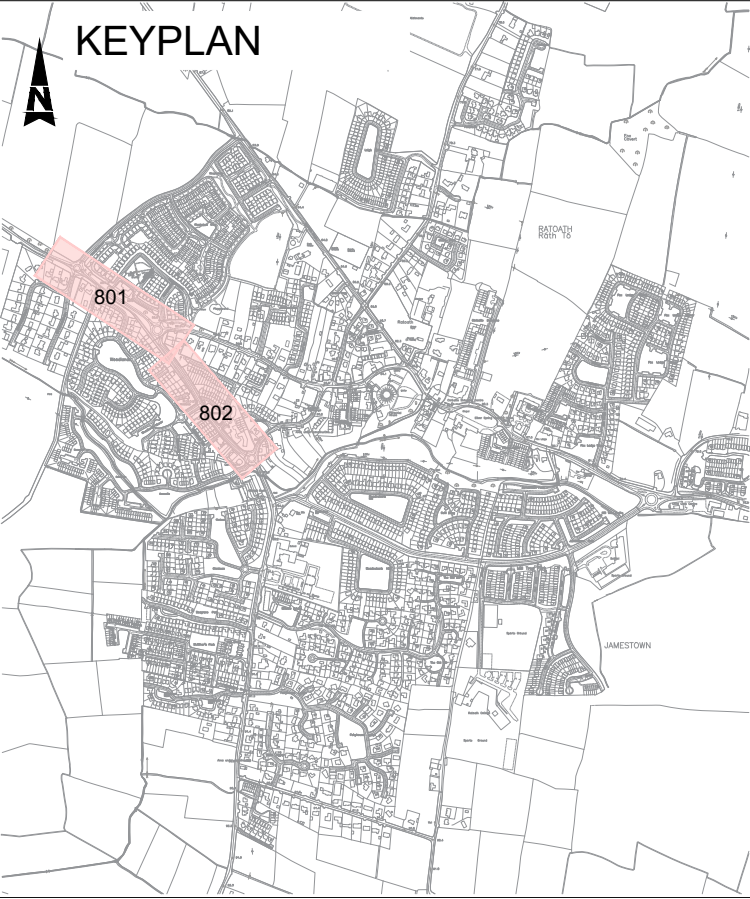
- LEGEND**
- CLASS A INDIVIDUAL TREE (HIGH QUALITY - RETENTION HIGHLY DESIRABLE)
 - CLASS B INDIVIDUAL TREE (MODERATE QUALITY - RETENTION DESIRABLE)
 - CLASS C INDIVIDUAL TREE (LOW QUALITY - RETENTION OPTIONAL)
 - CLASS U INDIVIDUAL TREE (RECOMMEND REMOVAL)
 - TREE GROUPS (COLOUR REPRESENTING GROUP CLASSIFICATION)

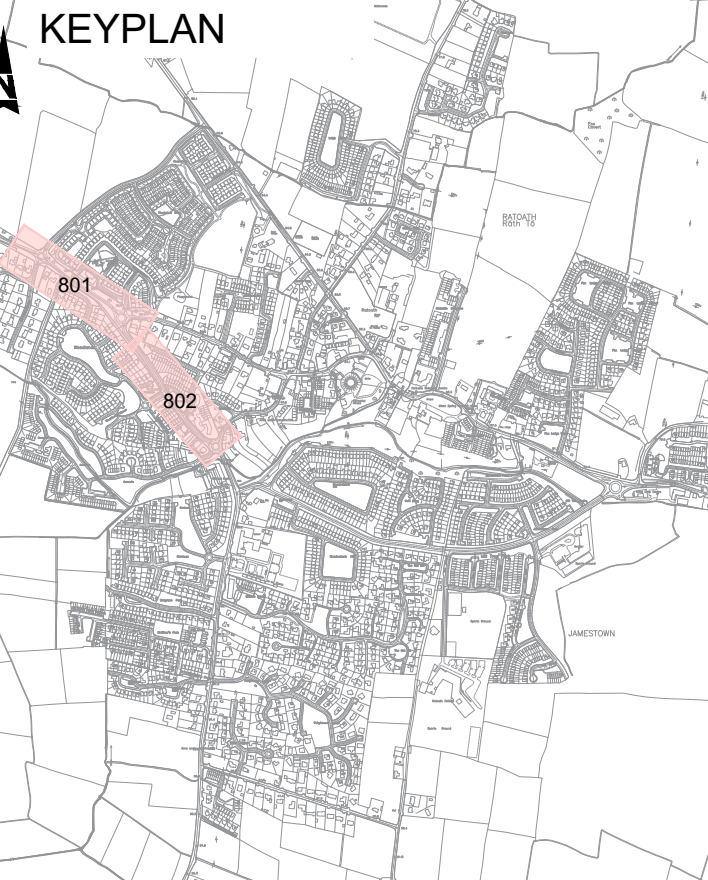
DRAWING NO: 19277_T_102

- CLASS A INDIVIDUAL TREE (HIGH QUALITY - RETENTION HIGHLY DESIRABLE)
- CLASS B INDIVIDUAL TREE (MODERATE QUALITY - RETENTION DESIRABLE)
- CLASS C INDIVIDUAL TREE (LOW QUALITY - RETENTION OPTIONAL)
- CLASS U INDIVIDUAL TREE (RECOMMEND REMOVAL)
- TREE GROUPS (COLOUR REPRESENTING GROUP CLASSIFICATION)
- CALCULATED ROOT PROTECTION AREA (RPA)
- TREES PROPOSED FOR REMOVAL
