Ratoath Pedestrian & Cycling Scheme

Ecology Report

April 2020

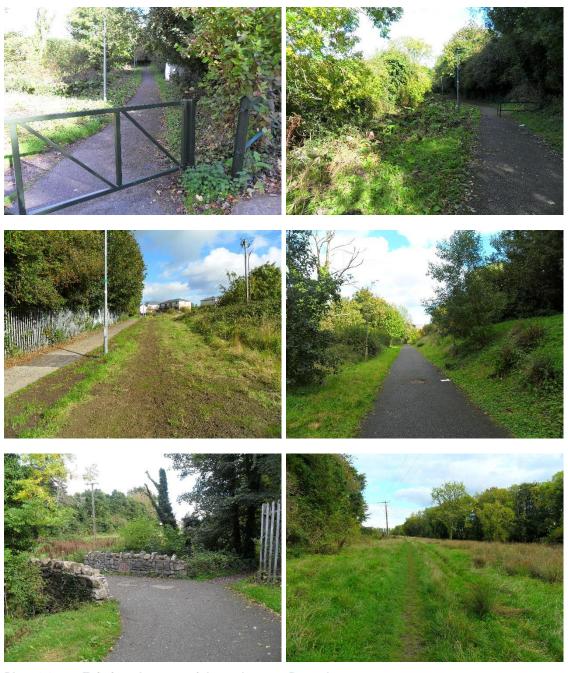
Plate 1.1 Existing elements of the pathway at Ratoath.

- 1.10 The overall development consists of cycleways on existing paths/roadways with a Greenway element adjacent to the Broadmeadow River. This greenway running through lands adjacent to the Broadmeadow River was the focus of this Ecology Report. It should be noted the Broadmeadow River is also named as the Ratoath Stream (EPA Seg Code: 08_577) on the EPA River Network dataset. For the purpose of this this report it will, however, be called the Broadmeadow River. The stream is illustrated in Figure 1.1.
- 1.11 The following plates illustrate elements of the existing scheme (Plate 1.1).

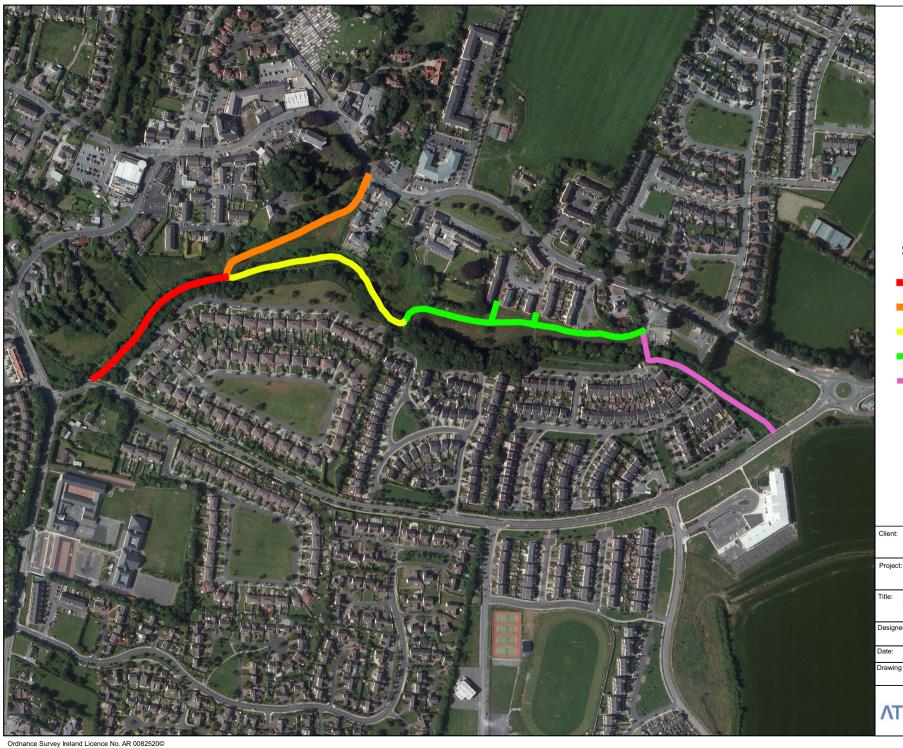
Designed/Drawn: CR Authorised: PO'D PO'D Date: 26/02/2020 26/02/2020 26/02/2020 Drawing No: Figure 3.1

- 3.6 For the purposes of this report, the routes have been divided into 5 sections and these are shown in Figure 3.1, while Figure 3.2 illustrates the habitats present for the new-build section of the route (section 4). The habitats adjacent to the existing path in the remaining sections are described in the text below.

Section of Greenway

3.4 The proposed Greenway starts at north of the junction Meadowbrook Hill and the R155, south of the Broadmeadow River (see Figure 3.1). The route extends eastward along existing surfaced

- 4.1 Along sections 1, 2 and 3, of the Greenway (See Figure 3.1) there are existing paths in place which do not need to be widened and so will only require resurfacing. Therefore, direct impacts on habitats will not occur as a result of the works. The western side of section 5 will require minor widening of the existing path at pinch points and resurfacing where necessary. The eastern section running south of the Meadowbrook stream will be resurfaced with the proposed bound greenway path. Similarly, no direct impacts on habitats will occur as a result of the works.

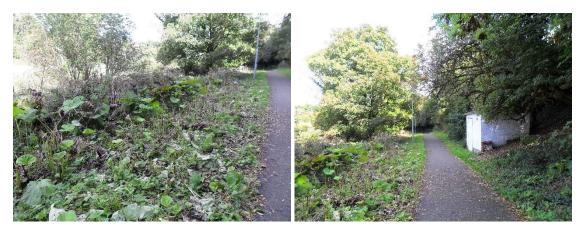
Plate 3.1 Vegetation cut adjacent to path; and treelines either side of path.

3.7 An existing path (BL3) is present along this section, which will require resurfacing; minor widening will be required at pinch points. The path is bordered by a grass verge (GS2) with ruderal species and treelines (WL2) on both sides. Near the western entrance there was abundant butterbur (*Petasites hybridus*), dock (*Rumex* spp.), hogweed (*Heracleum sphondylium*) and nettle (*Urtica dioica*); the butterbur had recently been cut. The treeline (WL2) to the south east consisted of sycamore (*Acer pseudoplatanus*), ash (*Fraxinus excelsior*), birch (*Betula* sp.), hawthorn (*Crataegus monogyna*), poplar (*Populus* sp.), beech (*Fagus sylvatica*) and elm (*Ulmus* sp.). The treeline along the river consisted of sycamore, ash, hawthorn and elder (*Sambucus nigra*). The habitat present in this section is of *Local Importance* (*Lower Value*).

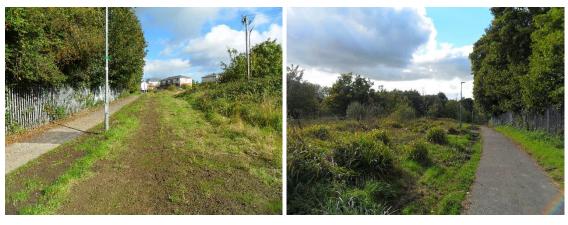
Plate 3.2 Northern existing path with cut grass and pockets of pendulous sedge.

An existing path (BL3) is present in this section which will require resurfacing. To the west is a fence; behind which is a treeline (WL2) of sycamore, hawthorn and ash. To the east are areas of rank grassland (GA1/GS4) with some planted trees. The grassland within 2-3m of the path had recently been cut. Dense areas of bramble are present adjacent to the river. Pockets of pendulous sedge (Carex pendula) are present with willow (Salix cinerea), vetch (Vicia sp.), clover (Trifolium repens), sedges (Carex spp.) and hard rush (Juncus inflexus), ribwort plantain (Plantago lanceolata), dock (Rumex spp.) and bramble (Rubus fruticosus). The habitat present in this section is evaluated as Local Importance (Lower Value).

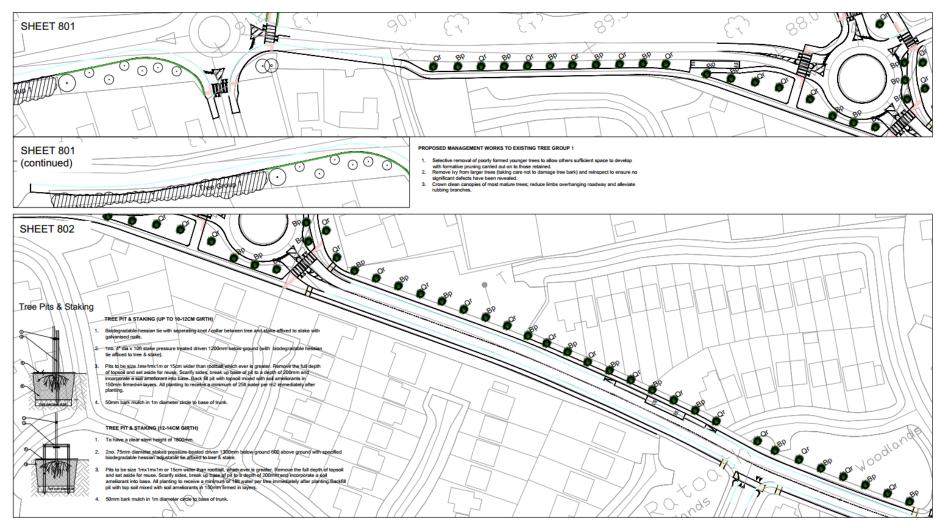
Figure 4.1 Compensatory Tree Planting (CSR Drawing: 19277_T_103 see Appendix D)

- Compensatory tree planting will be carried out along the Woodland Links road to mitigate
 against the proposed removal of 59 Lime, Sycamore and Pedunculate Oak. 52no. native
 semi mature trees will be incorporating into the existing grassed verge including Sessile
 Oak (Quercus petraea) and Sliver Birch (Betula pendula) (See Figure 4.1 below). The
 number of trees to be replaced is slightly less than removed to ensure appropriate spacing
 specifications for root and canopy expansion;

- In line with the All Ireland Pollinator plan, a wildflower meadow will be established between the compensatory tree planting on the Woodland Links Road. This meadow will be incorporated into the existing landscaping as a biodiversity enhancement feature. Areas disturbed following tree planting will be graded and seeded with an All-Ireland Pollinator Plan Wildflower mix, while existing intact grassed areas will be left unmown until September and managed annually in accordance with guidelines on the creation and management of a wildflower meadow⁸. If the species composition is found to be dominated by ornamental species within the sward, established species-rich plugs should be incorporated into the landscape plan to enhance species diversity within the sward. Plug compositions should be in line with All-Ireland Pollinator Plan guidelines. The overall aim of this feature is to form a continuous linear meadow running along the Woodland link road within the existing grassed verge.

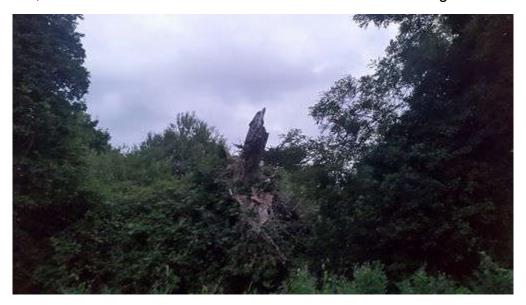
The survey took place on July 12th, commencing at 21.30 hours. Most trees are immature and unsuitable as roosts, however there are occasional trees with deadwood, cracks and crevices which would be suitable for bat usage.

This tree has crevices suitable for bat usage.

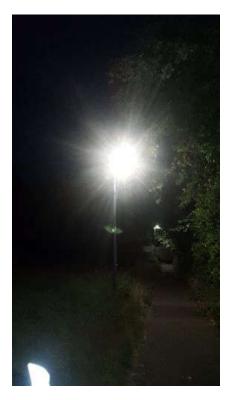
There is considerable light pollution, particularly along the western entrance at Meadowbank.

Light pollution with spillage into the sky at the western entrance

- (1) Avoiding light pollution- Light spillage must not occur on the river, and light pollution must be avoided. This can be achieved by using low level bollard lights, with hoods and cowls fitted to prevent light entering the river area. It is particularly important that light pollution is kept to a minimum in the wooded section of the cycleway, as this is where the Natterer's bat (a light intolerant species) was found

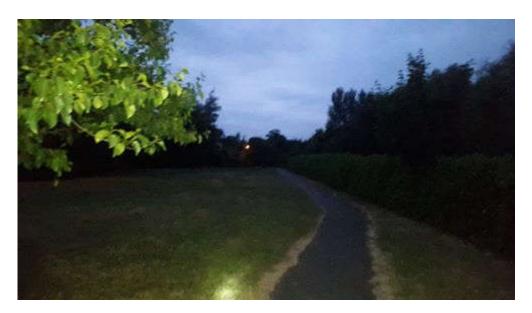
Some areas beside the river are intensively sprayed and cut and planted with laurel – which is toxic to both people and wildlife.

This area near the Jamestown estate is very poor for wildlife.

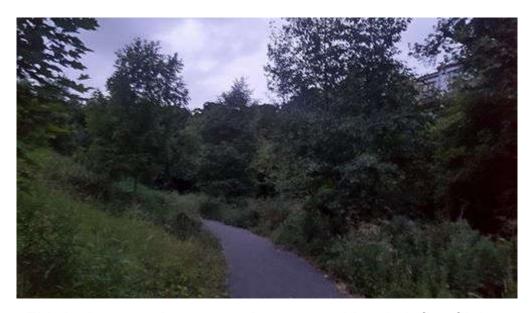
Both common and soprano pipistrelles fed under tree cover all along the river at dawn. Young bats were taking their first flights, and groups of two and three bats were seen flying together. This is clearly an important feeding area for bats taking their first flights.

This is the area where young bats were taking their first flights.

Note the tall vegetation.

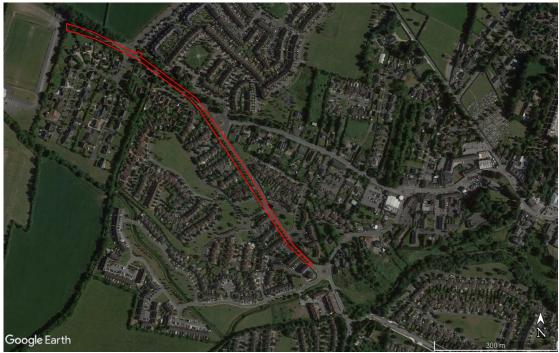
Figure 1: Low resolution satellite image of approximate tree survey area (courtesy of Google Earth).

2.1 The tree survey area (approximate area highlighted red - Fig 1) is an existing public roadway and footpaths located on the western side of Ratoath.

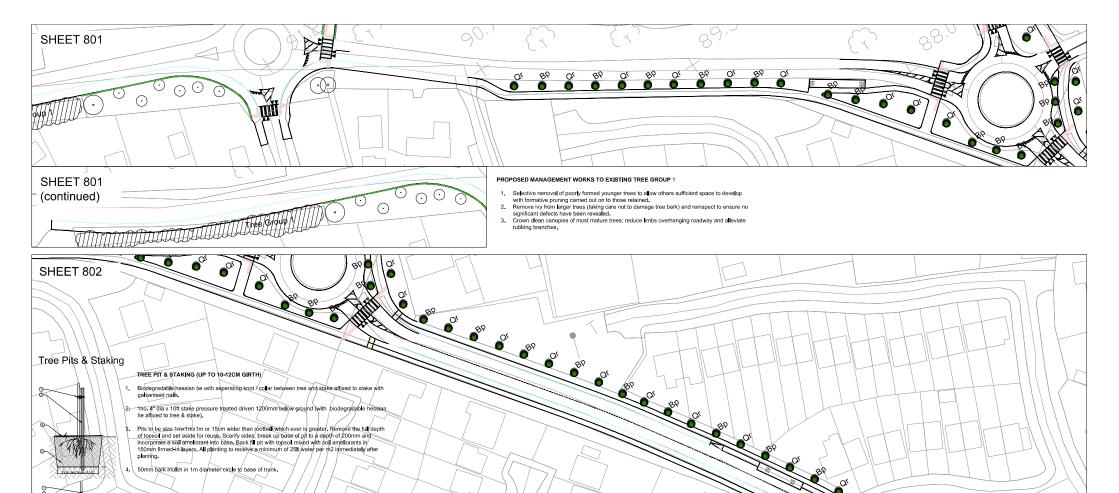
PROJECT:	DATE:	NOVEMBER 2019
RATOATH CO MEATH.	SCALE:	1:500@A1
DRAWING:	DRAWN: CHECKED:	KM KM
TREE PROTECTION	DRAWING NO:	19277_T_103

- 1. To have a clear stem height of 1800mm.
- 2. 2no. 75mm diameter stakes pressure treated driven 1300mm below/ground 600 above ground with specified biodegradable hessian adjustable tie affixed to tree & stake.
- Pits to be size 1mx1mx1m or 15cm wider than rootball, which ever is greater, Remove the full depth of topsoil and set aside for reuse. Scarify sides, break up base of pit to a depth of 200mm and incorporate a soil ameliorant into base. All planting to receive a minimum of 16th water per tree immediately after planting Backfill pit with top soil mixed with soil ameliorants in 150mm firmed in layers.
- 50mm bark mulch in 1m diameter circle to base of trunk.

- Removal/felling works as specified on Dwg No: 19277_T_102 (Appendix D), should be
 performed prior to project commencement, by reputable contractors in accordance with
 Tree work. Recommendations (BS 3998:2010) and current best practice;
