# PROPOSED ENHANCEMENT WORKS AT LOUGH BRACKEN, CO. MEATH

## Planning and Environmental Report

Prepared for:  
Meath County Council

Date: October 2024

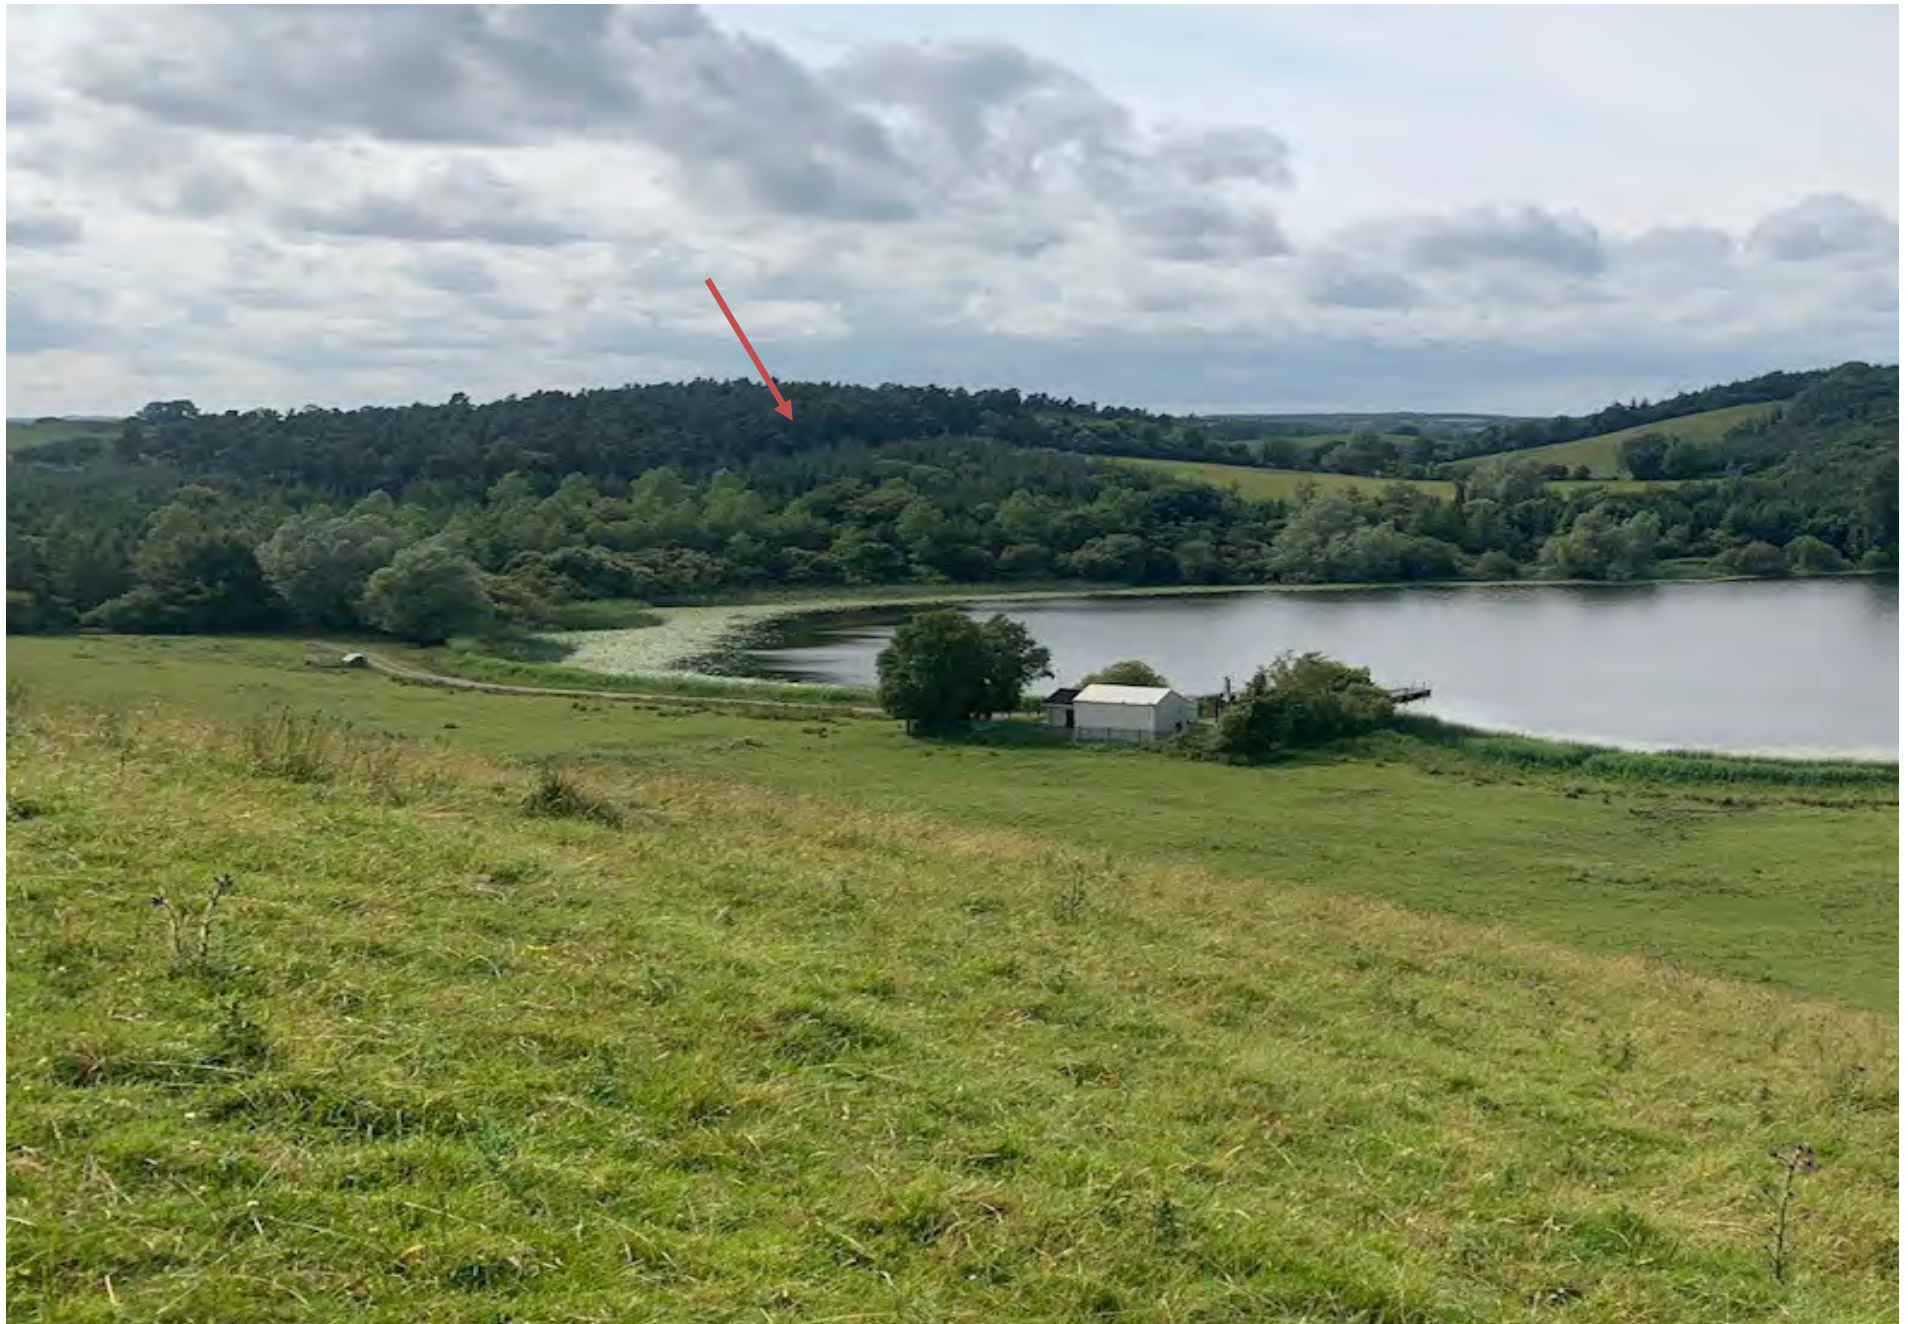
Plate 1: Site overview, pumping station in foreground, facing northwest. Showing location of National Monument in State Ownership No. 543, Motte and Bailey (ME006-027)

The site was subject to a field inspection visit on the 22nd of June 2023, which was carried out by Derek Gallagher of Archaeological Consultancy Services Unit (Plates 1–14). The site consists of Lough Bracken, Coillte forestry plantation, a pump station and associated access and paths. As detailed above, a monument (Motte and Bailey ME006-027----) is located within the northwest portion of the site and is surrounded by coniferous forestry with no buffer zone established (Figure 6; Plates 1–2).

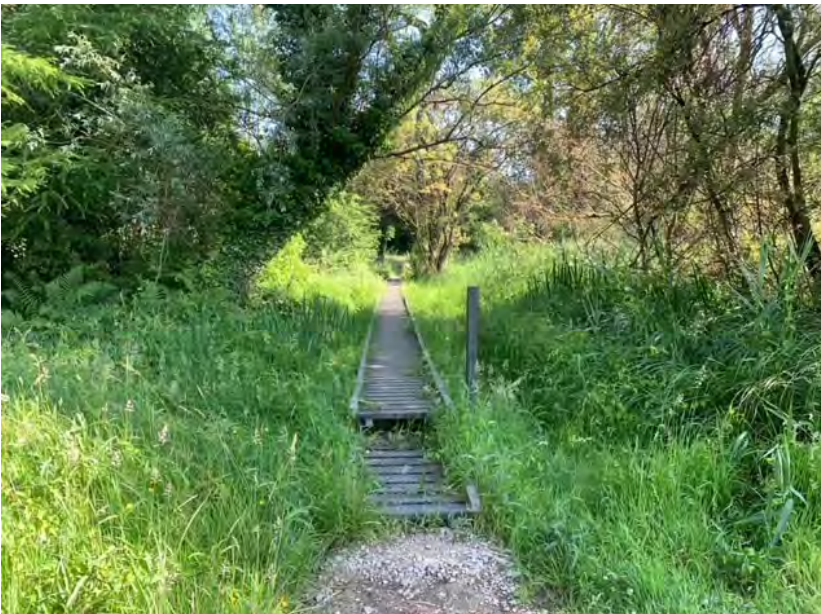
Plate 9: Existing walkway, facing north

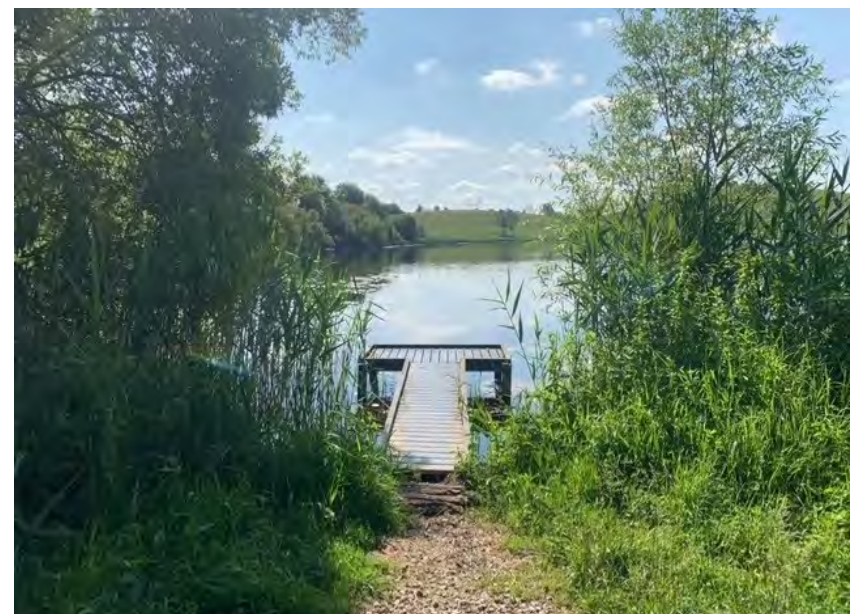
Plate 10: Existing jetty, facing southeast

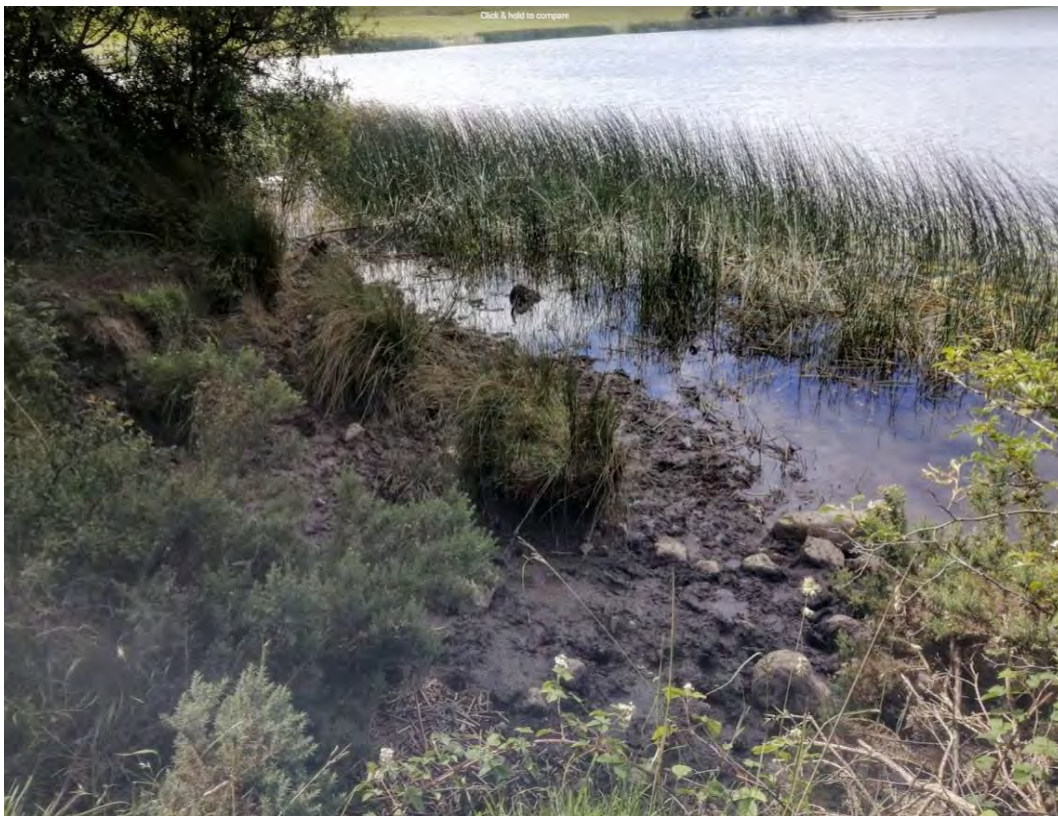
**Figure 2: Poaching and degradation of the reed fringe**

Much of the reed bed habitat surrounding the lake has become highly degraded as a result of cattle having access to the water's edge. This has meant the capacity of the reed fringe to complete these functions has been diminished.

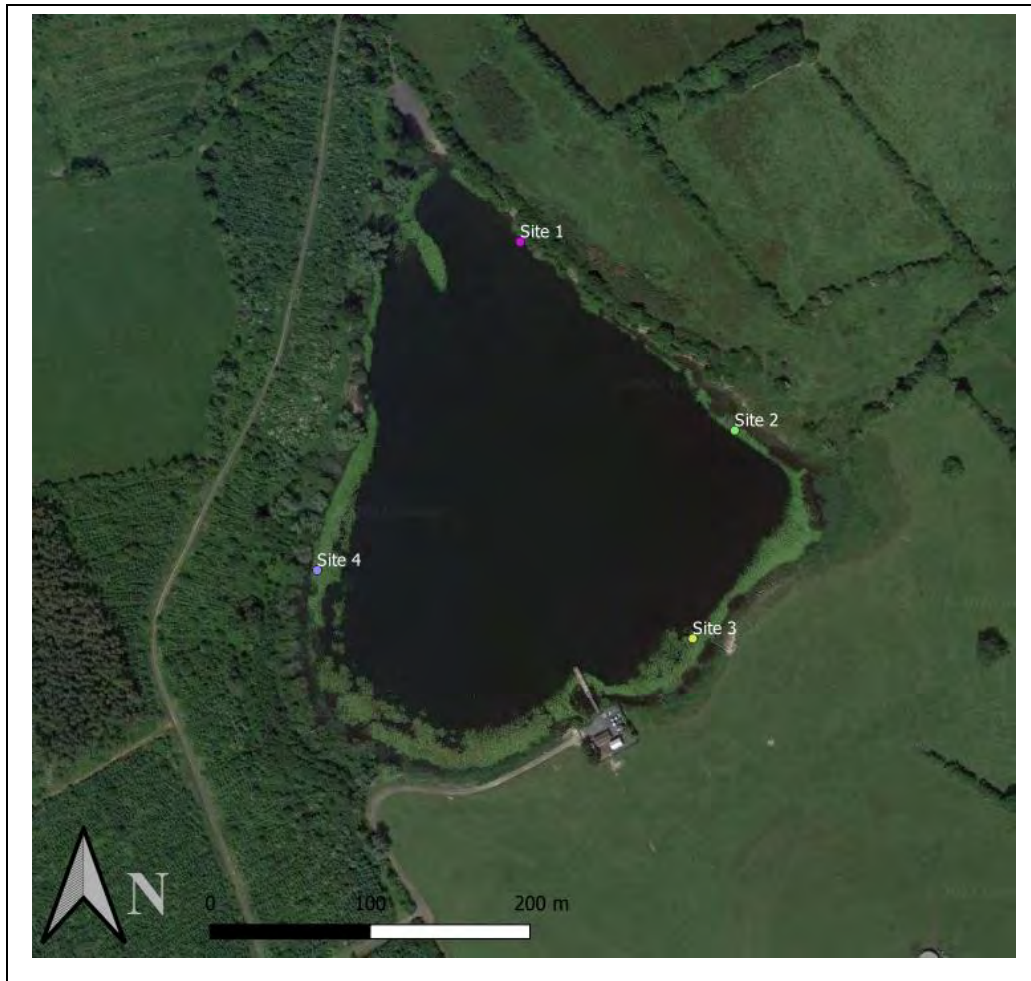
**Figure 4: Reed fringe and Macroinvertebrate sample sites**

Four locations were chosen for a detailed survey. These were chosen in order to provide a representative sample of the main shoreline vegetation communities. Areas that were devoid of plants (e.g. at angling pegs or where the lake is otherwise accessed) were not sampled. The location of sample sites is shown in Figure 4.

**Site 1.** This site has a substantial fringe made up almost entirely of Black Bog Rush (*Schoenus nigricans*). The fringe extends for around 3.5m. There is a single Willow (*Salix cinerea*) of around 2m in height. There is also a fringe of Water Lily (*Nuphar lutea*) at the furthest extent of the Rush. The ground flora here is rather poor with Water Mint (*Mentha aquatica*) being among the few vascular plants here and the only one that is water dependent.

**Site 2.** A very substantial fringe of vegetation occurs at this point. A total fringe extent of 15m was recorded here. Here, Soft Rush (*Juncus effusus*) occurs on tussocks that have been formed through the action of cattle poaching. This extends over an area of greater than 2.2m. Silverweed (*Potentilla anserina*) also occurs here. 1m out from the track Silverweed is occasional, giving way to occasional Water Horsetail (*Equisetum fluviatile*) and then an area of bare ground. Moving toward the lake, Brooklime (*Veronica beccabunga*) is abundant and Water Mint frequent. Common Reed (*Phragmites australis*) is initially dominant on the wetted area for around 3m. It

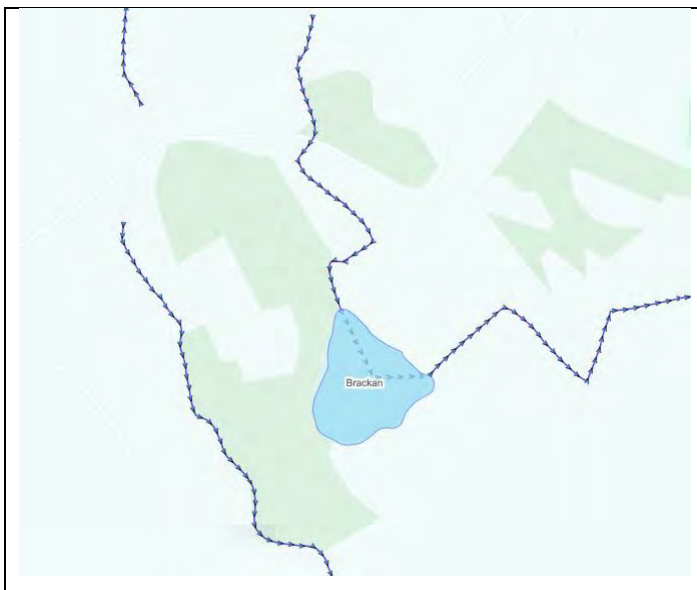
**Figure 1: Lough Bracken and tributary, River Dee\_050. Source: catchments.ie**

In the 'EPA Catchments: 3rd Cycle Draft Newry, Fane, Glyde & Dee Catchment Report, 2021', Lough Bracken (referred to as 'Brackan') is listed as having 'Agriculture' as its significant pressure. The issues related to farming in this catchment are predominantly due to phosphorus loss from pastures to surface waters, for example, direct discharges, or runoff from yards, roadways or other compacted surfaces, or runoff from poorly draining soils. The report states that "one lake waterbody (Brackan) is confirmed to be affected by eutrophication". The report also acknowledges that sediment can also be a problem for surrounding waterbodies from land drainage works, bank erosion from animal access or stream crossings. A significant proportion of the catchment is underlain by poorly draining soils and subsoils, and there are significant areas of high pollution impact potential for phosphate to surface water.

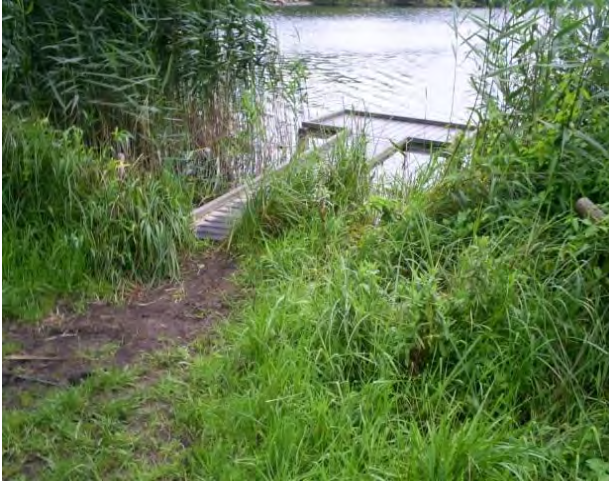
**Figure 5: One of the lake’s current poorly maintained angling stands**

Erosion has become a major concern at a number of these stands and gabions have been placed along the track to halt any further subsidence. A rehabilitation plan and angling stand design has been provided in the Landscape Masterplan document. This consists of bank stabilisation works and the creation of permanent ecologically sensitive angling stand designs.

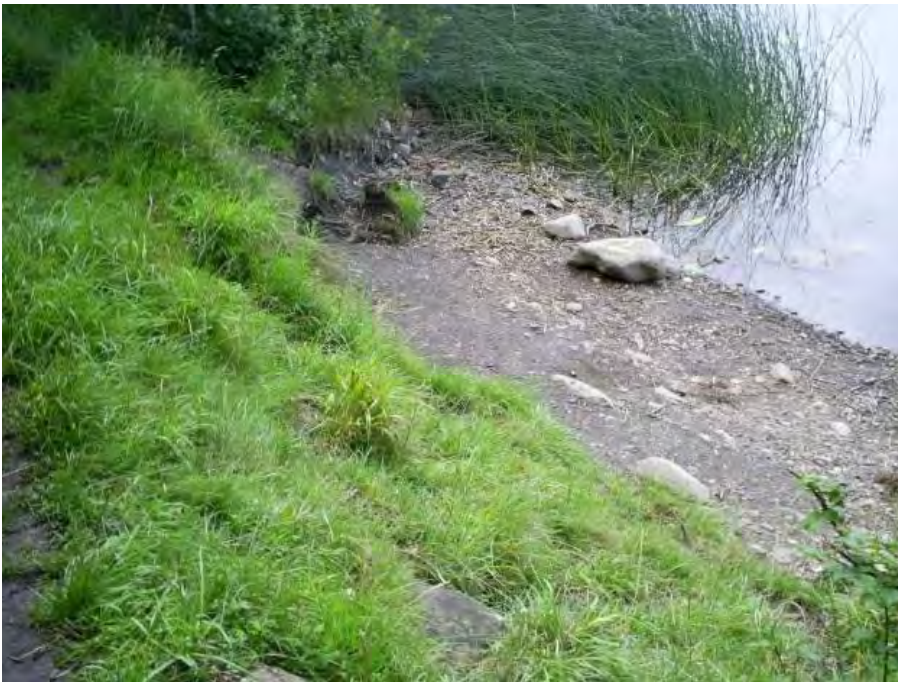
**Figure 6: Severe erosion around informal angling stand**

On the eastern side of the lake, accessed for angling has created erosion of the bank with some near-vertical slopes being created. These are very close to the main (informal) access track and as such are somewhat hazardous for walkers and other site users. Gabions have been placed in order to reinforce the bank. However, these cannot be considered a safe surface for angler access.

Aesthetically they are also poorly located and will never become revegetated. A plan for the rehabilitation of this area as well as angling stand designs have been provided in the Landscape Masterplan document. This allows for bank stabilisation works with natural materials and the creation of permanent and more ecologically sensitive angling stands.

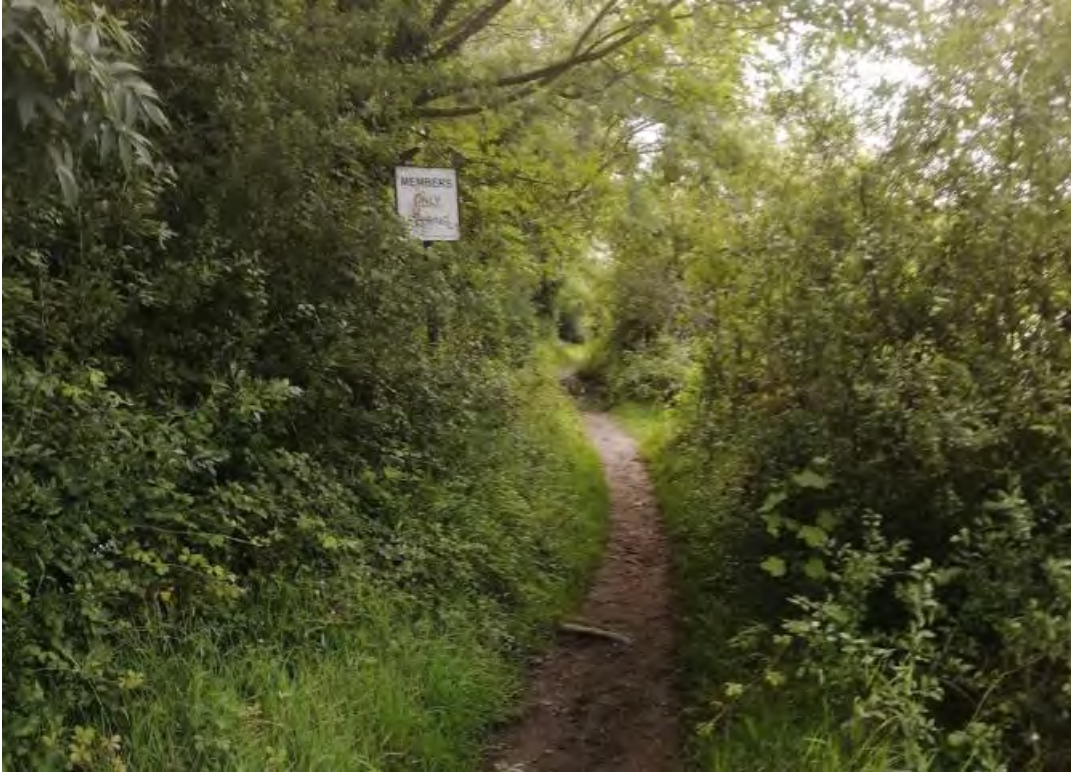
**Figure 7: Semi-formal track near the car park. The hedgerow on the left of this photo has sadly been removed**

From there two trail options exist. The pump station access road can be followed through an area of Coillte plantation woodland before looping back to the lake car park entrance. This is evidently already a popular walking and cycling route for locals and allows access for all abilities. The second trail option continues around an informal and likely rarely used trail along the lake's western shoreline. Here, excellent mature riparian woodland, reed fringes and mature mixed woodland flank the walkway. Track condition is informal with some areas being muddy even in mid-summer and other areas drier as they enter the plantation woodland. No track markings exist and it becomes easy to lose the main trail in places. Closer to the car park the track opens up as you emerge from the woodland. This area is one of the most heavily trafficked portions of the lakeshore for anglers. No formal track exists here and soil erosion and the exposure of tree roots were noted through this area. A raised walking platform extends from the car park for the last 20 metres of the lake loop to help site users avoid a seasonally flooded area. This platform is narrow and would not be suitable for all site users.

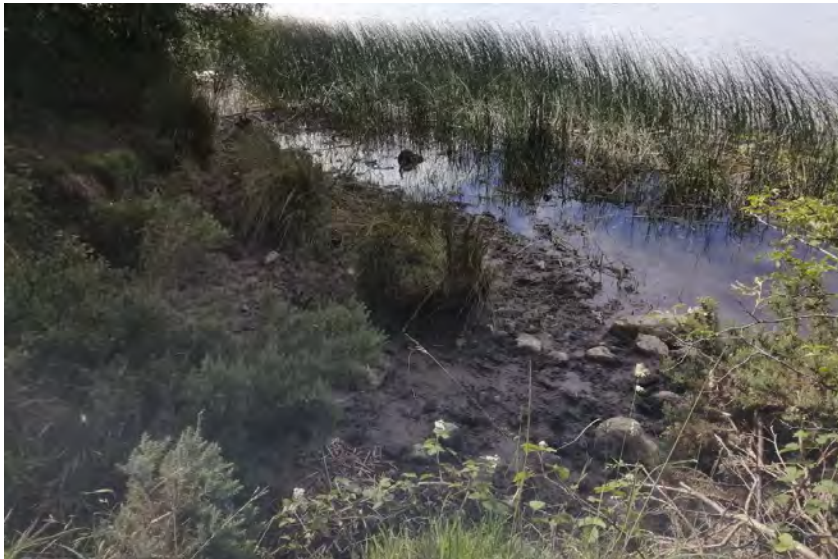
**Figure 8: Poaching from cattle along the shoreline**

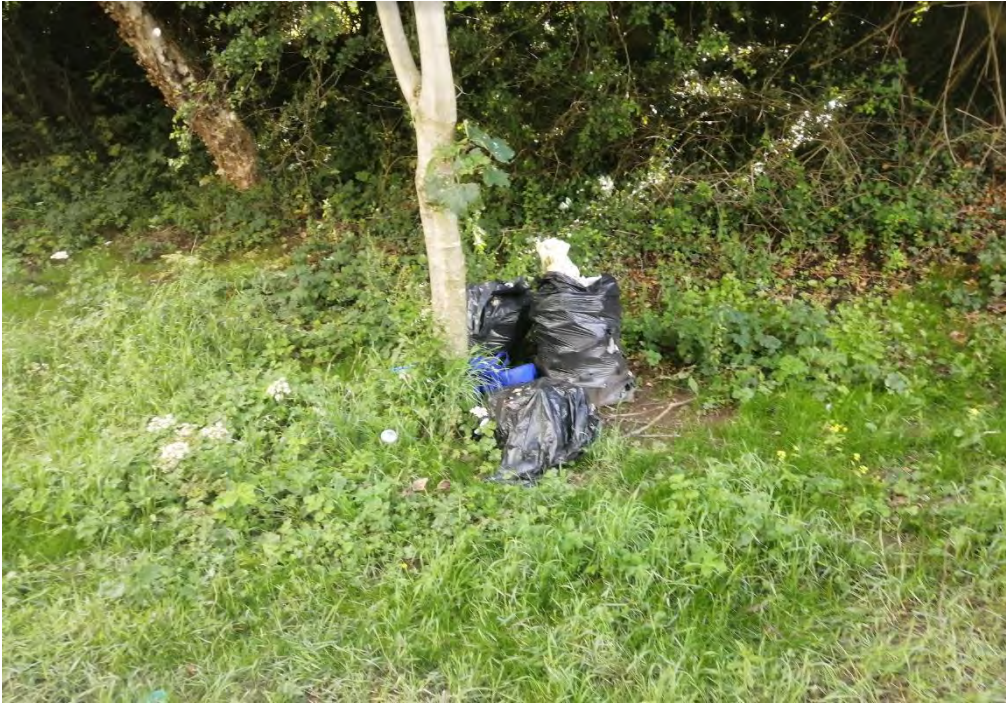
**Figure 9: Rubbish and fly tipping in the car park**

Evidence of public defecation and urination were seen commonly within the adjoining woodlands and scrub areas around the lake. The lack of public toilet facilities, particularly for users who may be at the lake for several hours, is further impacting the perception and safety of the lake for all users.

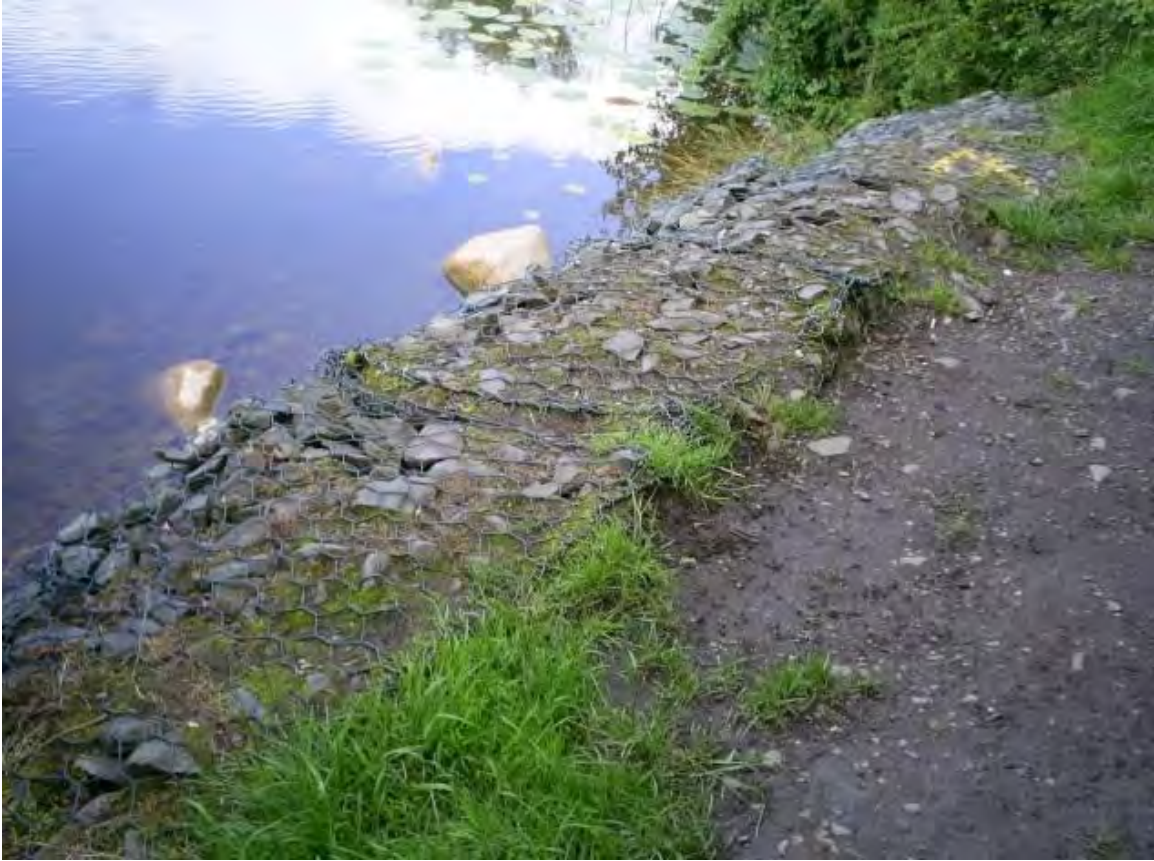
**Figure 10: Gabions used to halt further bankside collapse. This area is also used as an informal angling stand**

Collapsing and widening of angling stands is another major concern for the ongoing function of the lake. Year round use of the lake, coupled with a prolonged period where no maintenance has occurred, has left some areas becoming severely undercut. This has led to more losses of sediments and nutrients to the lake and impacts on the site's amenity value. This is particularly apparent along the eastern shoreline where the lake abruptly drops off to a higher depth. This issue is further exacerbated through anglers cutting back vegetation and making informal paths down to the water's edge.

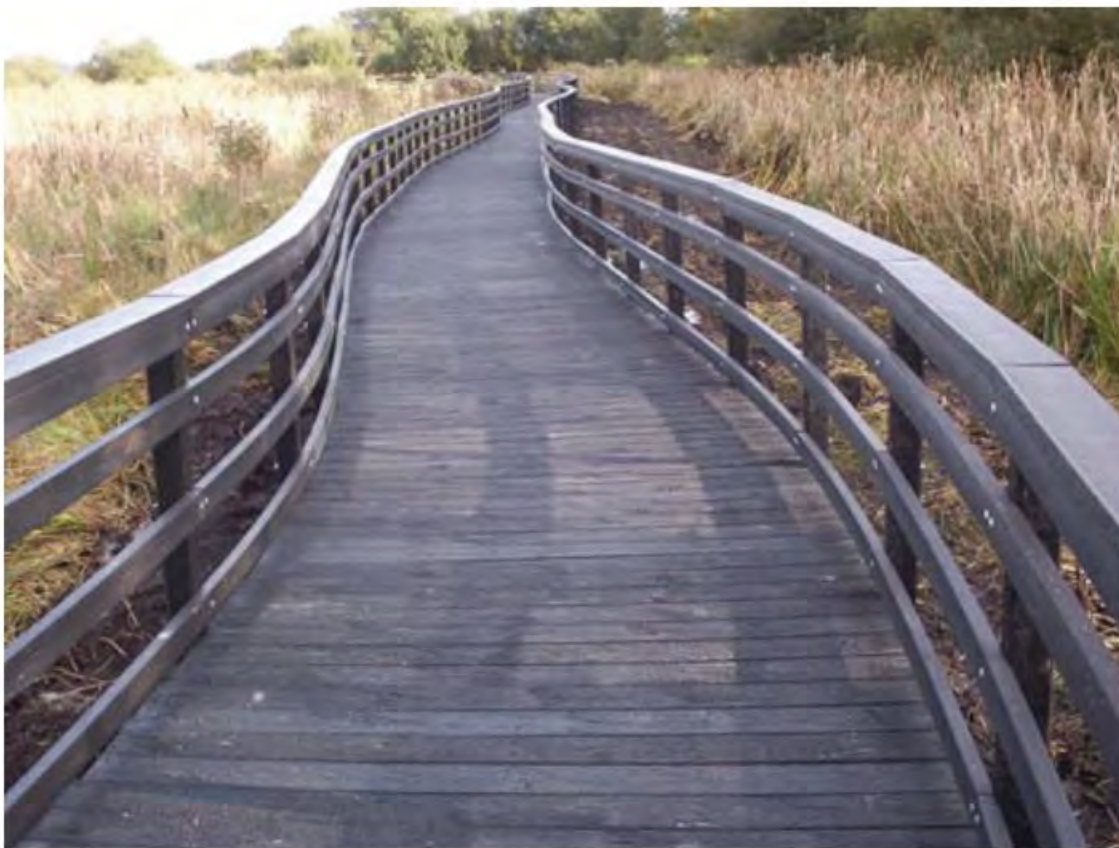
**Figure 13: Example of universally accessible boardwalk suitable for the lake shore**

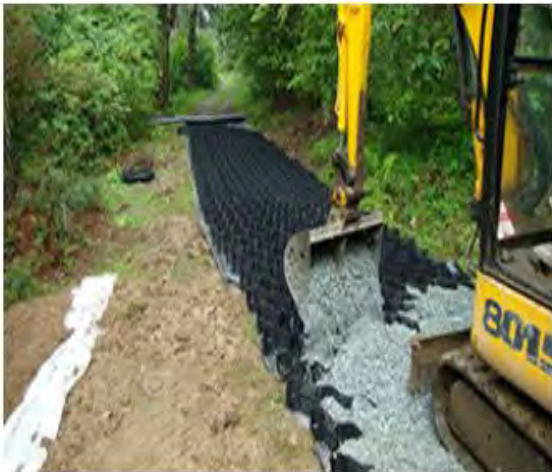
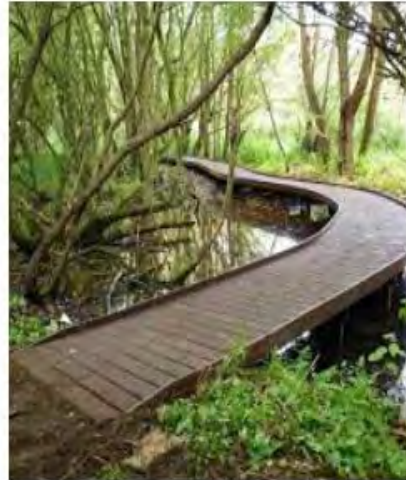
**Figure 15: Proposed Geocell track design and boardwalk design where seasonal flooding is a concern**

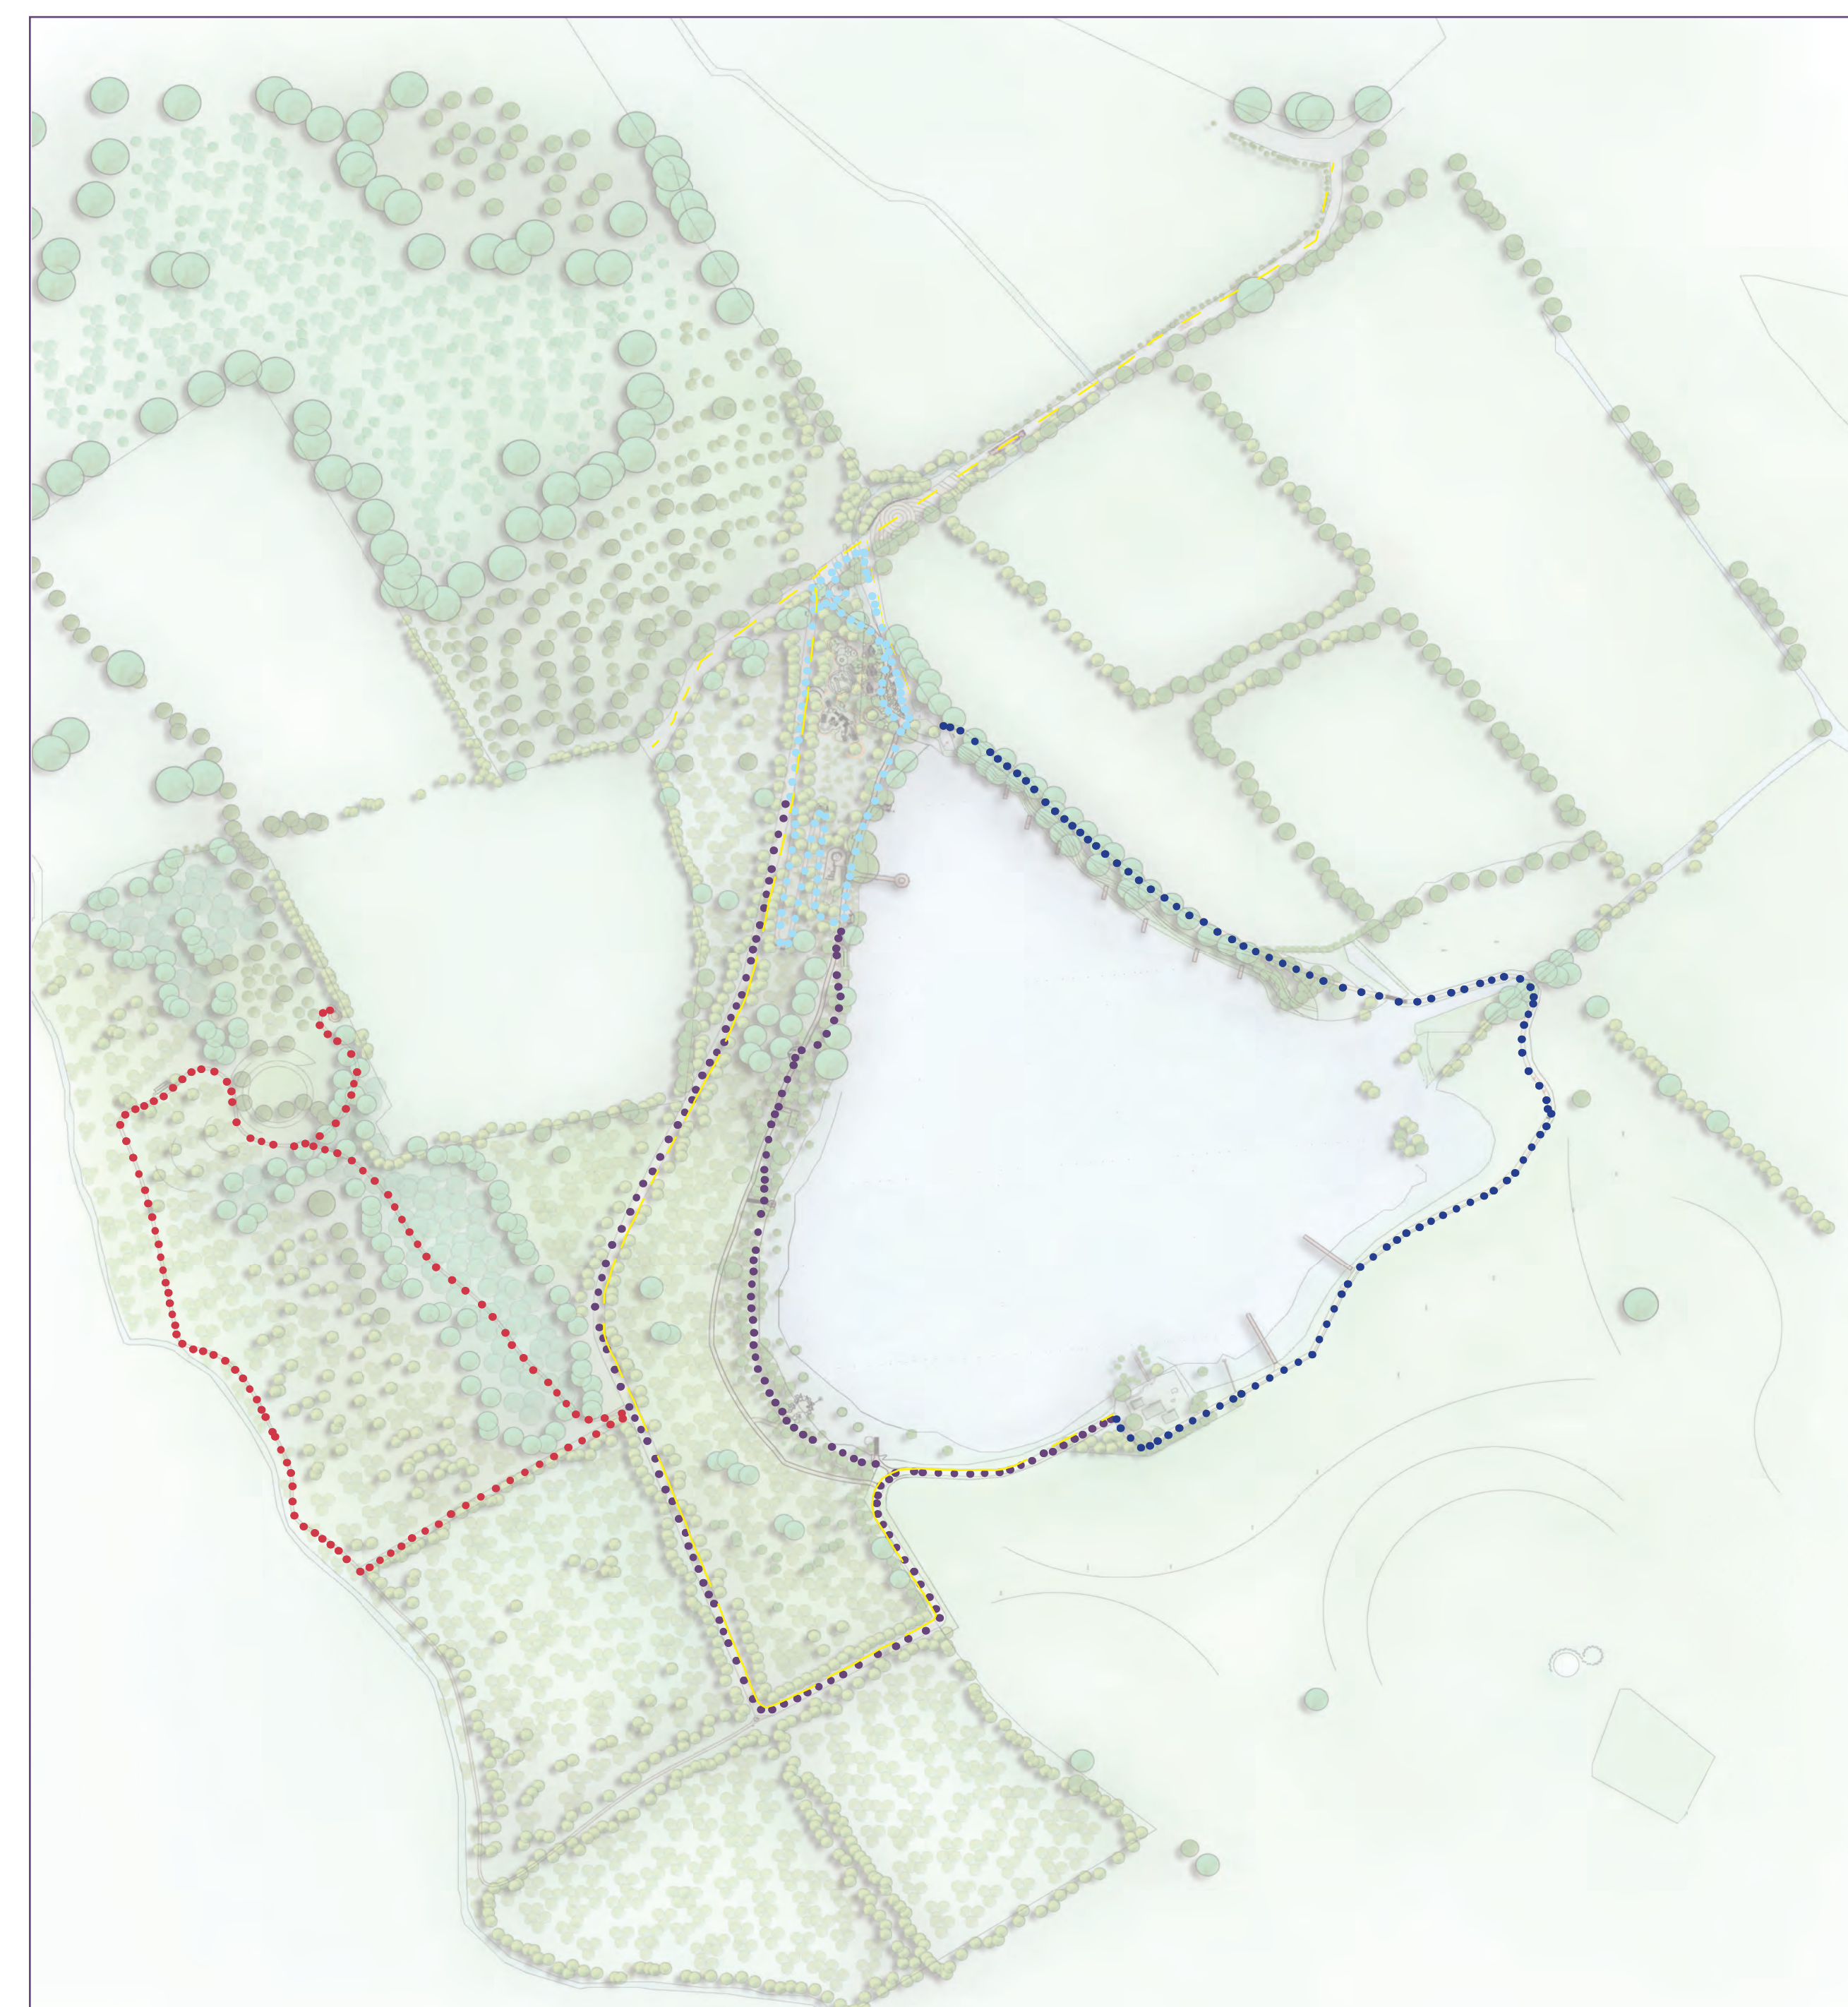
Circulation

- ● ● ● ● ● ● ● Lough Bracken Lake Loop Walk -Challenging Access
- - - - - Restricted Vehicular Access
- ● ● ● ● ● ● ● Lough Bracken Lake Loop Walk - Universal Multi-Access
- ● ● ● ● ● ● ● Scots Pine /Moat Loop Walk
- ● ● ● ● ● ● ● Lough Bracken Lake Loop Walk -Fishing Access

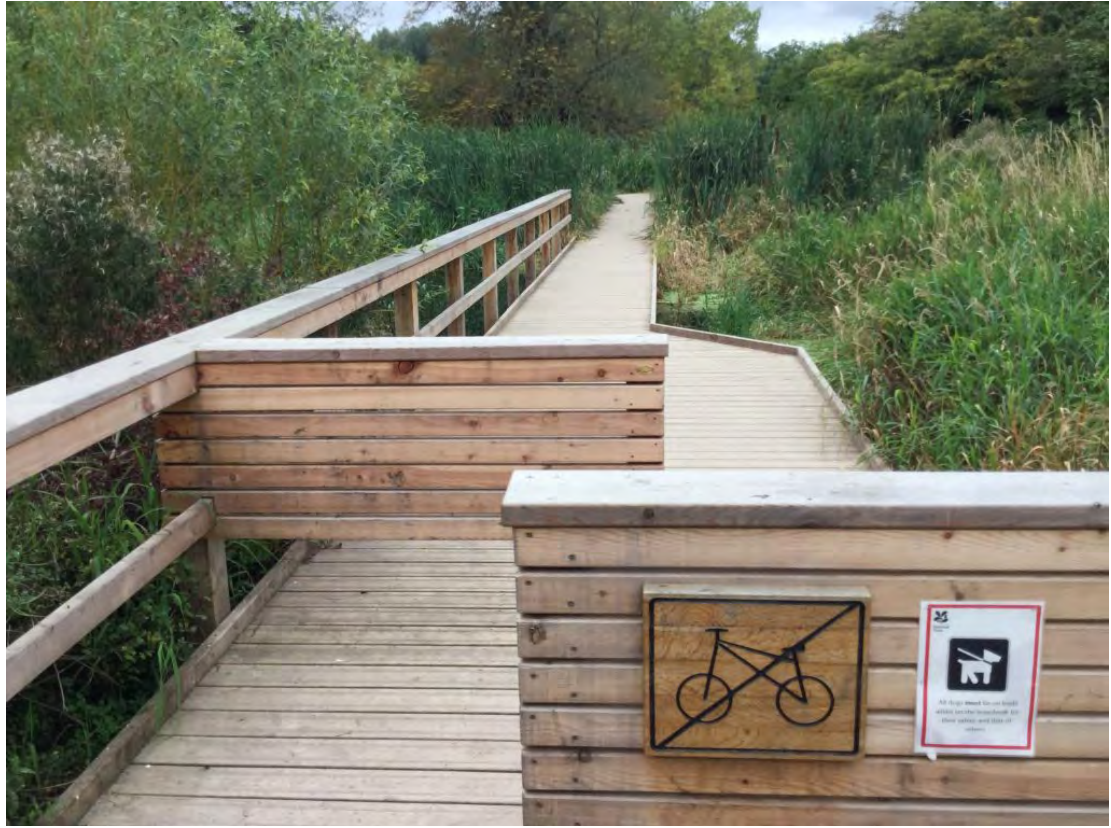
Habitat information can also be integrated into boardwalk floor

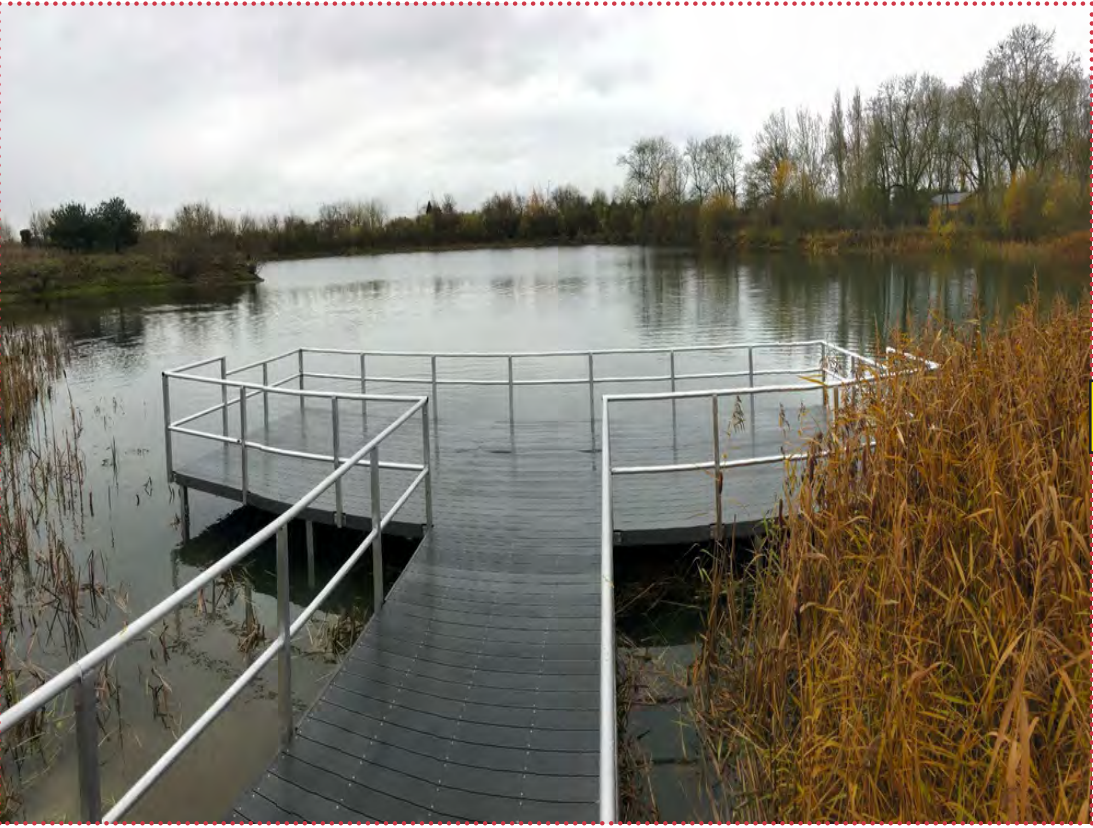
Information integrated into the boardwalk to reduce the necessity for additional signage

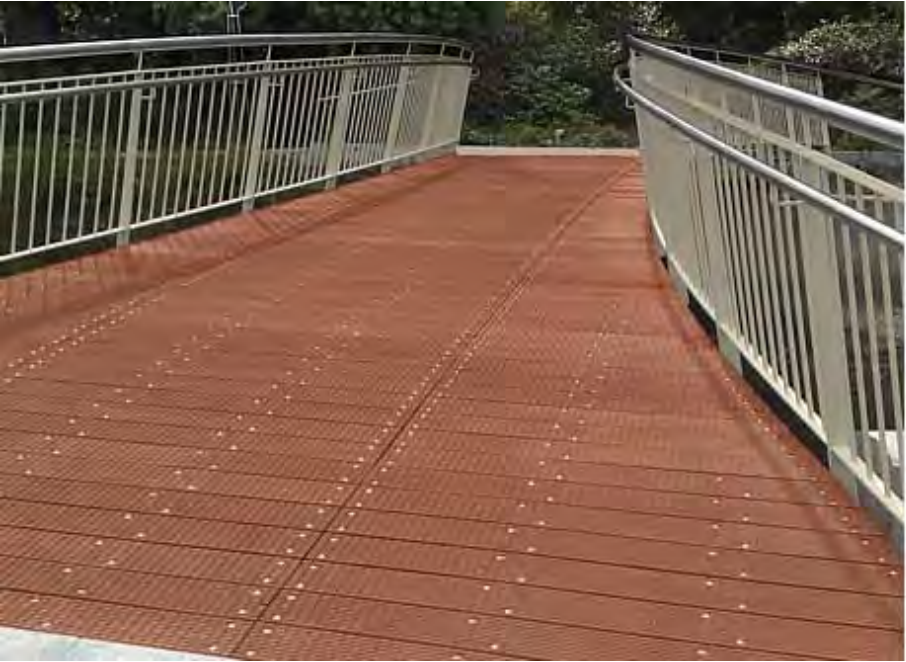
Habitat information at appropriate locations integrated into wooden surfaces in a sustainable, durable and artistic manner. Information including tactile communication to avail of the extensive lengths of handrails. Etching to be clear and attractive.

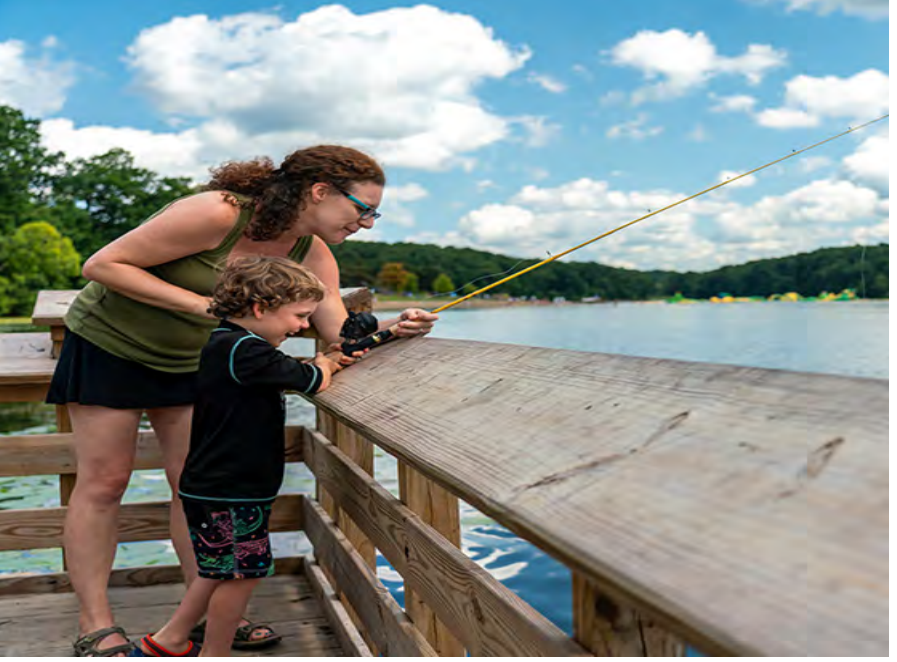
Anti-slip board treatment in areas liable to occasional wetting

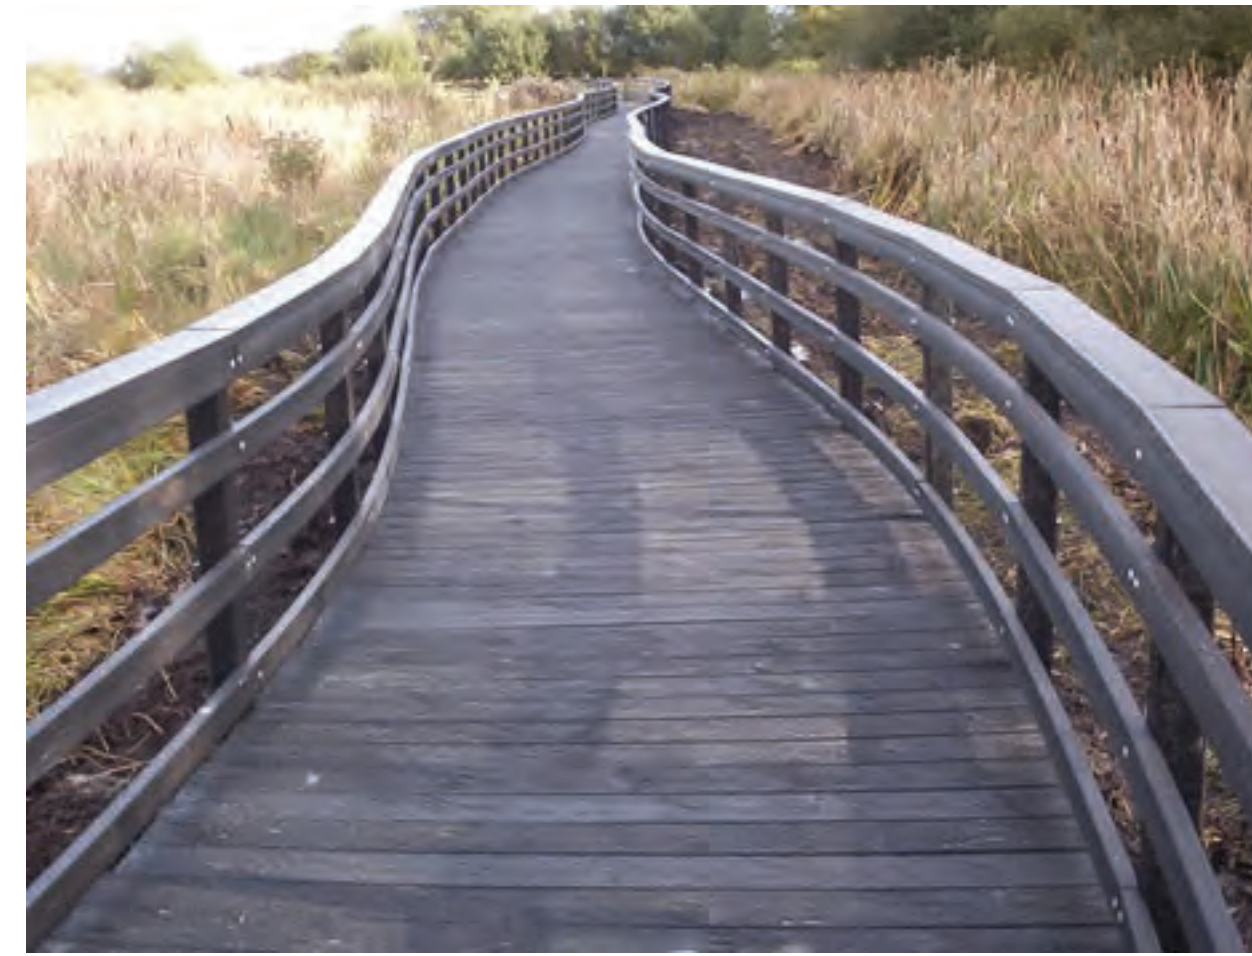
Universal access routes with good rail protection whilst allowing viewing. Boardwalk to clear 600mm over water body

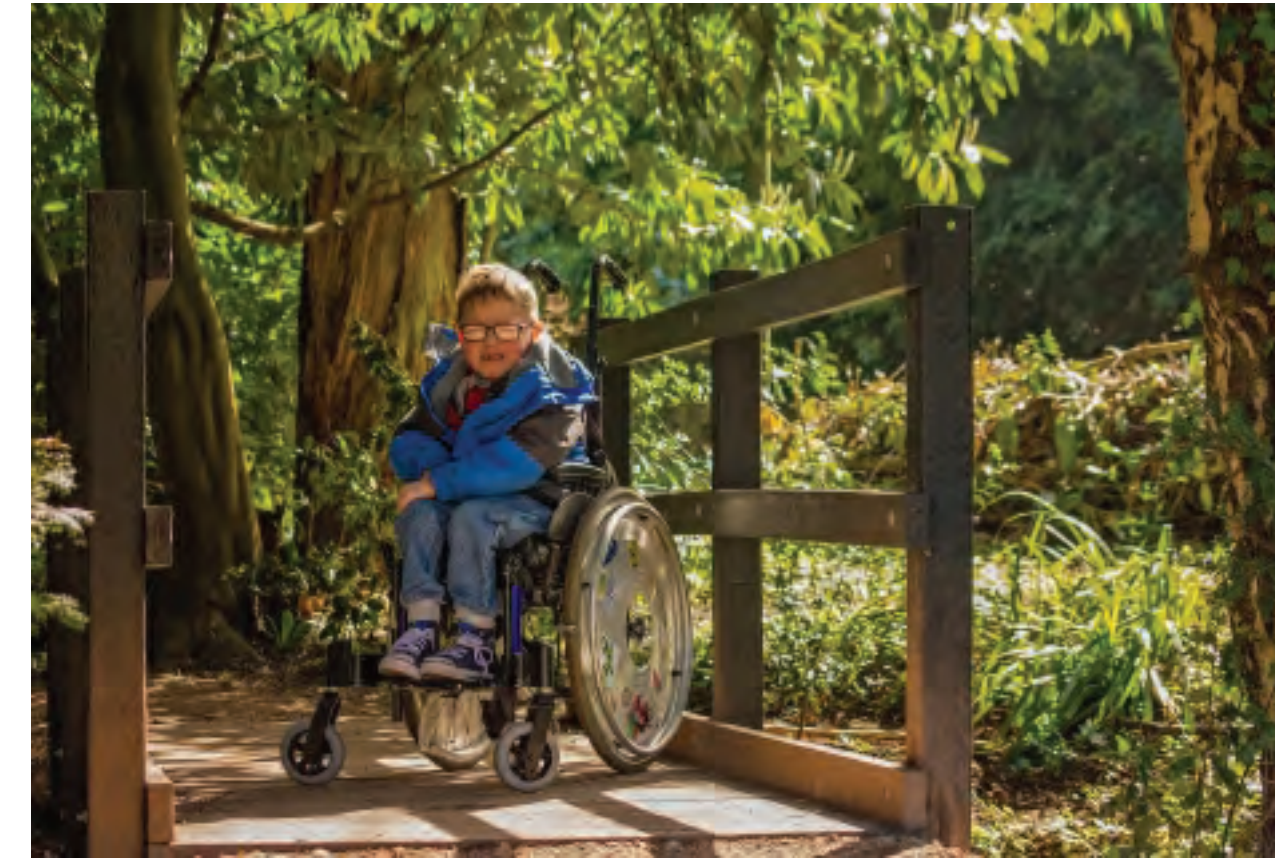
Example of universally accessible boardwalk over a wetland system
