# PROPOSED ENHANCEMENT WORKS AT LOUGH BRACKEN, CO. MEATH

## Planning and Environmental Report

Prepared for:  
Meath County Council

Date: October 2024

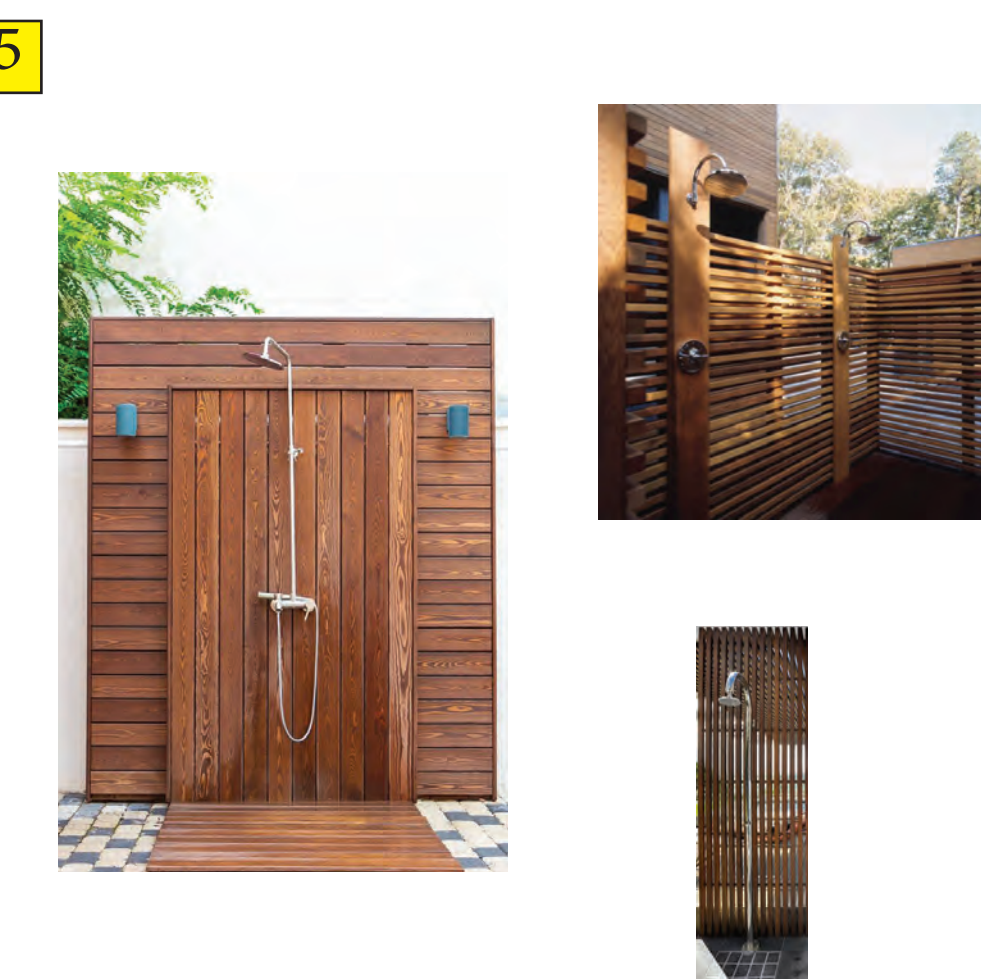
Rinsing shower heated from solar panels mounted on changing room roof. Rain water harvesting to supply water source with automatic UV disinfectant. Shower post with circular grab rail for universal access mounted under the shower head between 840-950mm above shower floor. Floor to slope no more than 2% in all directions or as advised by ability consultant.

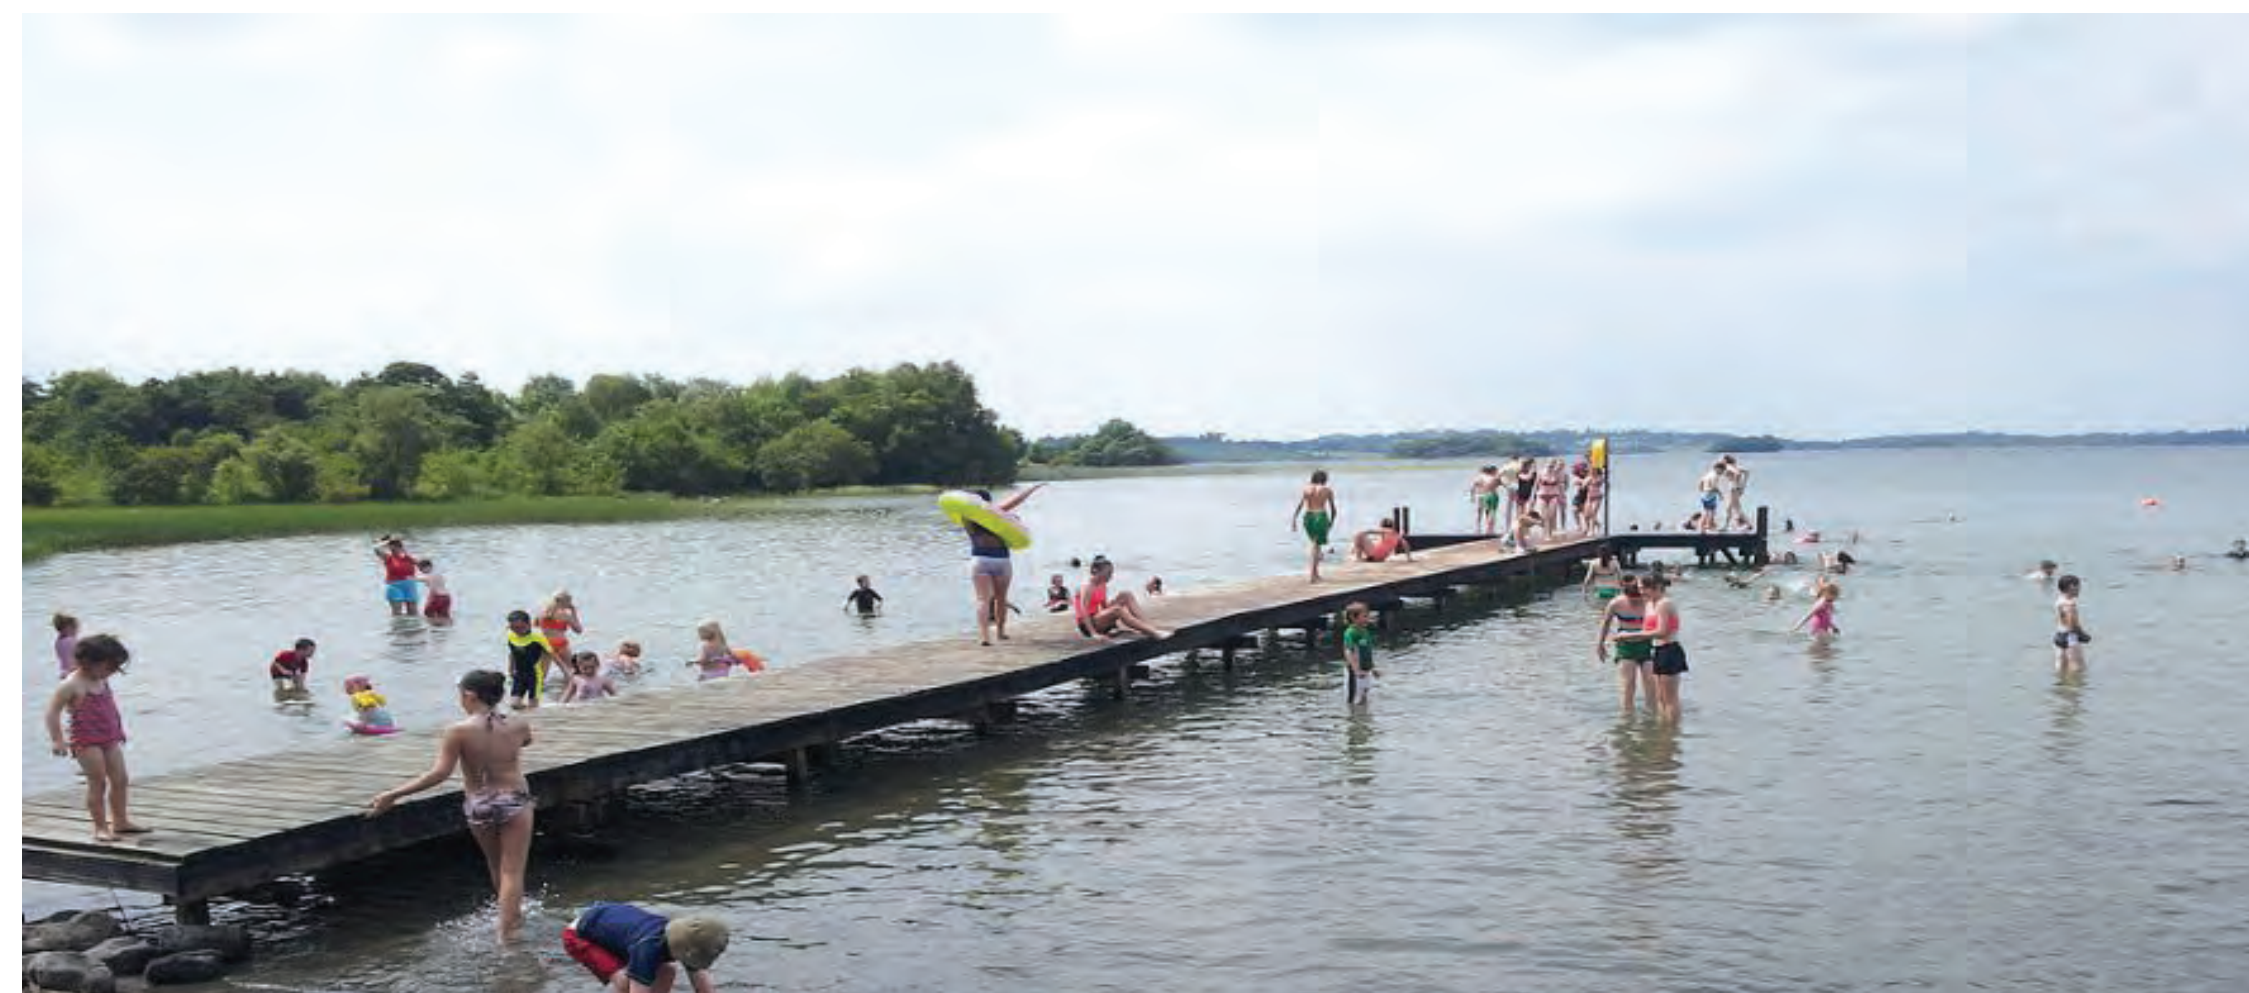
Swimming piers to facilitate swimming at differing depths of water, long enough to allow for multiple users in fine weather. Swimming piers to double as viewing platforms

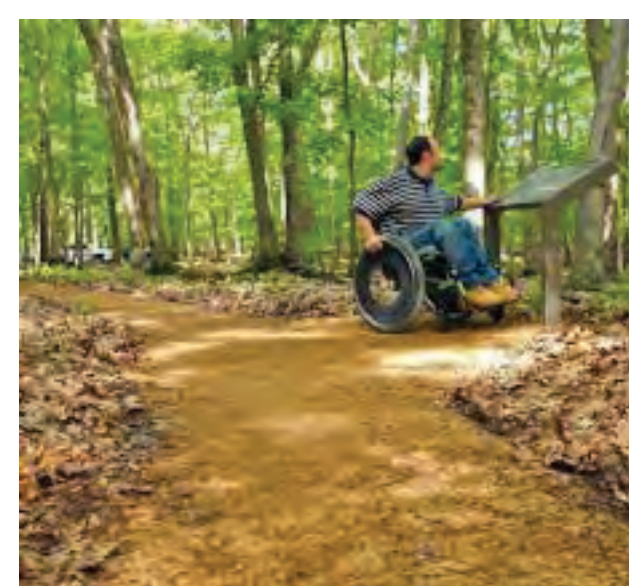
Trail head information advising as to the length and accessibility grade of the loop

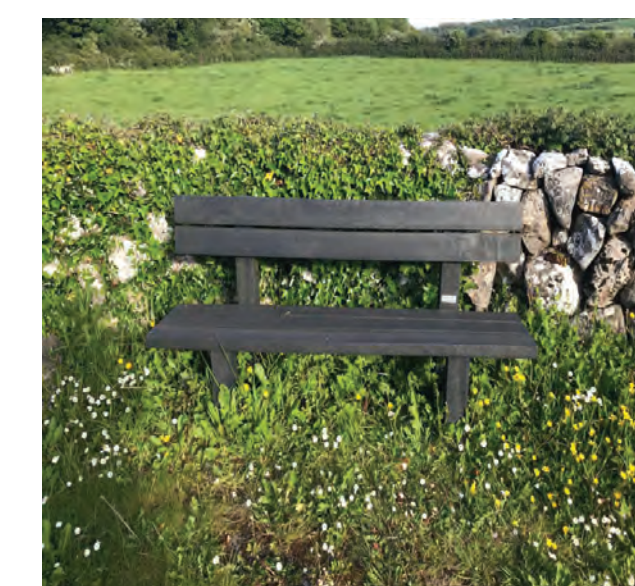
Rest bench composed of durable recycled plastic

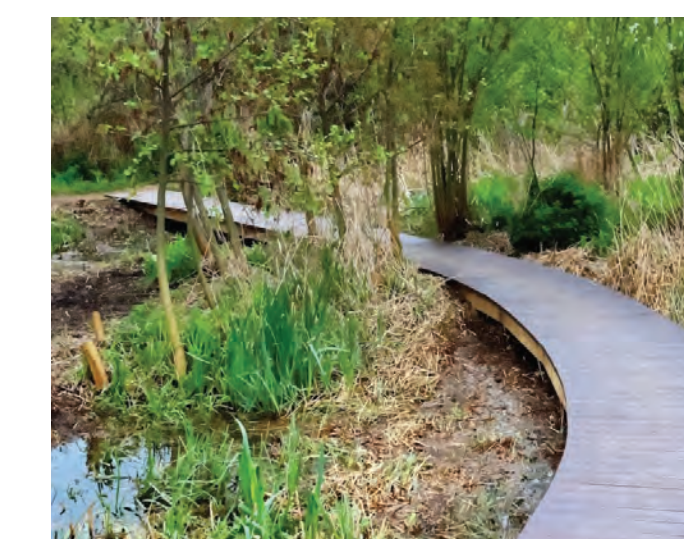
Simple boardwalk, ungraded for access, to allow for riparian zone regeneration and planting whilst allowing pedestrian access over wet spots on the trail.

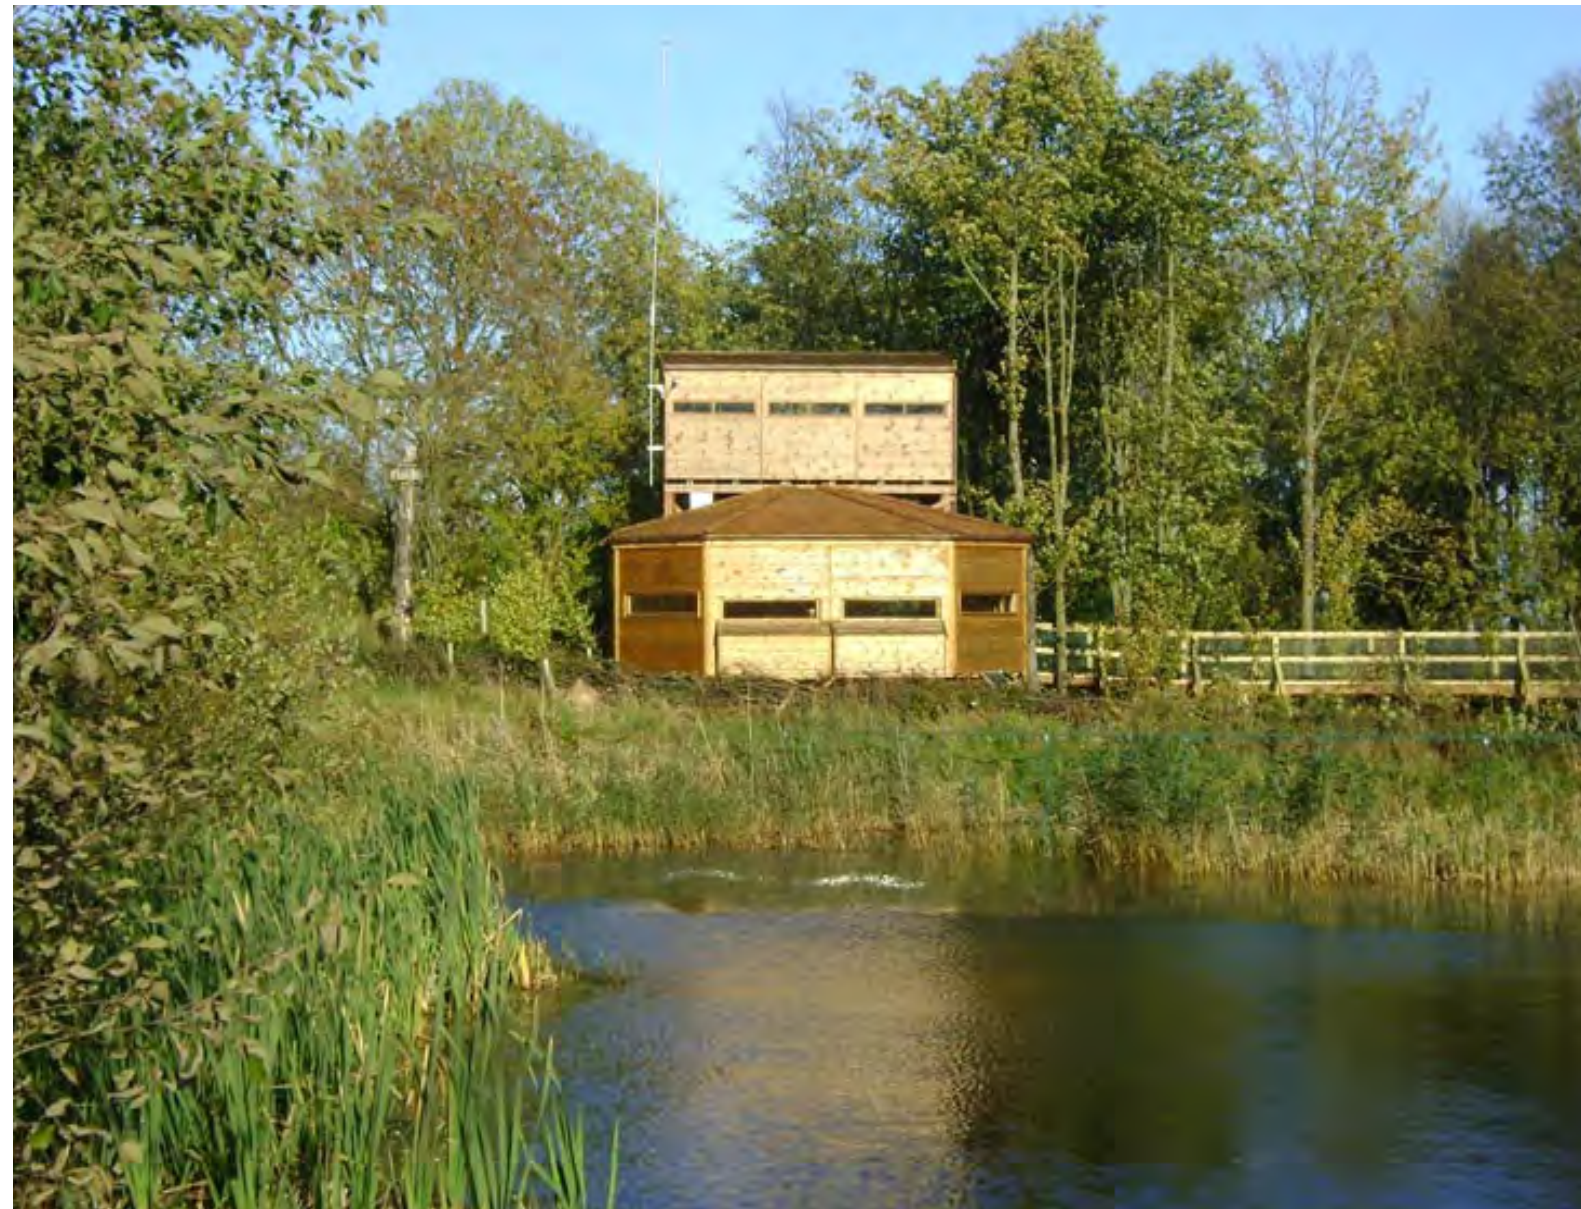
Large hide composed of timber materials situated near water body

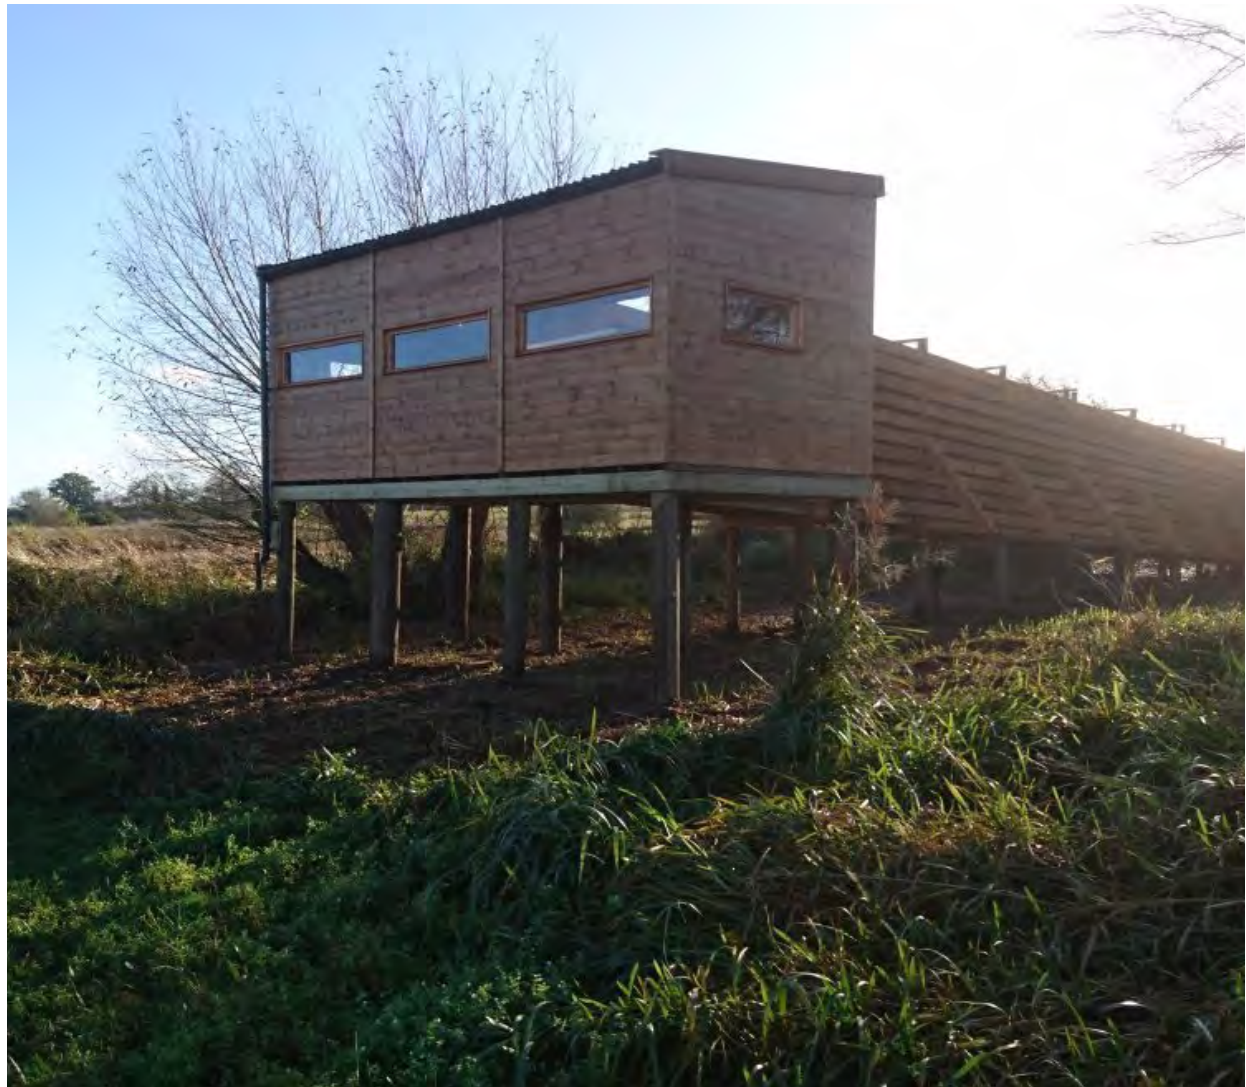
Bird hide composed of timber materials with glazed hatches and rear universal access ramp with a high degree of light and shadow reduction.

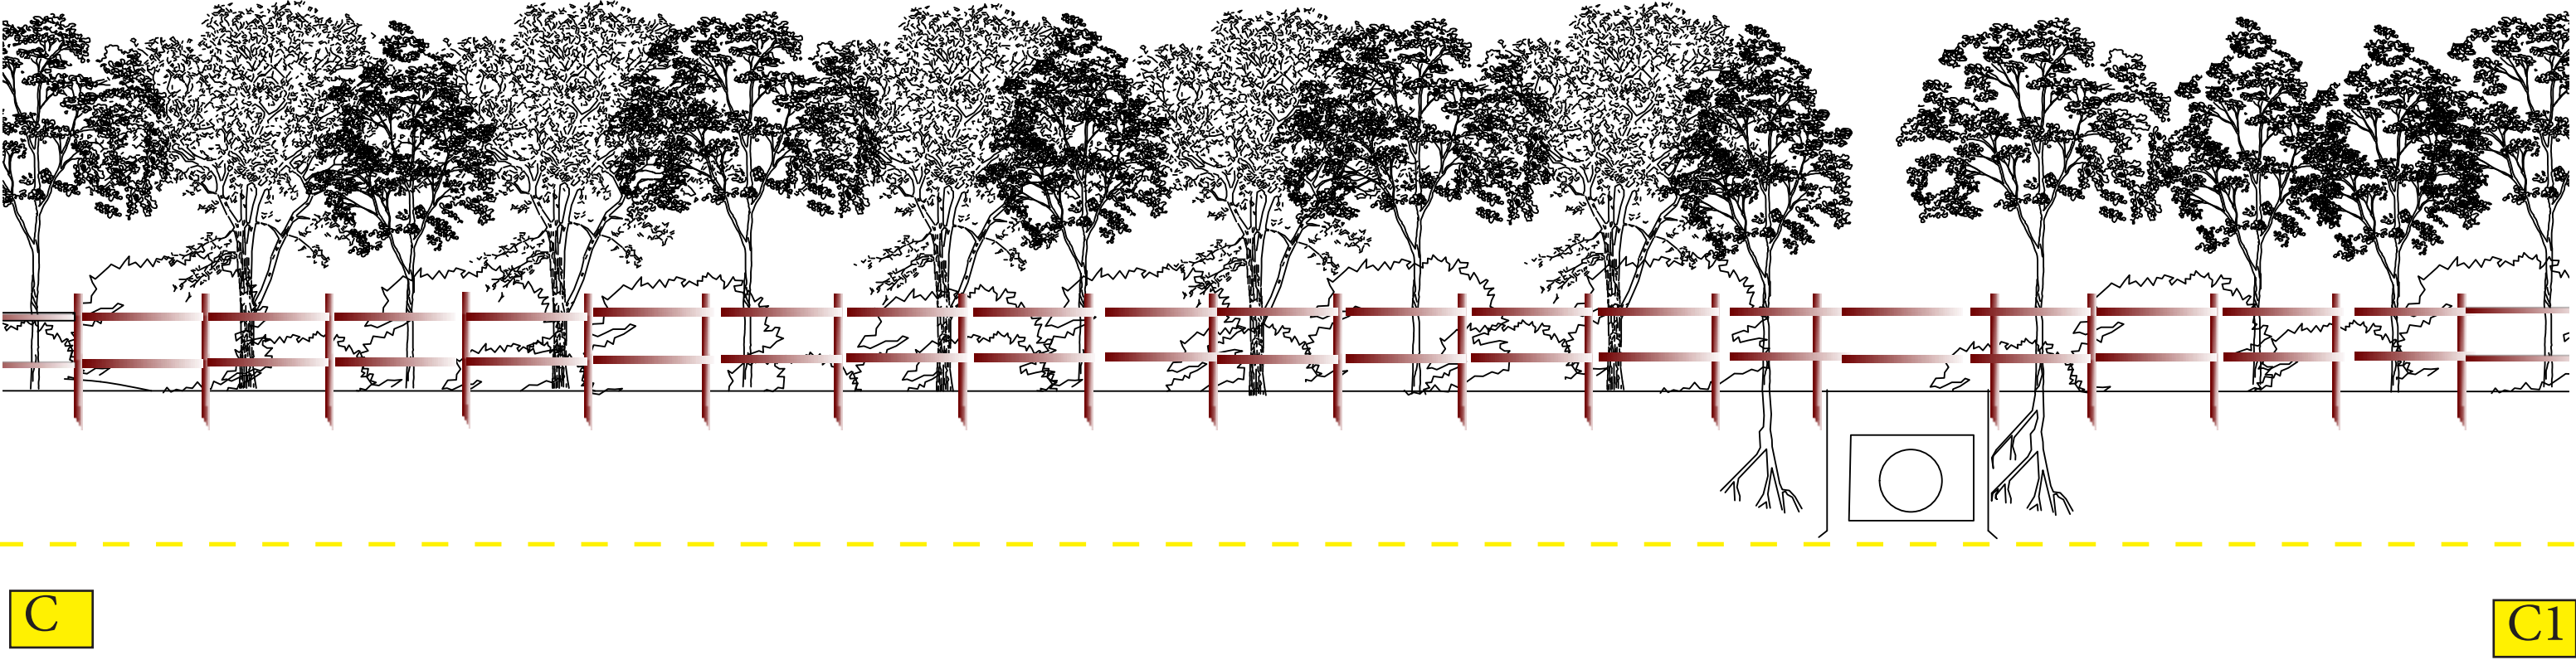
## ZONE K Section

Rowan Sorbus acuparia, Crab apple Malus sylvestris, Prunus avium, Prunus padus wild cherry and bird cherry can be grown 5m from water pipes. They are also useful pollinators and visually blend the water plant into the landscape

New sitka spruce fencing posts and rails to be erected to secure cattle and prevent their entering the lake-shore. Galvanised or plastic coated sheep wire to be firmly attached to the lake side of the fence reinforcing the stock proof capacity of the fencing system.

Holly, Ilex aquifolium can be grown to 2m of the water pipe infrastructure. It is also useful for surrounding habitats and blends the security fence into the landscape.

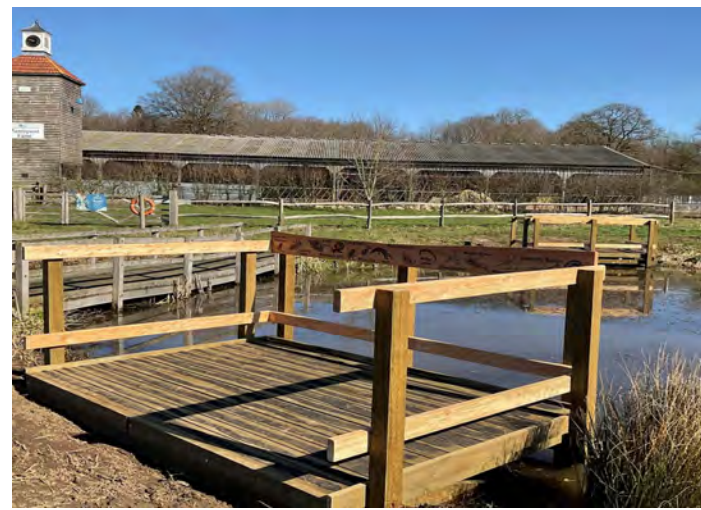
All ecological information and information and identification of aquatic life to be integrated into the railings surrounding the dipping platform or presented as here on the right. Tactile information also to be available.

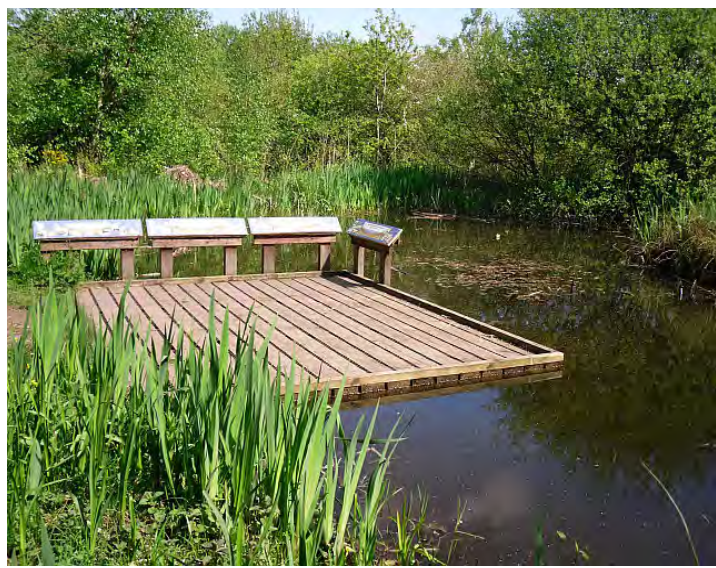
A jetty similar to this adjacent to the boat house to be constructed as a dipping platform on the site of the original jetty.

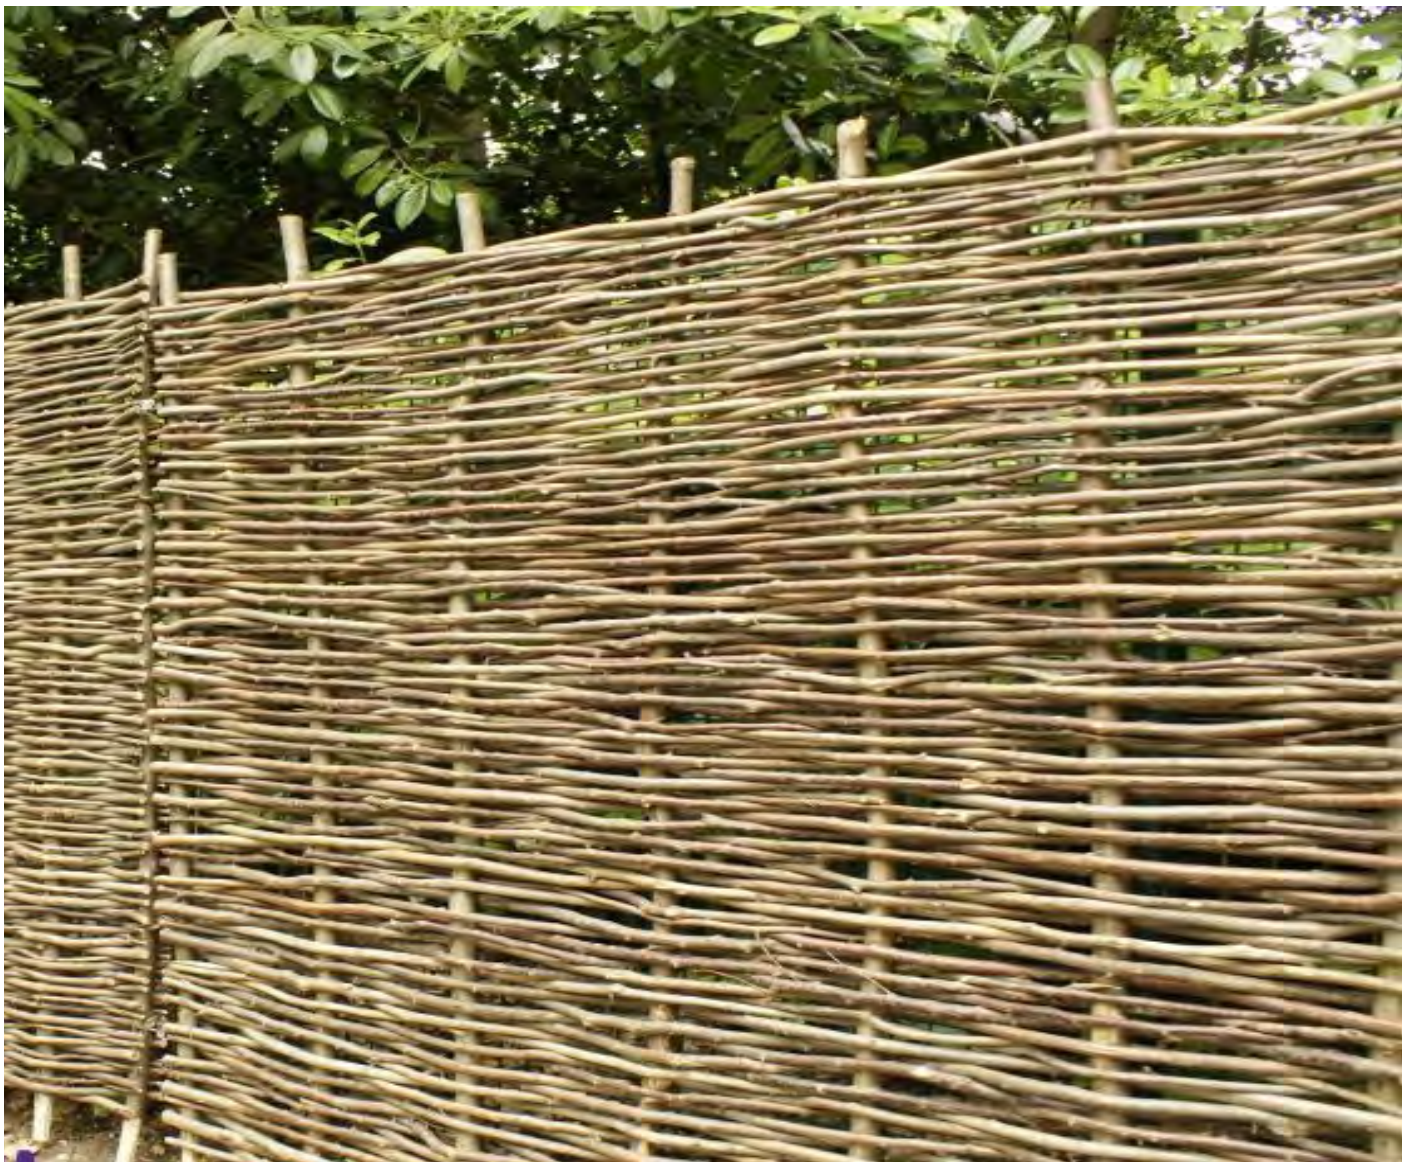
Sample of woven panels adjacent to temporary or movable structures add a sense of unity to a lakeside setting ensuring the image of lake is visually integrated into the overall development and landscape.

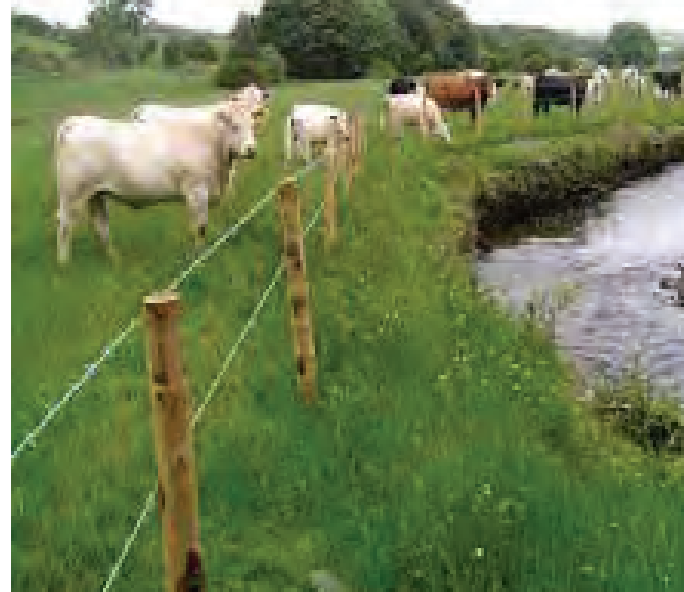
Cattle to be fenced off from lakeshore. This will protect the lakeshore and allow a margin of plant life to regenerate which helps reduce sediment and microbes arriving into the lake water.

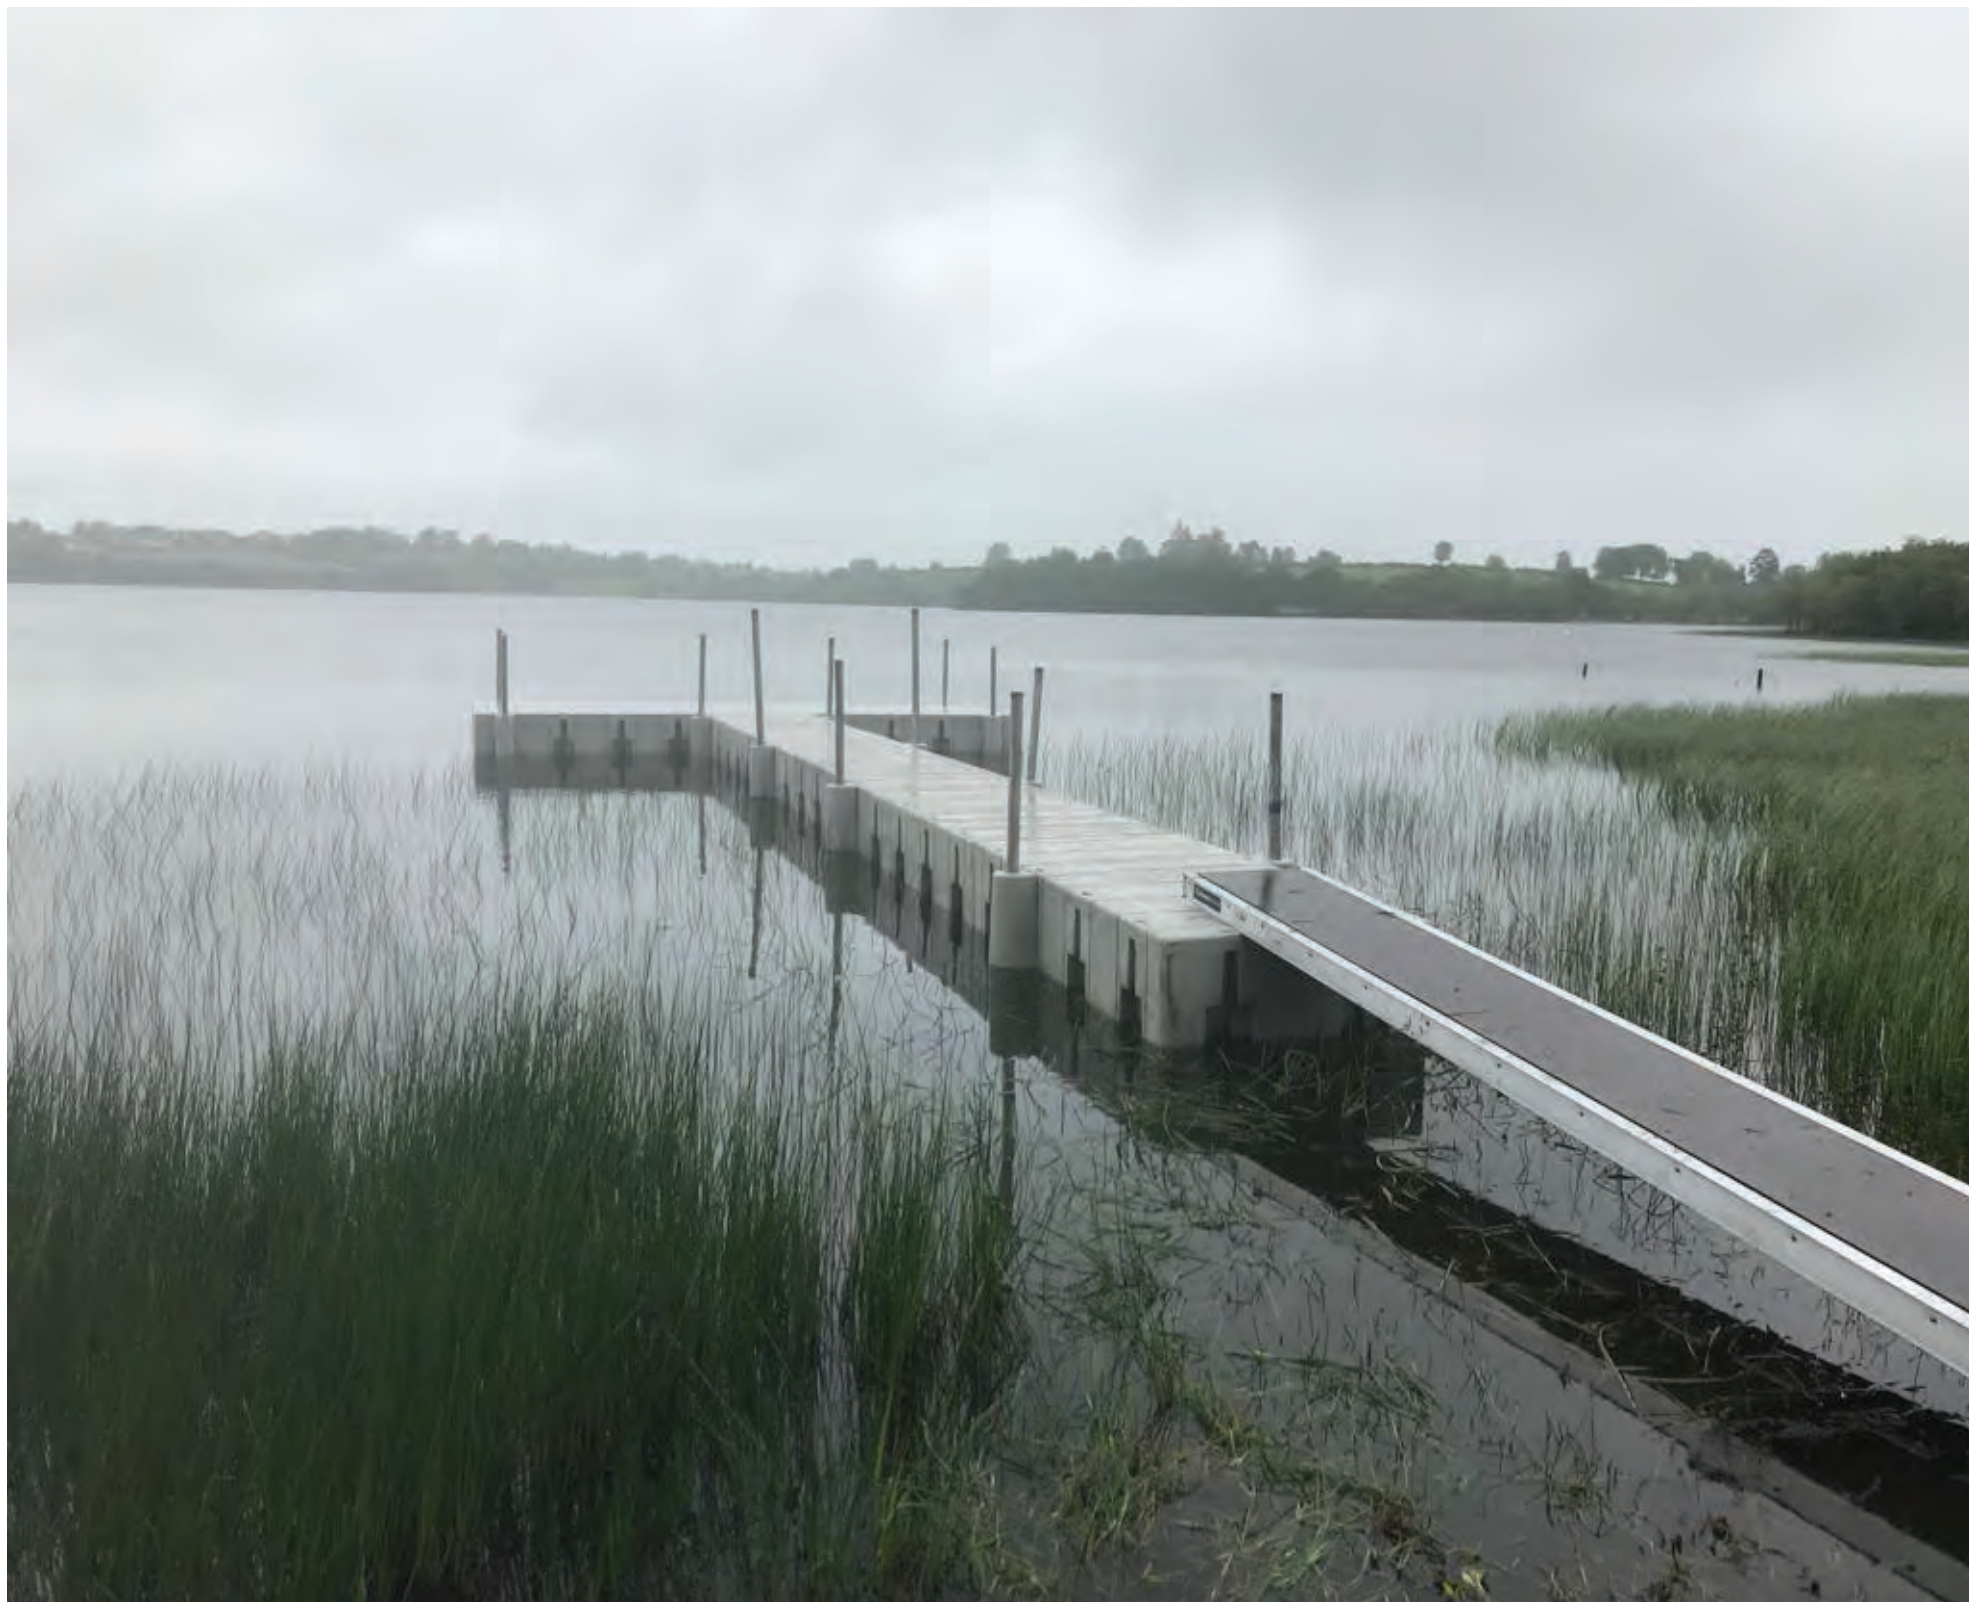
Floating jetties allow for a good extension of the jetty into the lake clear of aquatic and riparian vegetation.

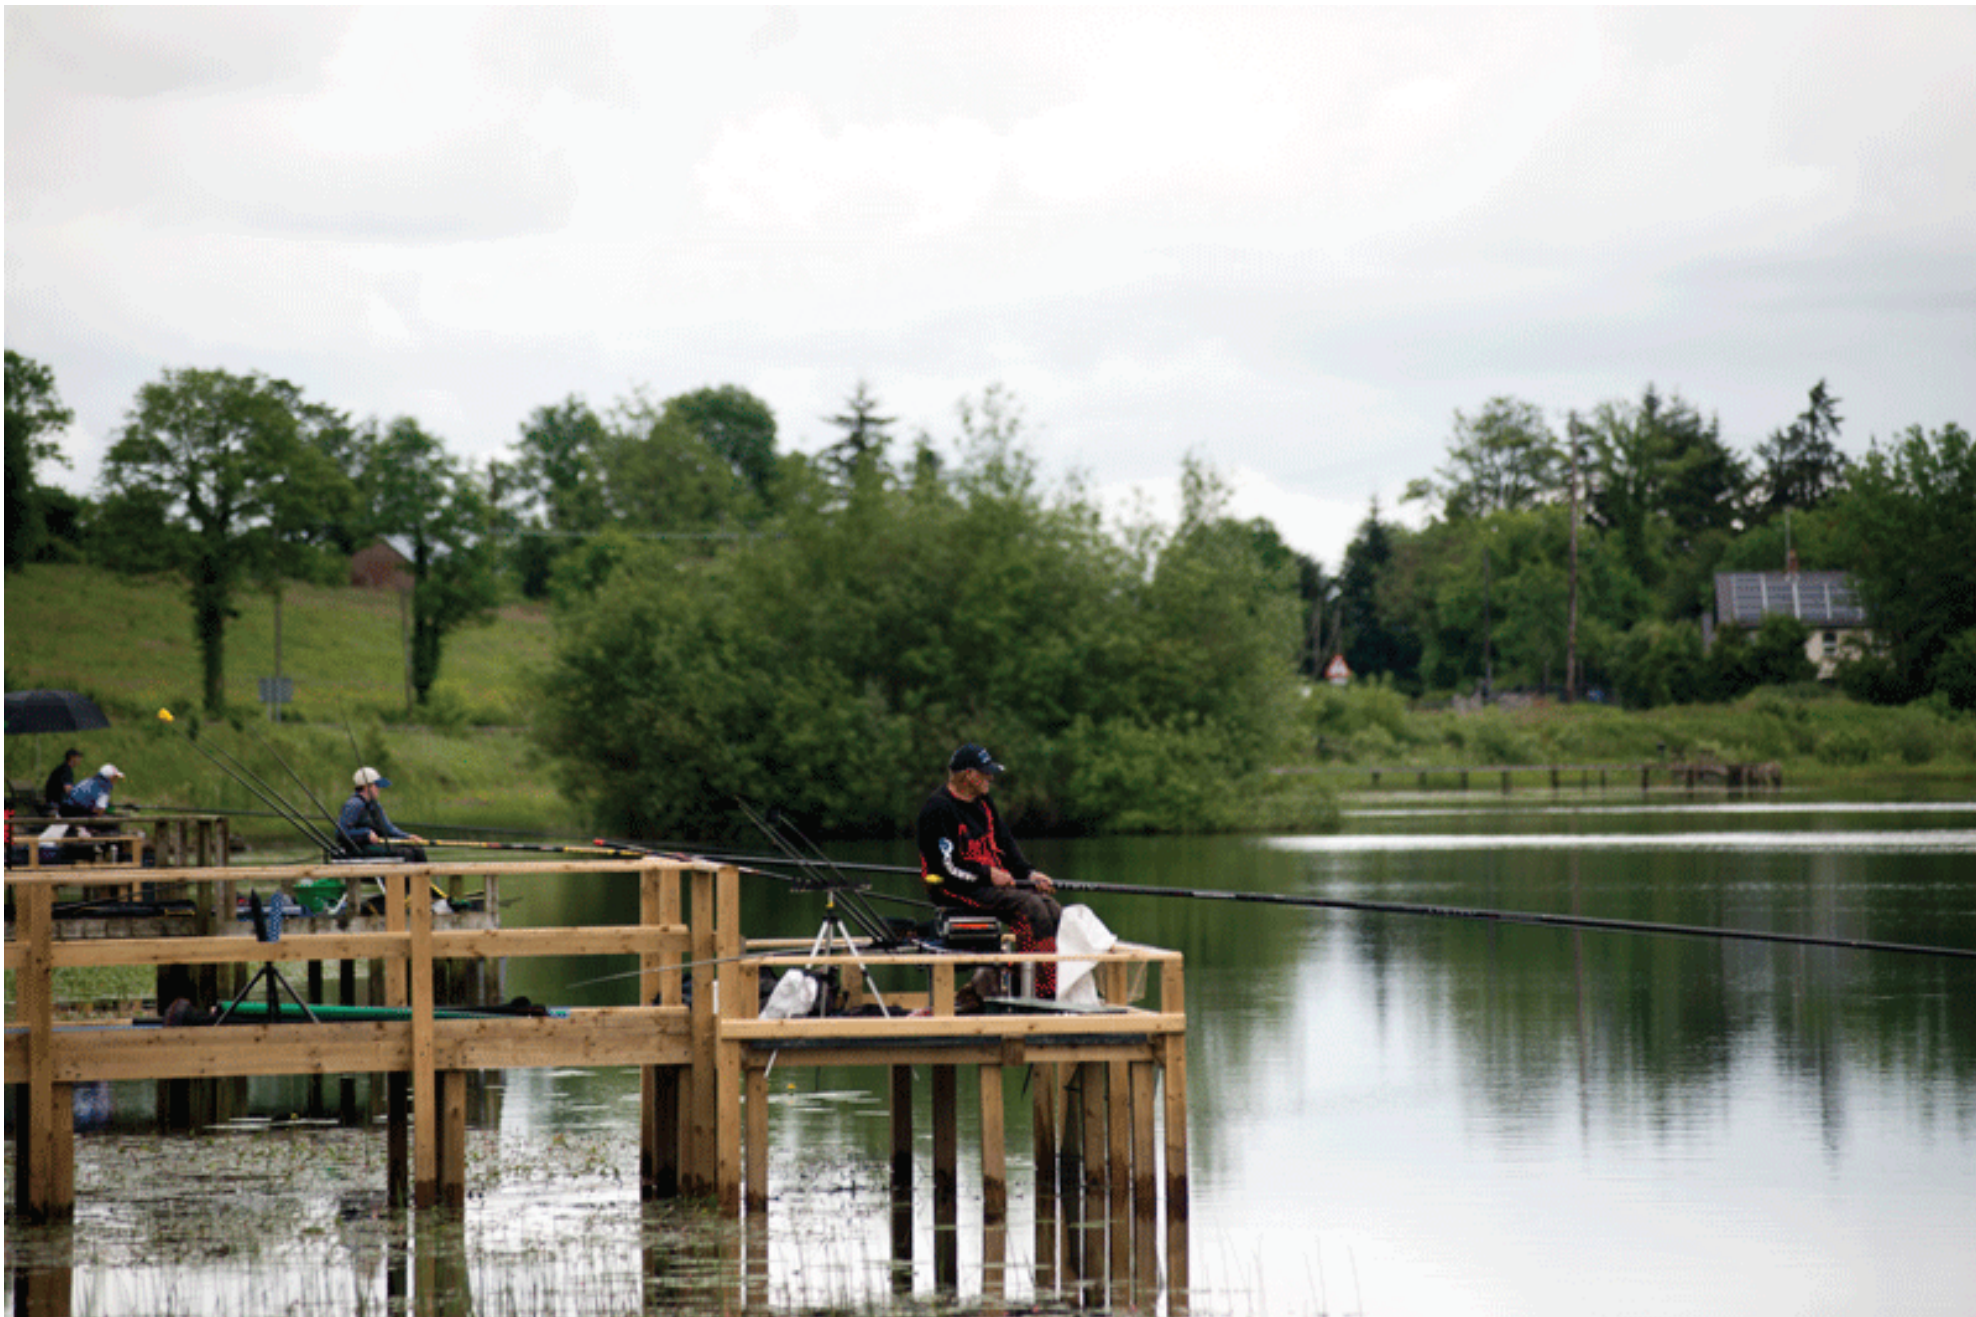
Multiple locations for fishing reduces wear to soils and aquatic and riparian vegetation at popular fishing stretches along the lakeshore

11. Increase the number of fishing stands to reduce the risk of erosion and wear. This will also increase water safety. The stands to be secluded from the path to ensure they are most likely to be used solely for fishing or viewing.

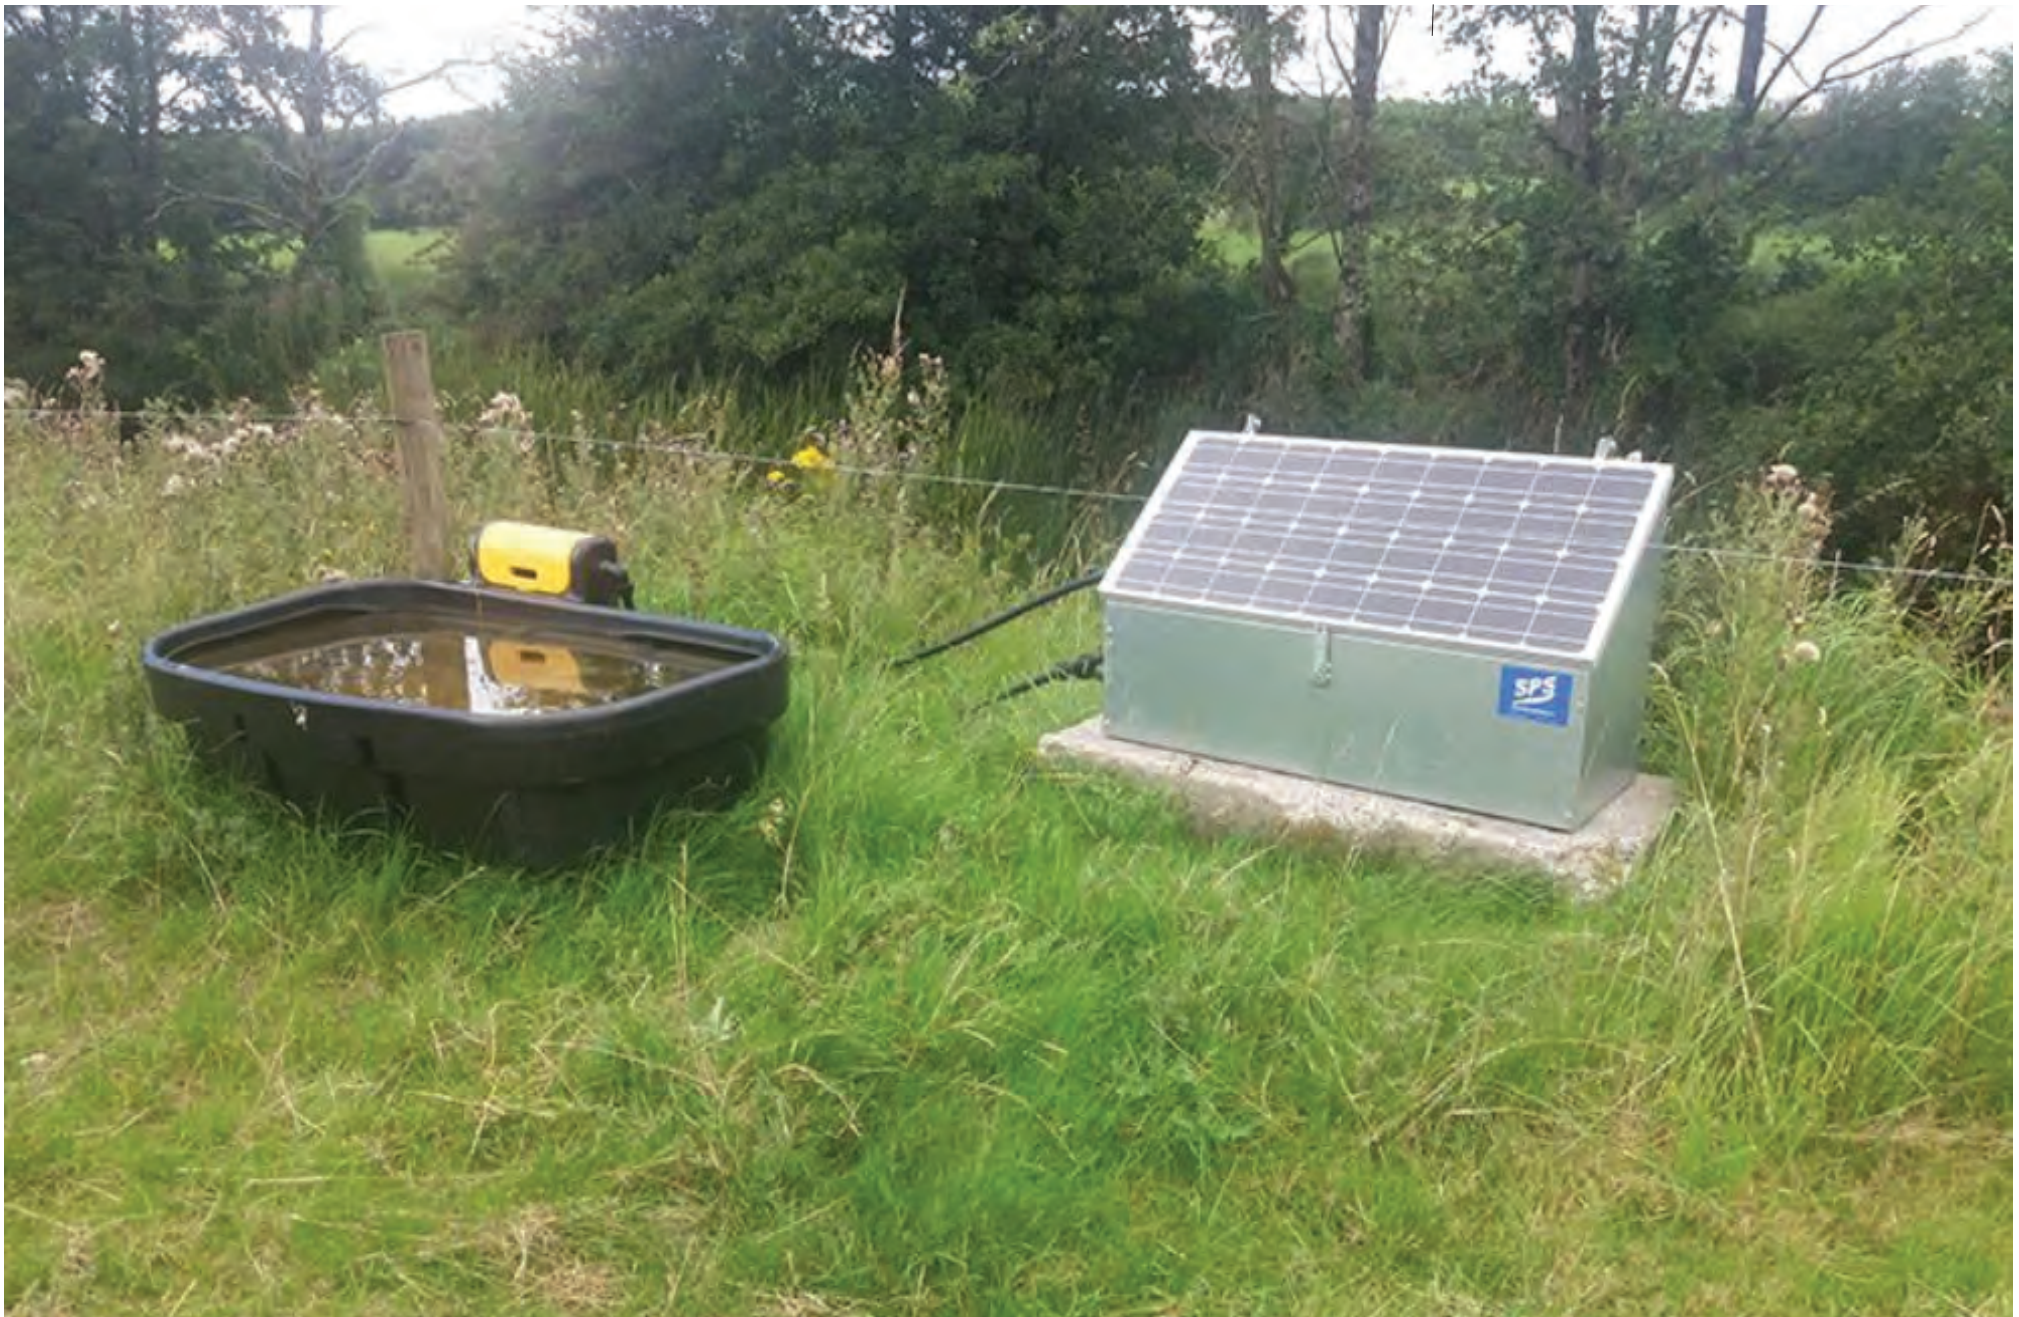
Drinking troughs to be placed at movable sites at least 20m from shore. The use of solar powered pumps allow water to be brought up the slope to troughs at various locations.
