# PROPOSED ENHANCEMENT WORKS AT LOUGH BRACKEN, CO. MEATH

## Planning and Environmental Report

Prepared for:  
Meath County Council

Date: October 2024

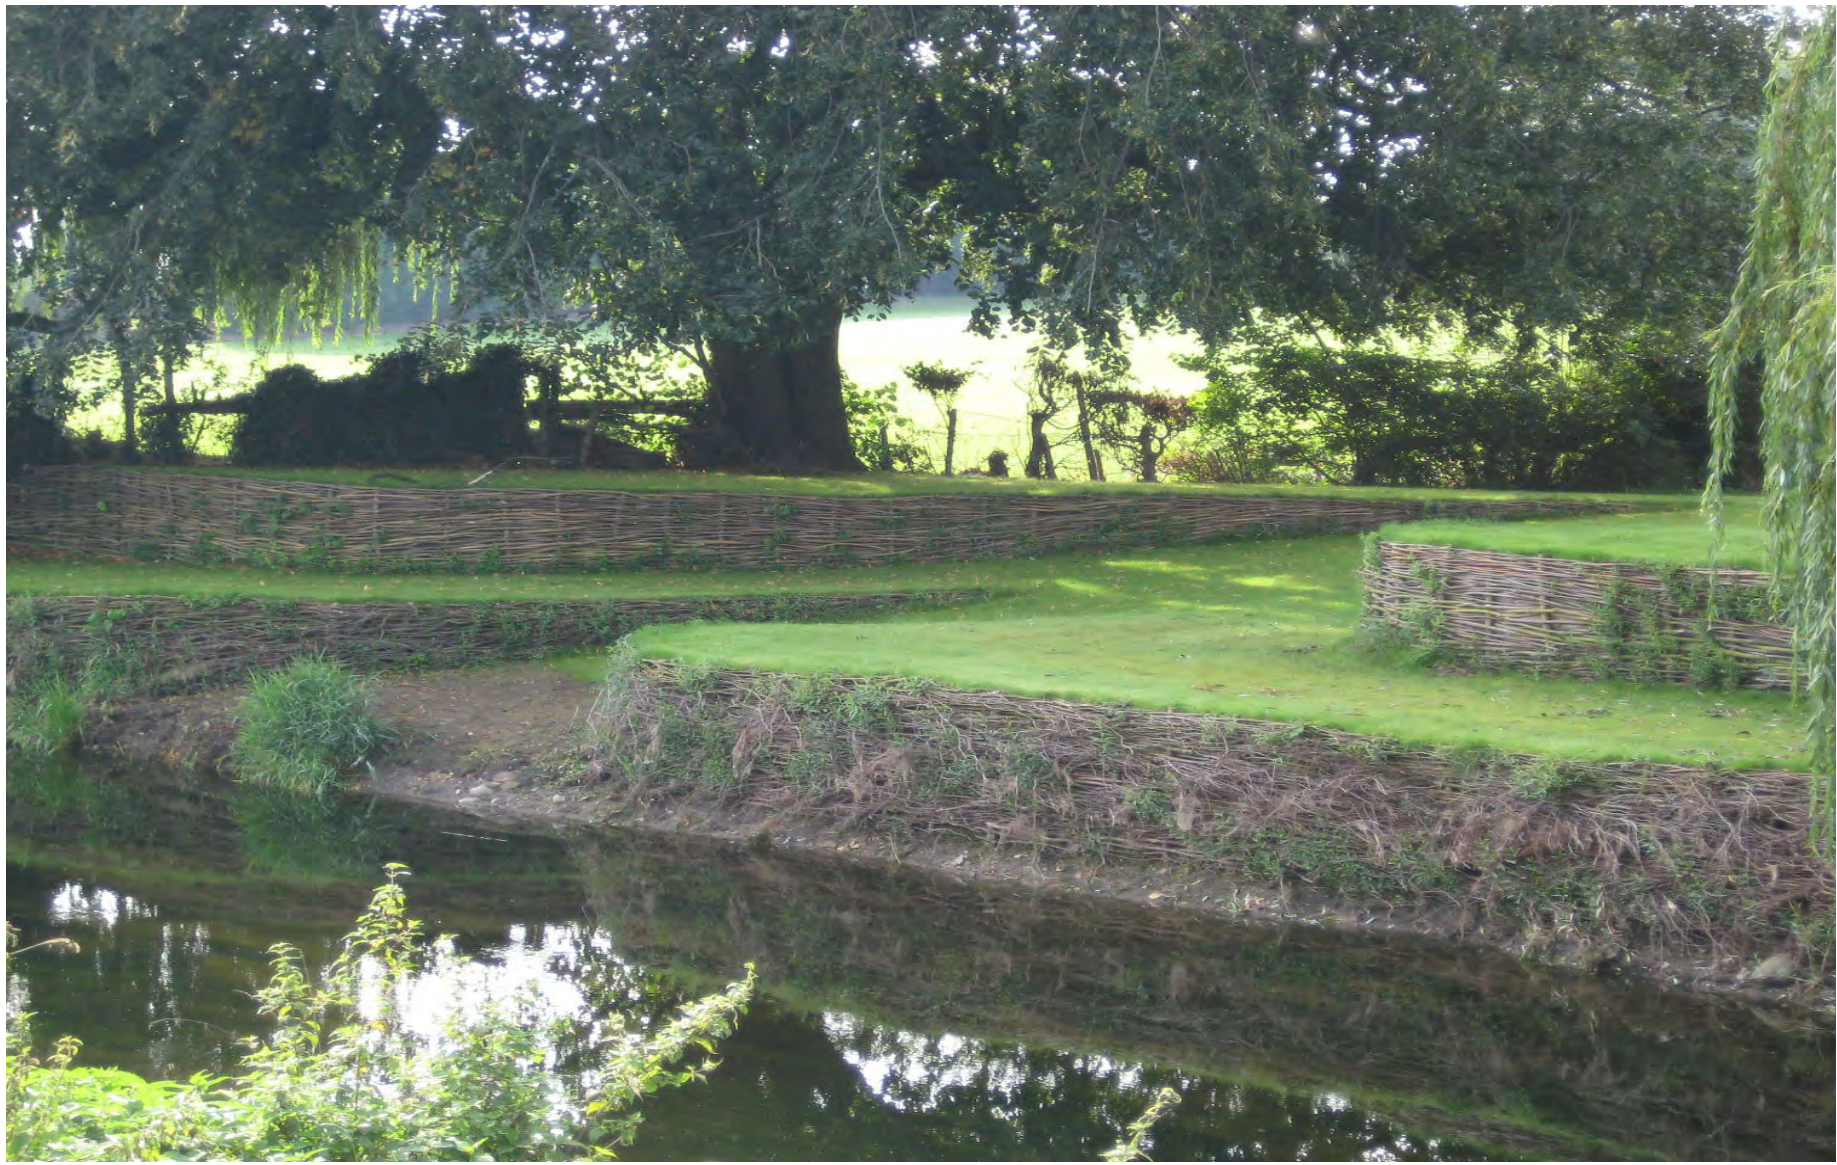
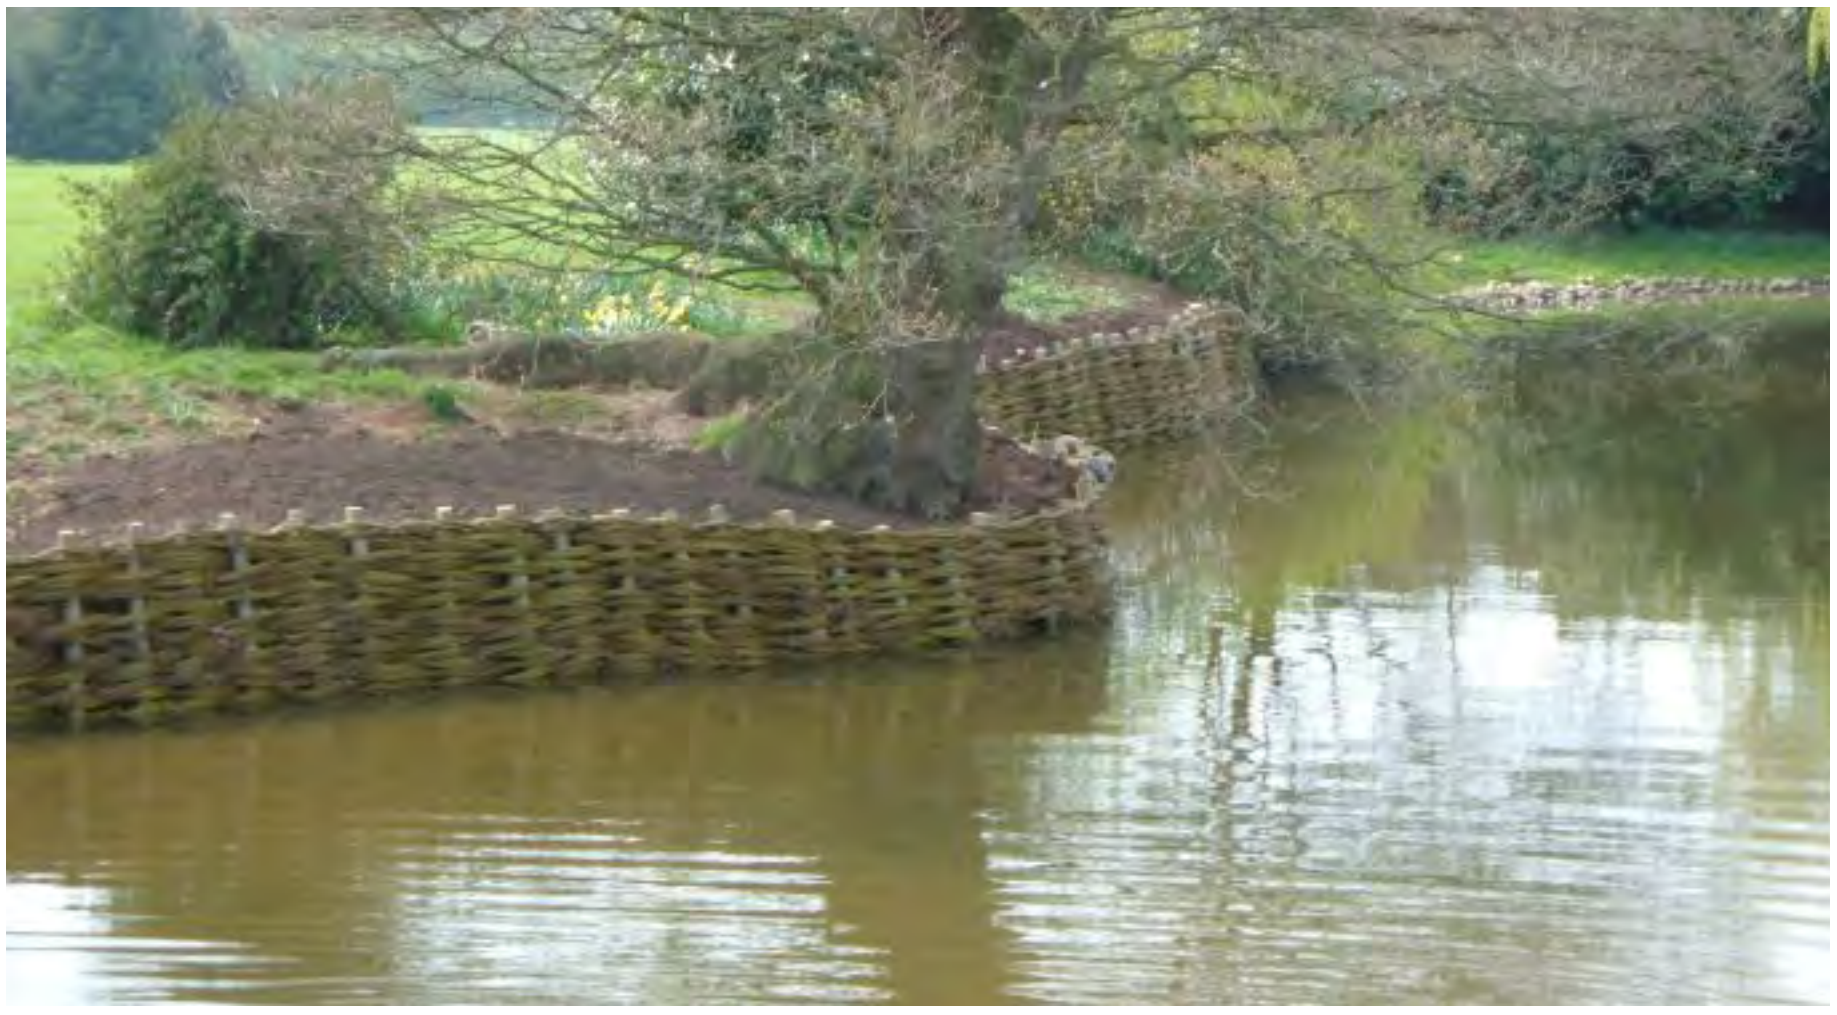
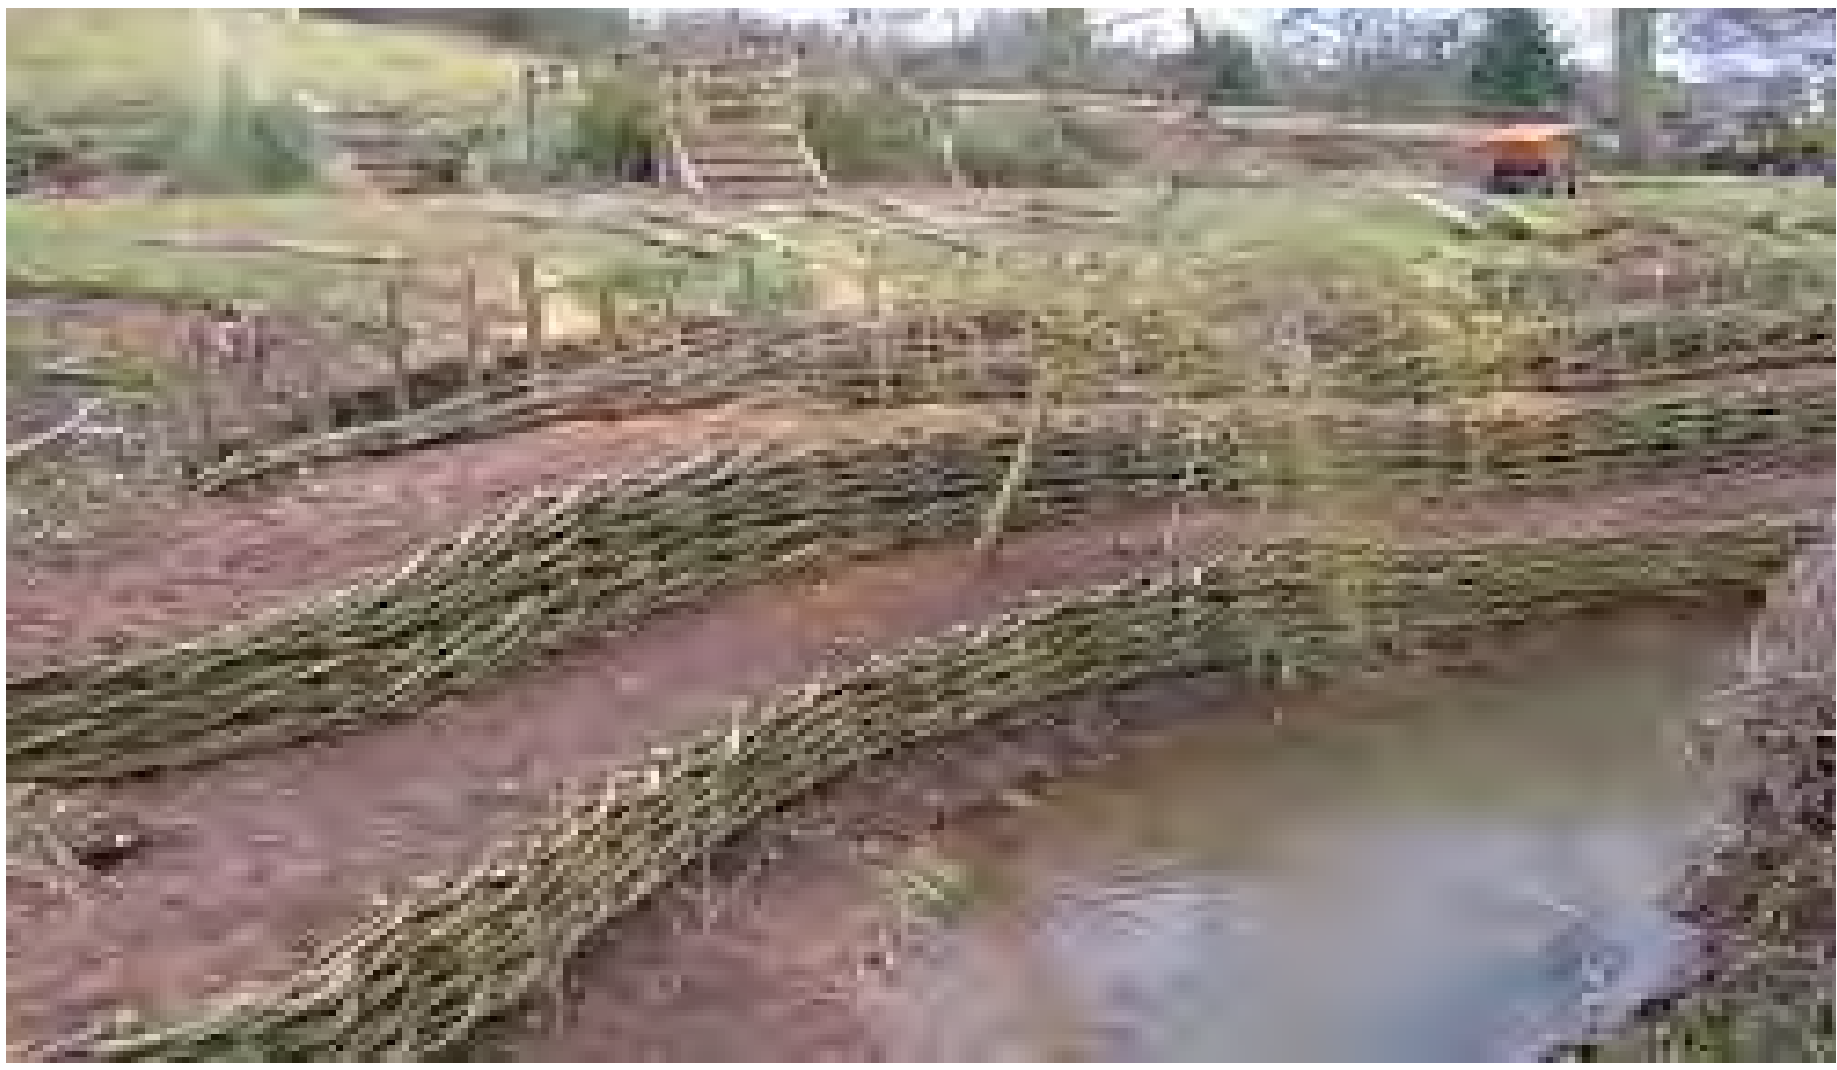
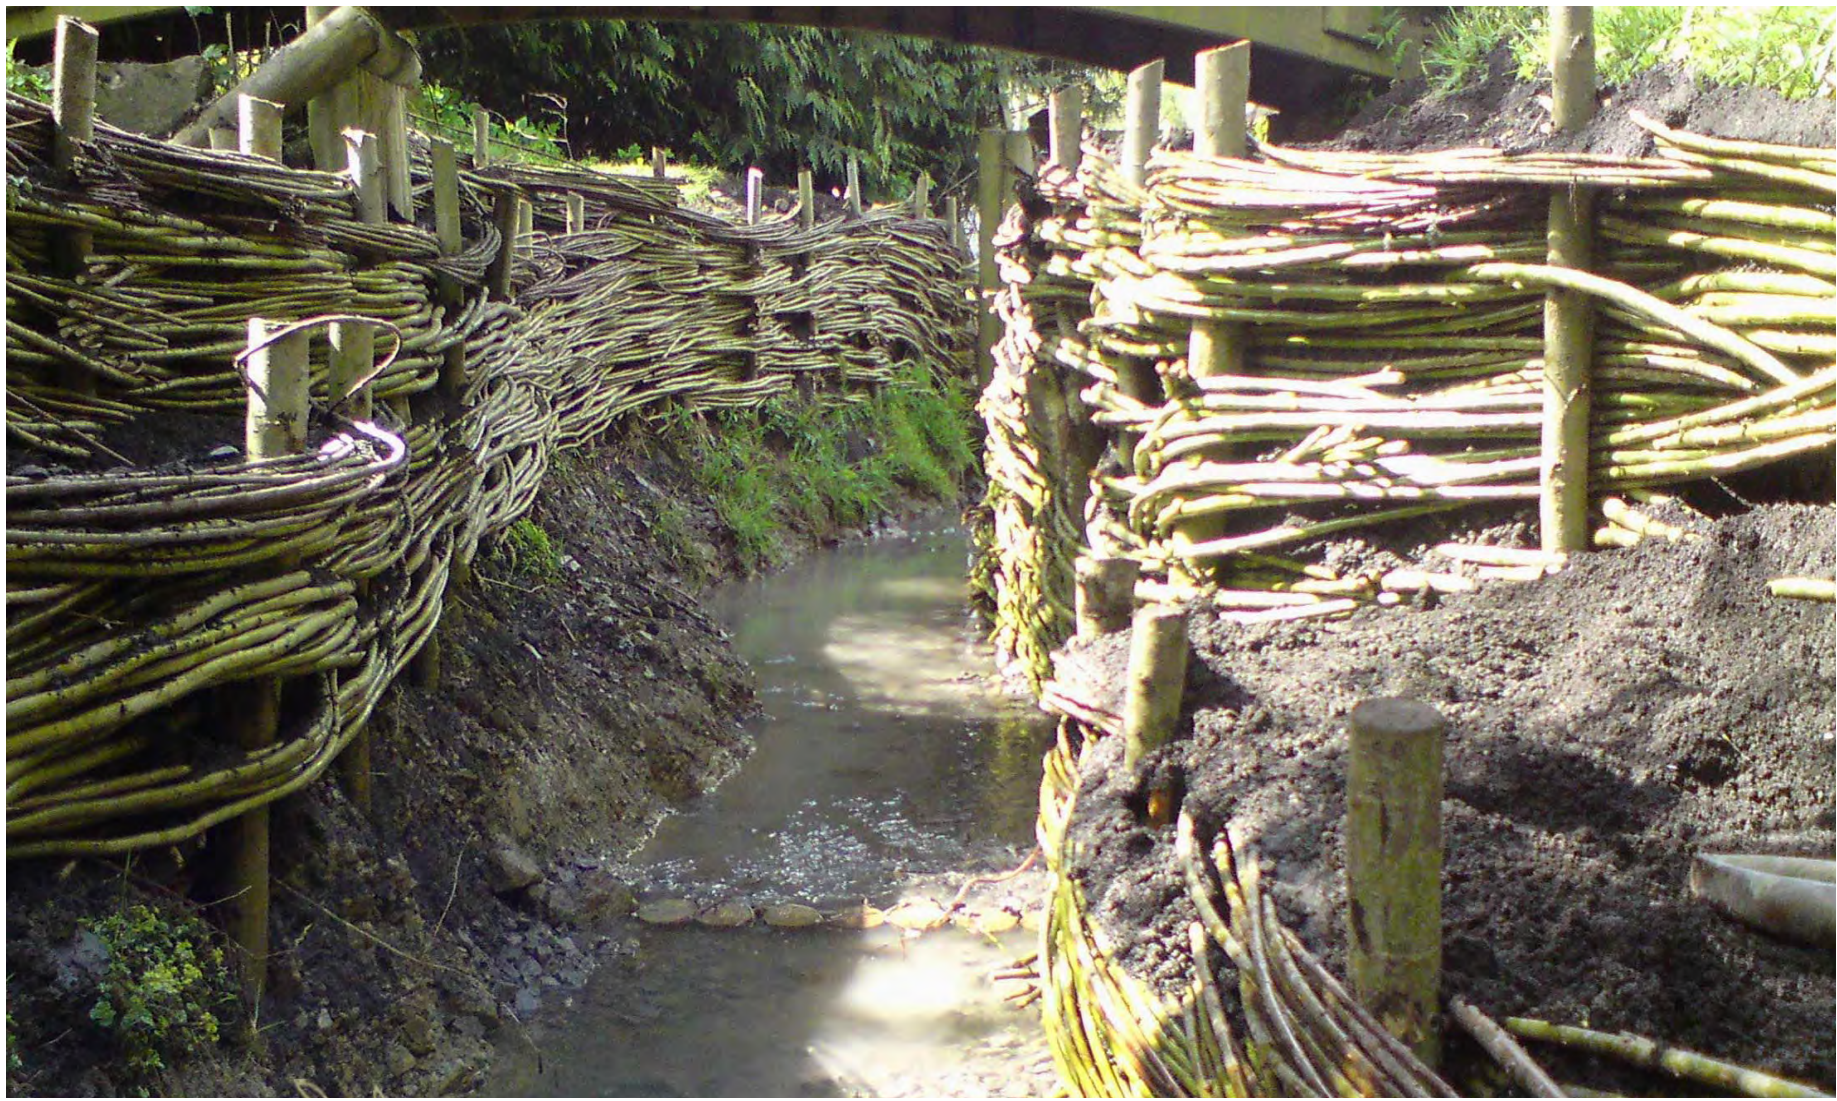
Typical spiling section showing live willow stakes and rods which are used to retain the banks. Soil is filled in behind to allow the willow to strike and grow and act as a revetment. As the root system grows and develops it retains and strengthens the banks of the lake shore. Additionally the willow itself provides shade in summer to cool the lake water and reduce the capacity for lake algae to photosynthesis and reproduce.

O Erosion control and safety provision. Lake bank repair using willow spiling with an increase in the quality and number of fishing stands and bank strength.

10. The willow spiling used to reinforce the bank to have a double function by allowing for rescue from a terraced slope with a reduced incline. All finished works to have as built risk assessments carried out by Water Safety Ireland. Fishing stands to have boarding ladders fitted at construction to ensure safest possible outcome from slips trips and falls into the lake water.

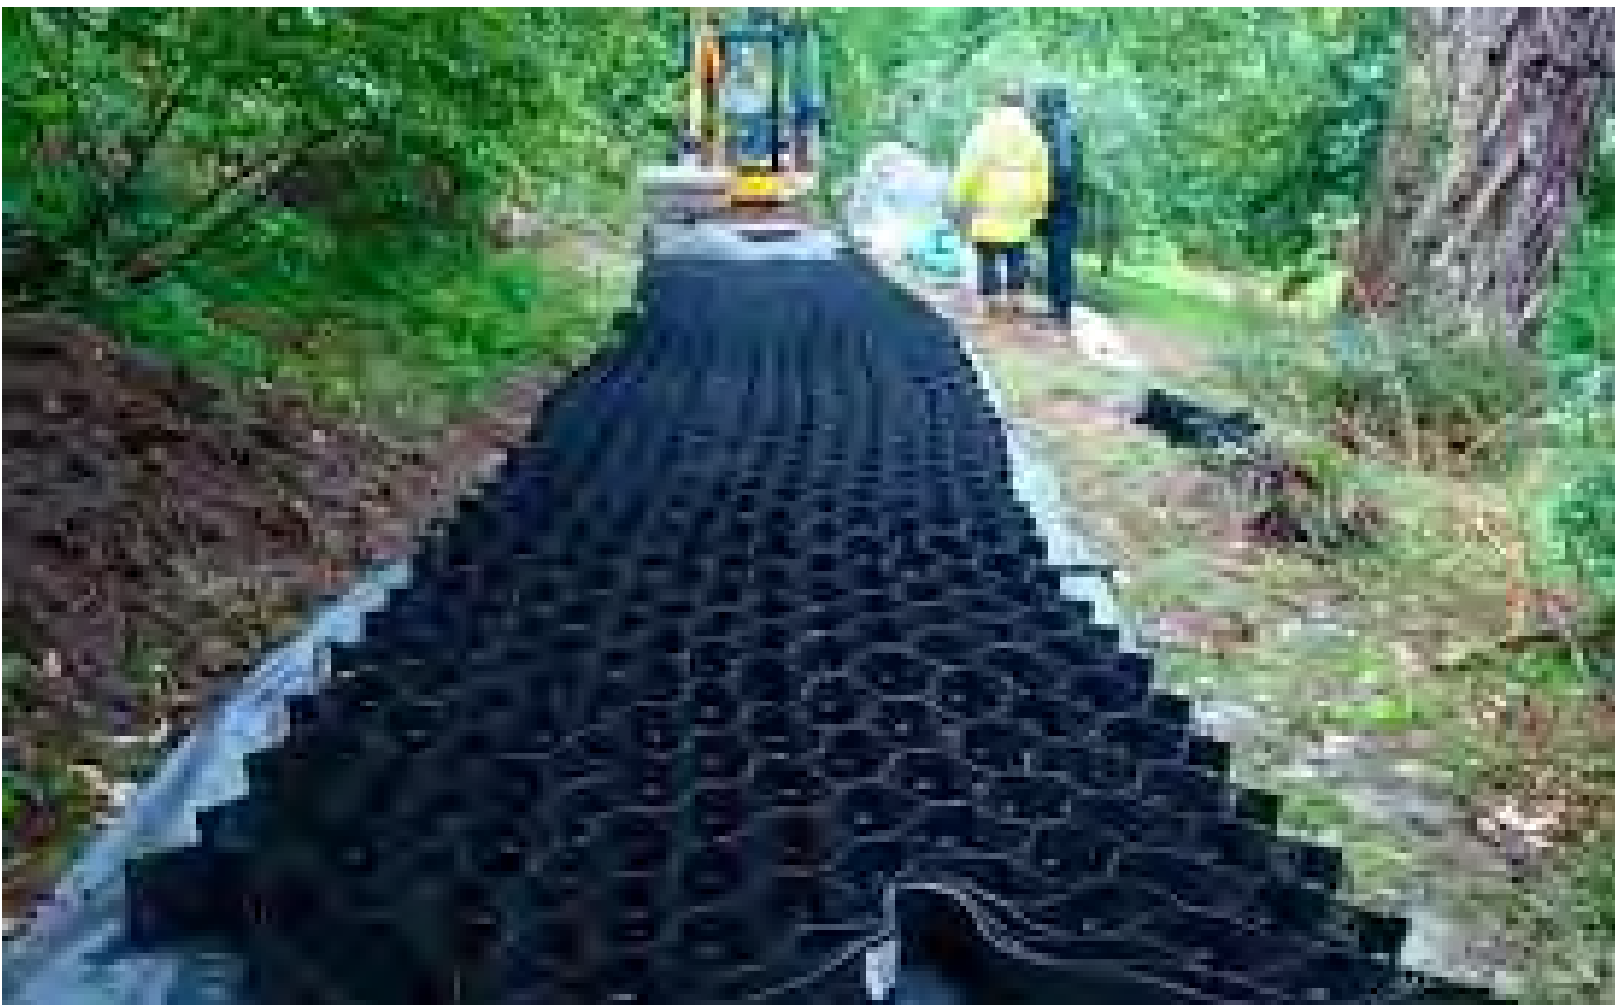
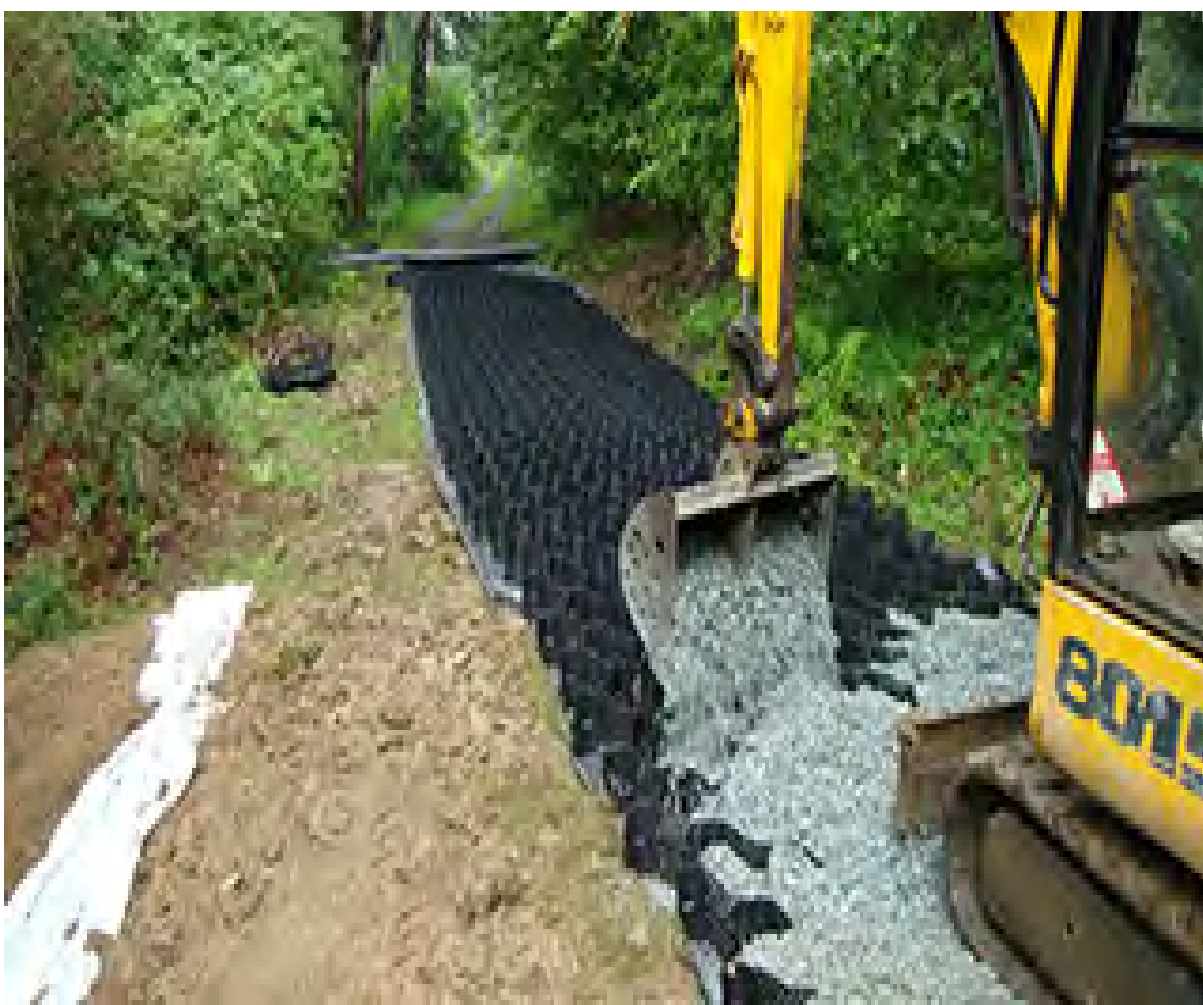
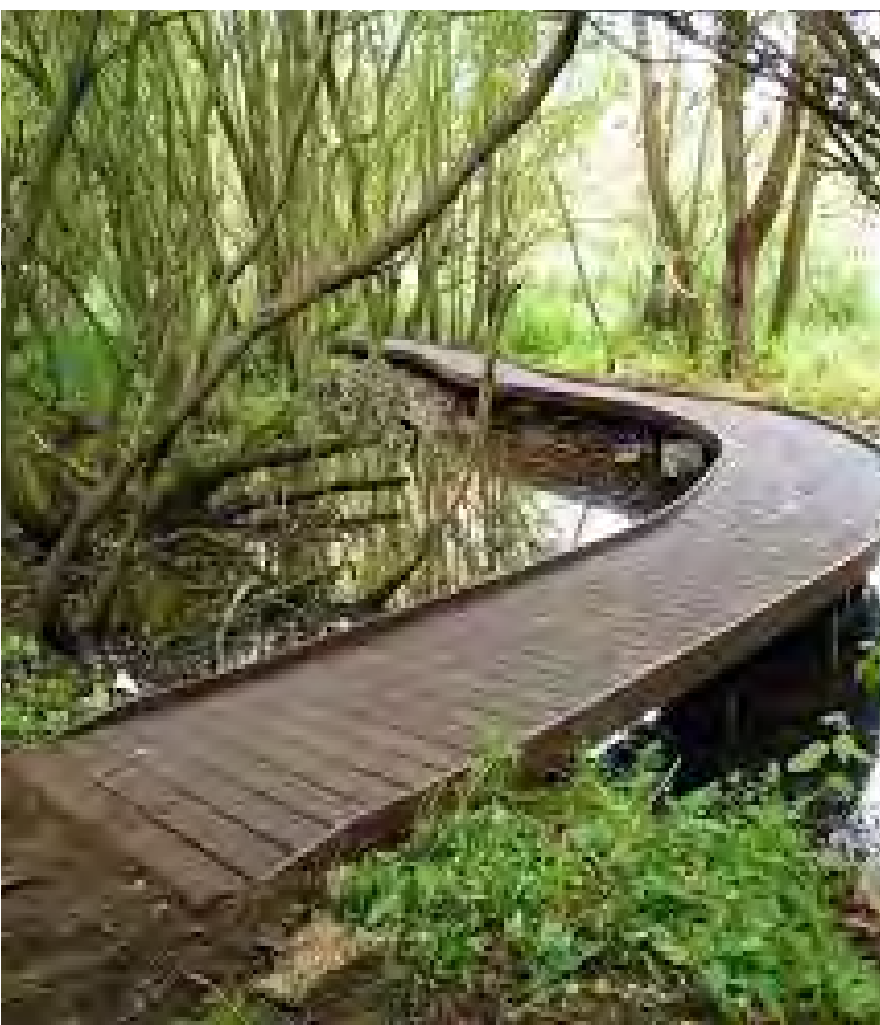
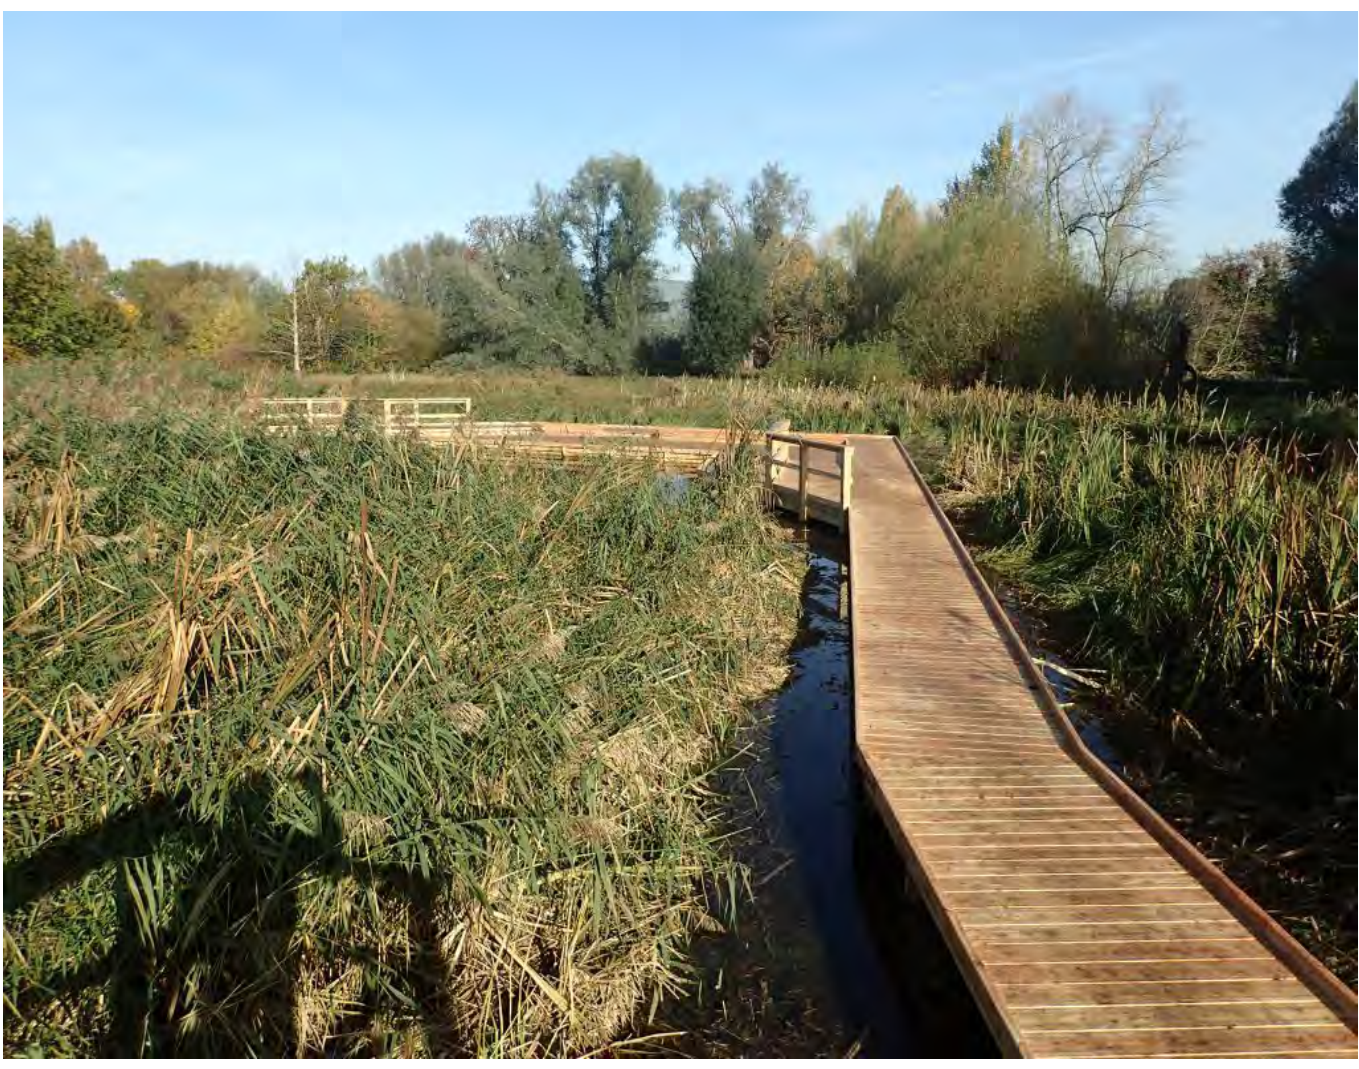
Project; Lough Bracken  
Client; Flynn Furney for Meath Partnership  
Drawing; Masterplan Detail Zone N, Zone O  
Drawing No.; MLBLMP036A  
Drawn by; GH  
Scale; Varies 1:500, 1:30, NTS Print A0  
Date; 22/12/21

Examples of willow spiling on the right, at various stages of construction. As well as revetment willow spiling terraced as seen here improves water safety by reducing the incline of banks to the lakeshore.

Root protection to be ensured during construction and operation by spreading the load and avoiding compaction at the root system of the hedgerow and hedgerow trees in Zone O. Water and air to be allowed to exchange freely using the geocell system.

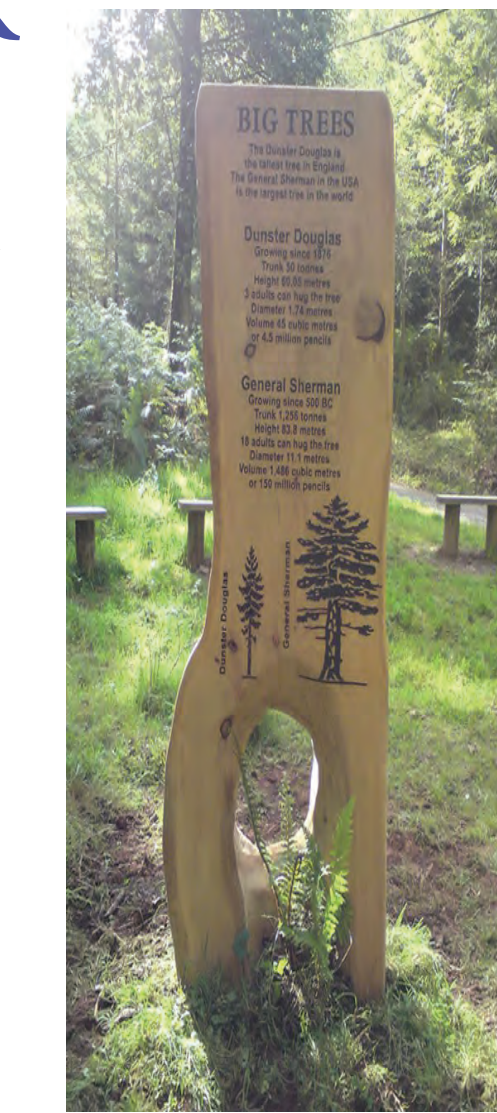
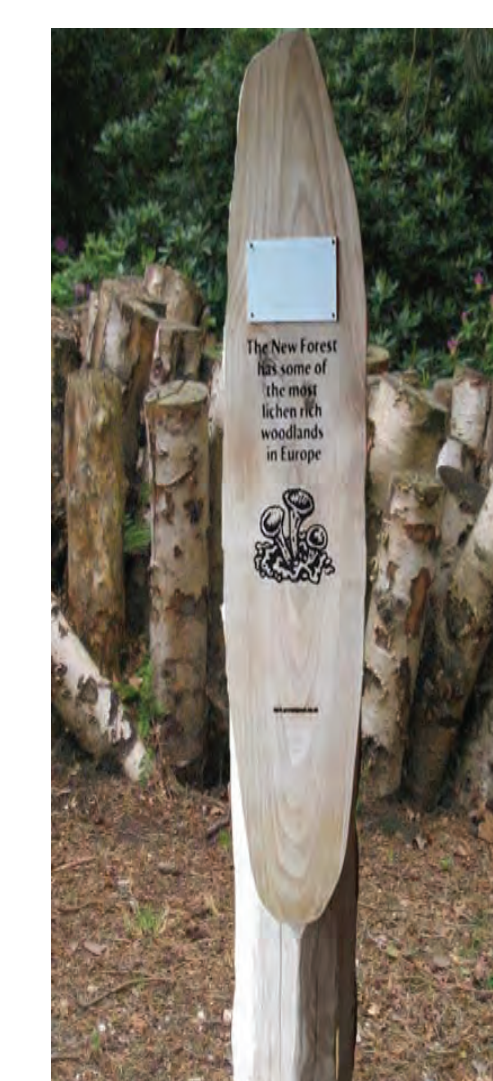
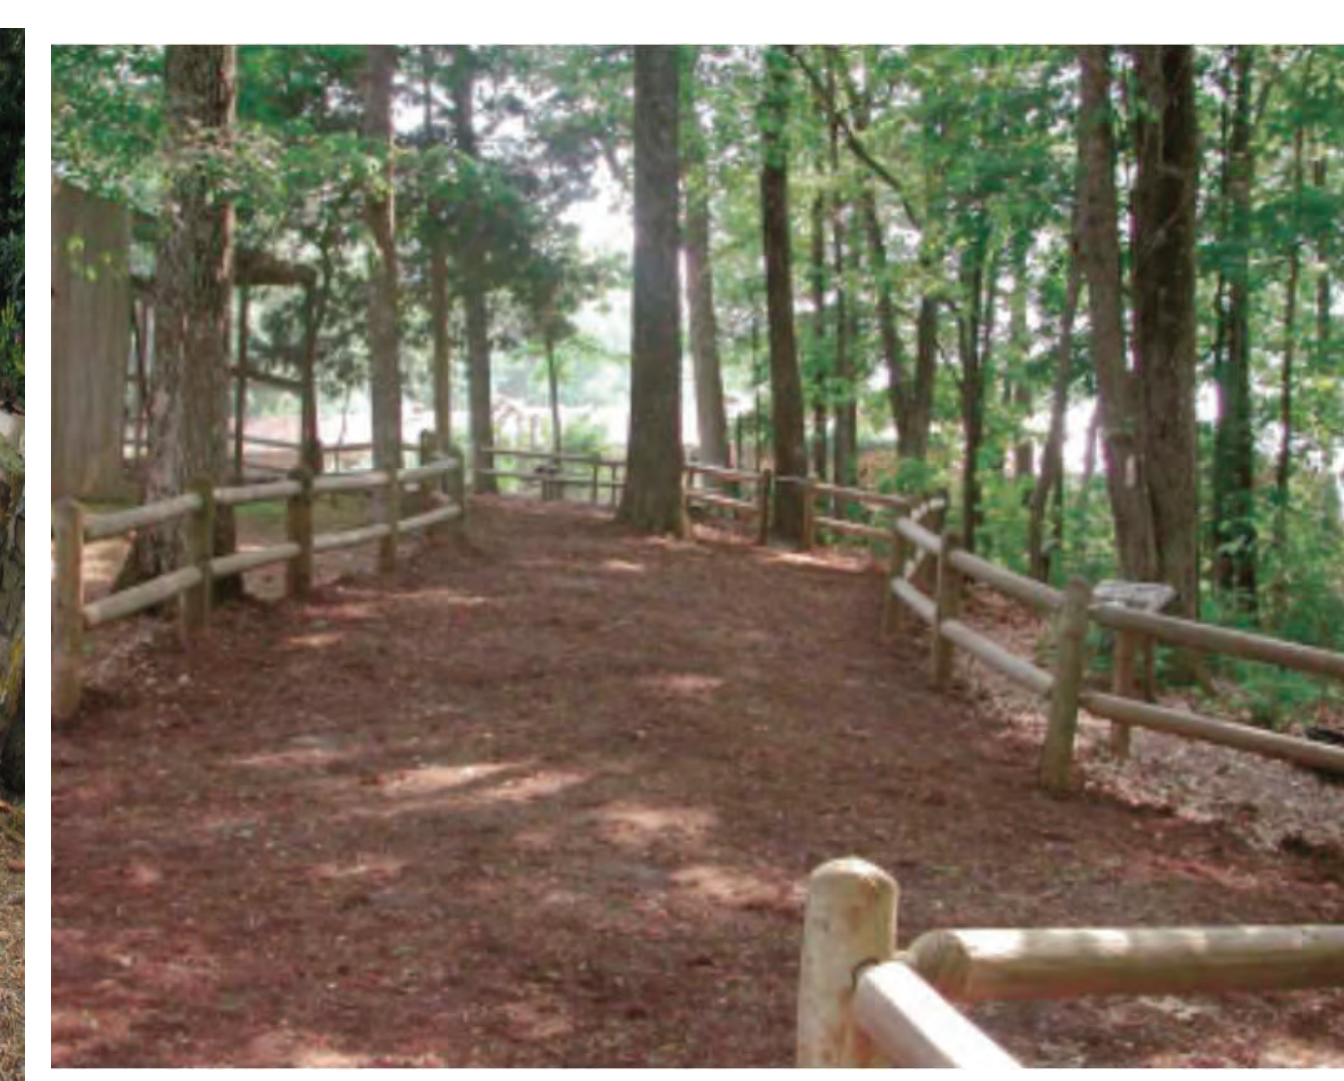
The rest area in Zone Q will be important and to have a triangular shape with plenty of trail information also in tactile format to indicate the grade and level of challenge of trail options at this point. For Zone Q and R, information on trail grade, trail length, trail slope and surface materials to be clearly outlined. Natural timber materials to be used to convey trail information and to convey habitat information over the course of the woodland walk

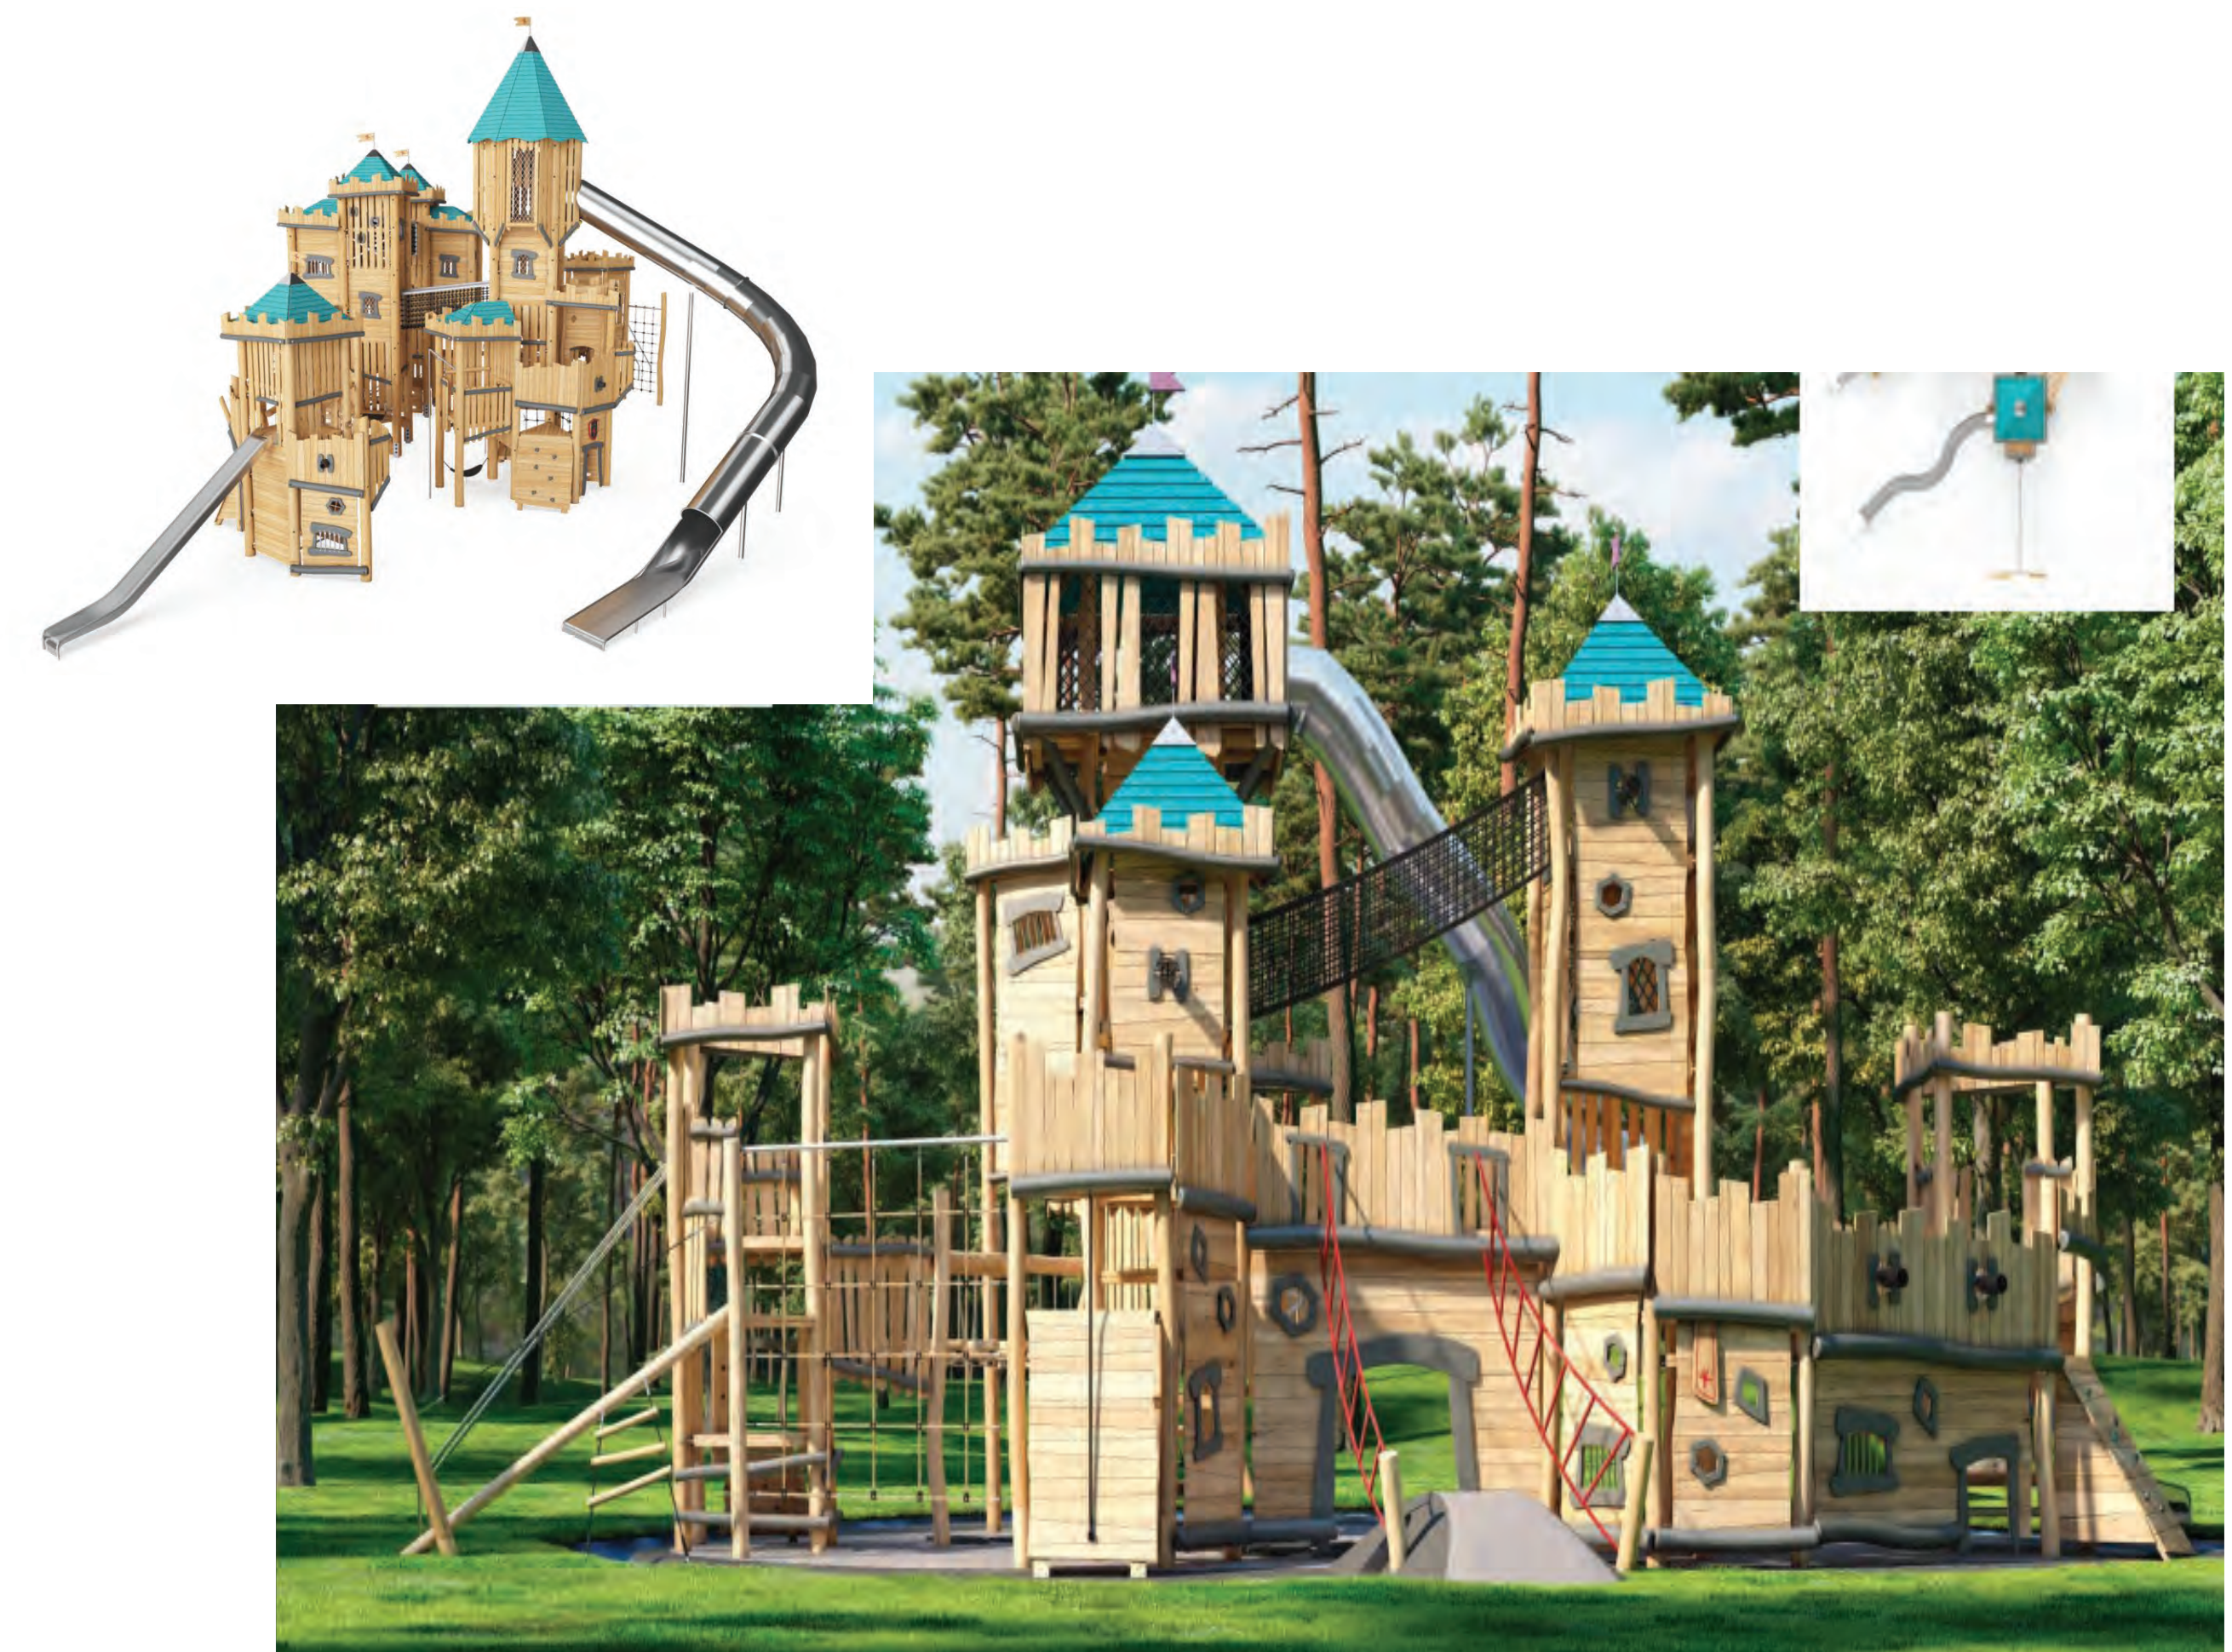
## Sample play system- Medieval Castle

Many companies are now producing similar play systems which are unpainted and are close in overall appearance to natural wood and rope. They allow children to climb safely to a height that allows for a sense of risk without the exposure to fall. This underpins a child's developing sense confidence.
