TRIM MILLENNIUM PEDESTRIAN BRIDGE SCHEME

Cultural Heritage Assessment Report

Date: May 2024

TRA 12 10 08

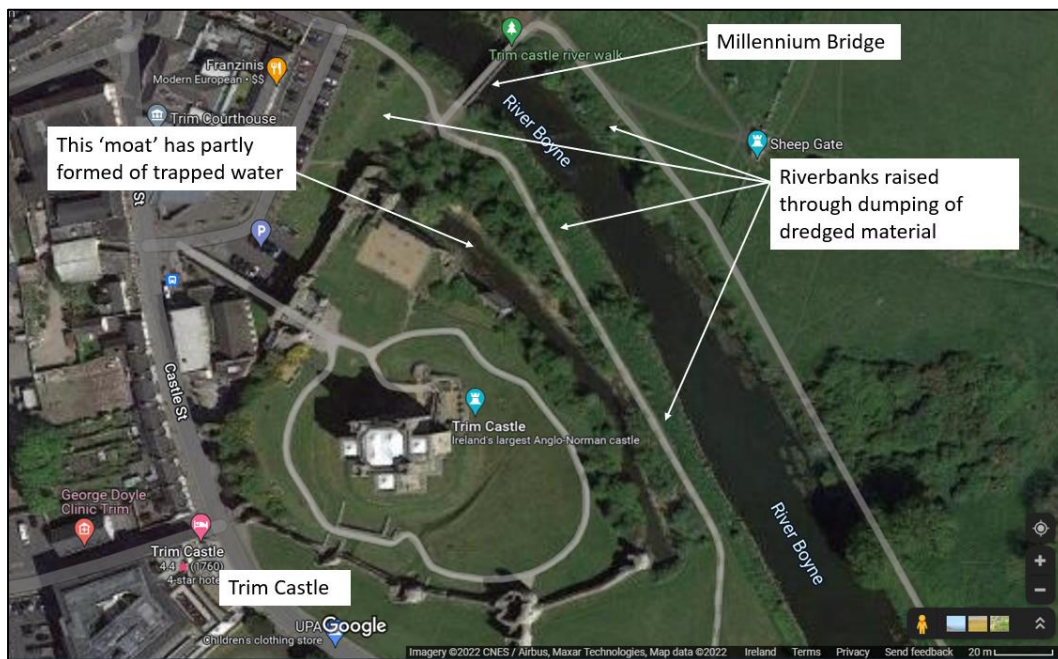
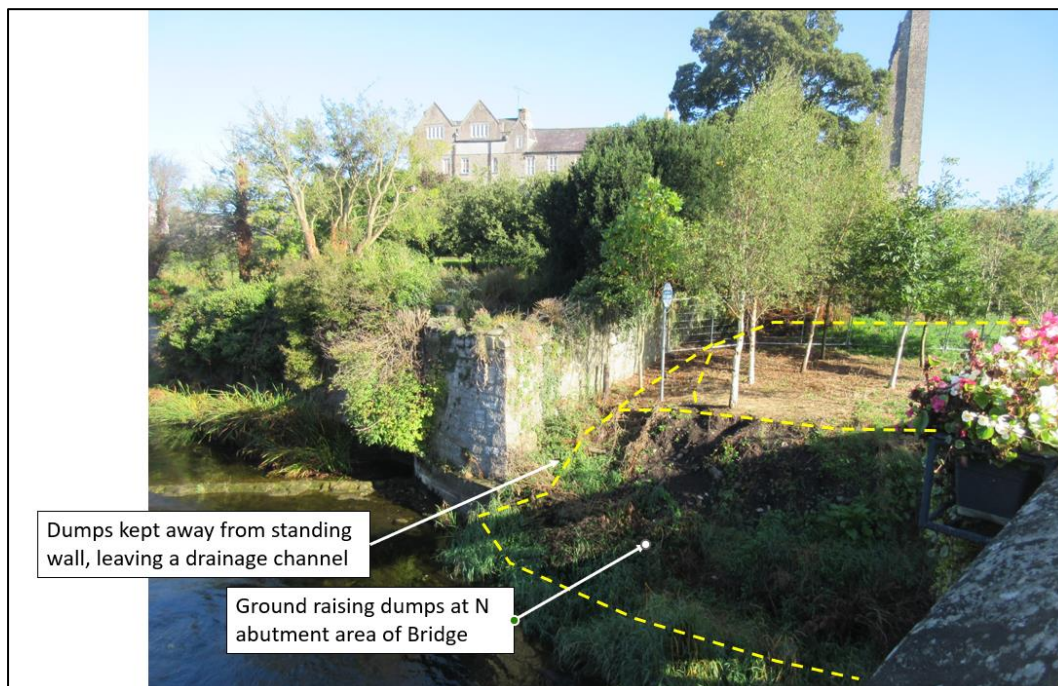
The above image shows the area on NW side of Millennium Bridge showing considerable ground-raising dumps when compared to the low-level riverbank in the early 20th C photograph. Several meters of dumping comprise dumps from OPW dredging, but also from imported material from 2001 Millennium Bridge construction.

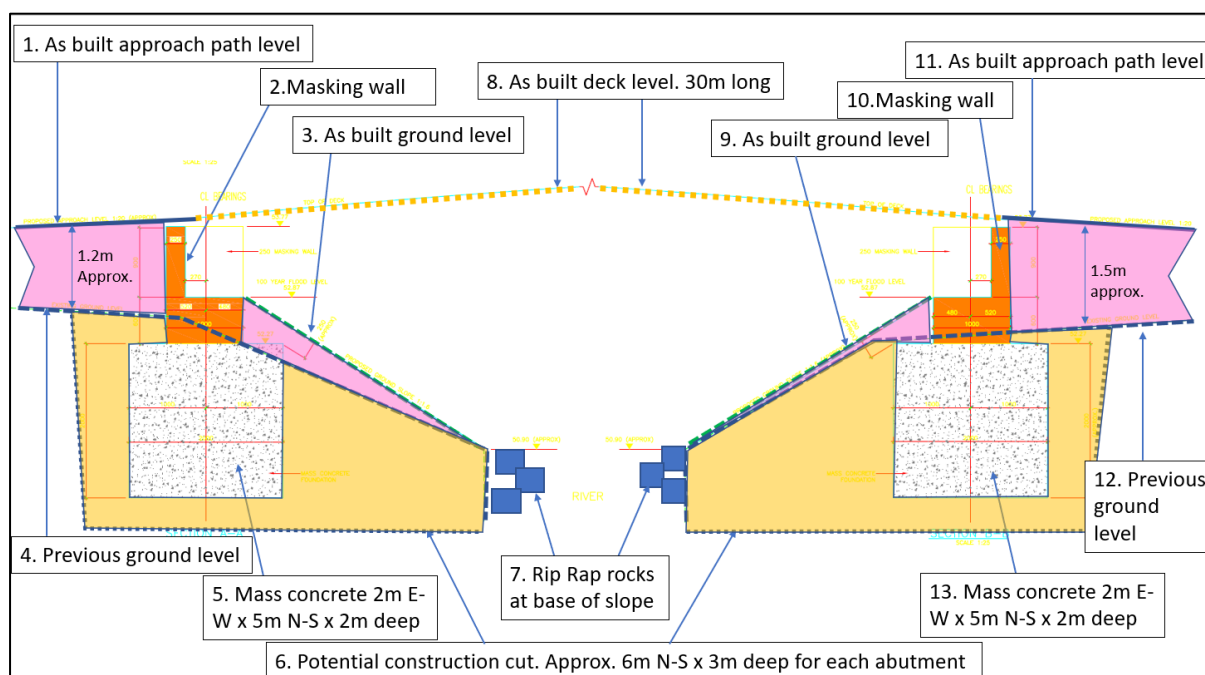
The above image shows general discussion elements of the 2001 construction. How big a construction cut was required for the mass concrete block abutments [5] and [13] (each 2m x 5m x 2m deep) is not known. The drawing has pre-bridge ground levels noted as [4] and [12] above. This is 1.20m to 1.50m below present ground level for the approaches [1] and [11] to the bridge. How extensive the landscaping was for this bridge in 2001 is not known.

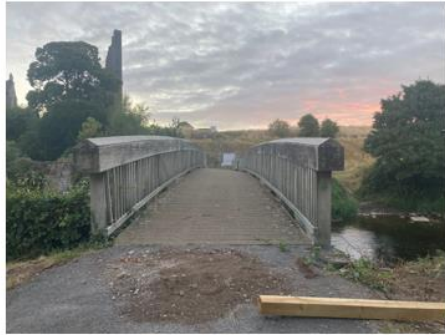
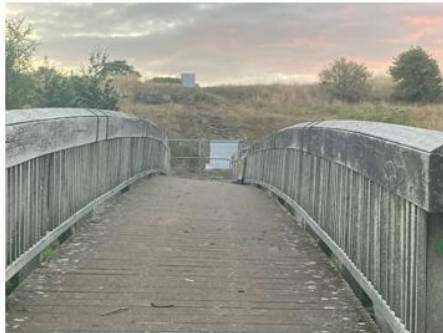
The Millennium Bridge (Photos 1-2) Inspection of July 2022 condemned the bridge as having seriously failed and it must be removed for safety reasons. Since July 2022 the bridge has visibly deteriorated further (Photo 3). An application for Ministerial Consent C001141 was made in August 2022 and the bridge was removed on 19th August 2022.

IMG_2451 Facing N

IMG_2452 Facing N

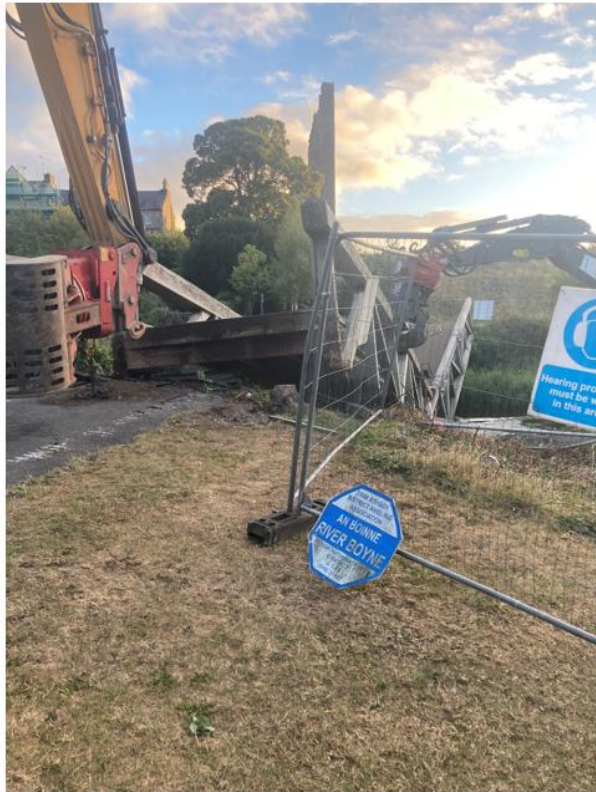
Photo 3

IMG_2466 Facing N

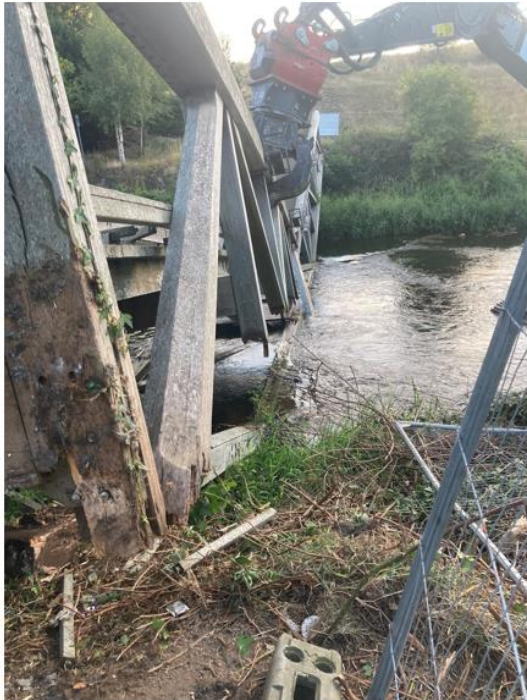
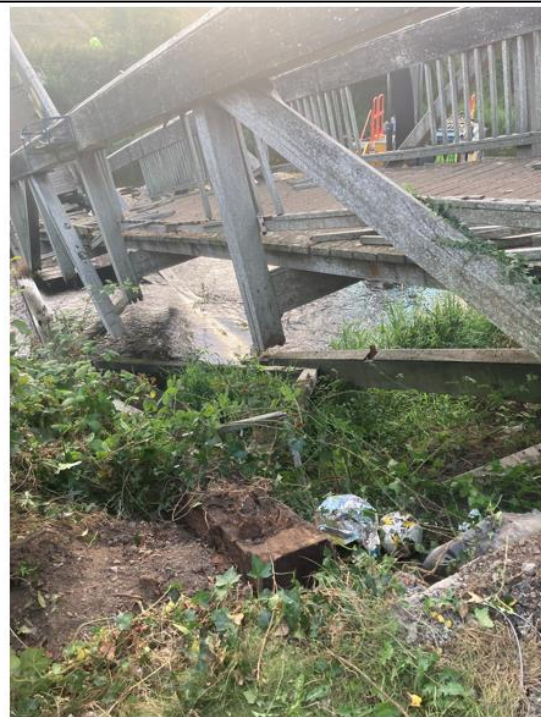
Photo 4

The bridge was seen to be lightly anchored onto two abutments (approx.. 6m x 2m x 2m founded on bedrock) and demolition consisted of placing a digging machine in the River Boyne and the bridge was broken into two pieces, which were then towed onto the southern bank of the River (Photos 3-5). These pieces were then broken up and loaded onto a lorry and removed (Photo 6). The Riverbed is bedrock at this point and water was around 0.30m deep (see Photo 5). No Riverbed material was removed from the river.

IMG_2473 Facing N showing minimal disturbance

IMG_2469 Facing N showing minimal disturbance

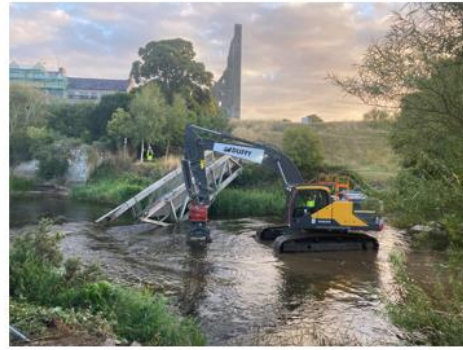
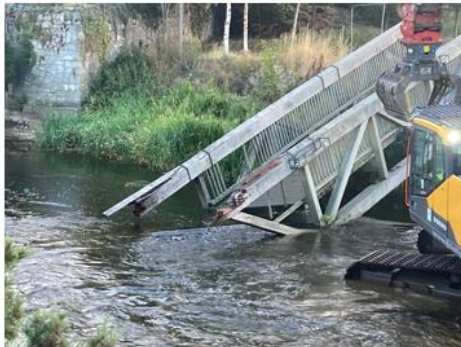
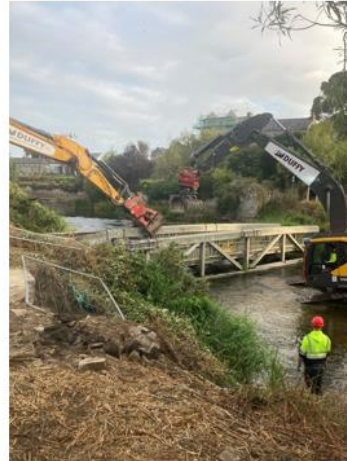
Photo 5

IMG_2482 Facing N

IMG_2484 Facing N

IMG_2491 Facing W

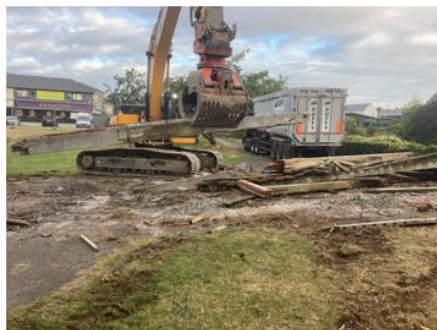
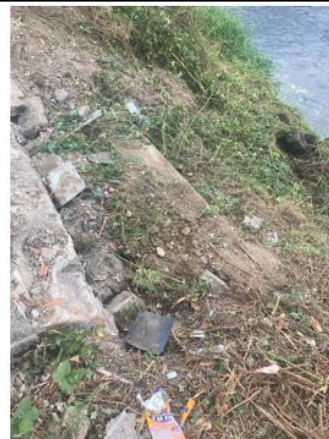
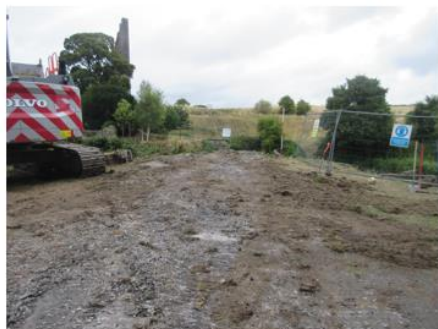
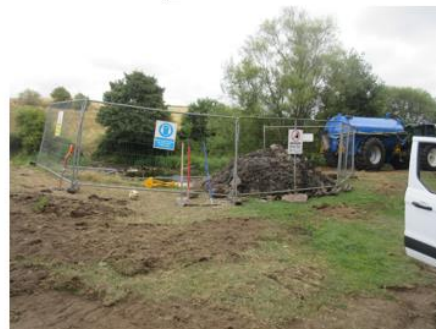
Photo 6

IMG_2495 Clearing up

IMG_2501 S abutment

IMG_4805 Minimal disturbance at S abutment.
Facing N

IMG_4807 OPW water pump works. Facing E

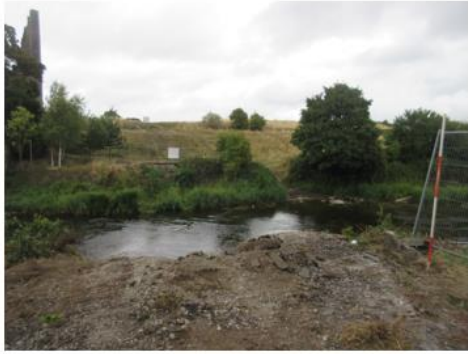
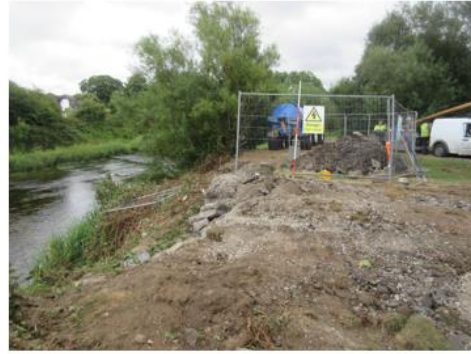
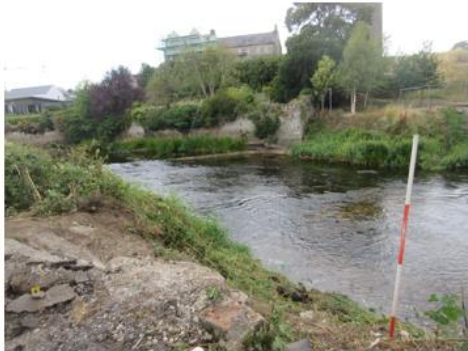
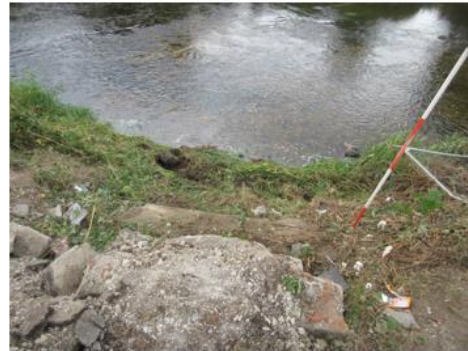
Photo 7

IMG_4808 Facing N

IMG_4809 Facing E to OPW works area

IMG_4811 Facing NW

IMG_4812 S abutment

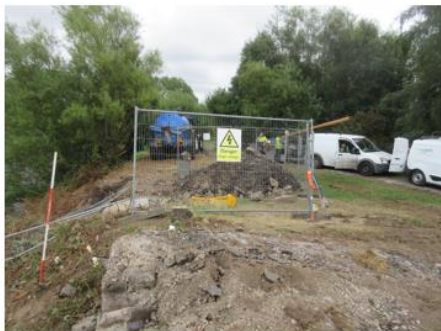
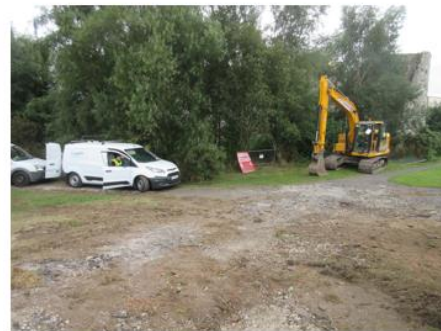
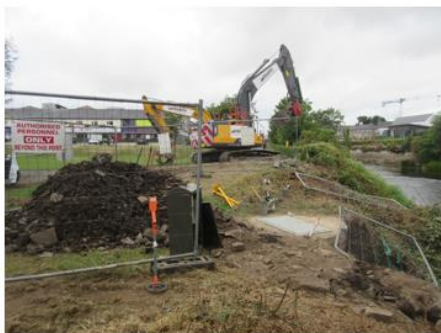
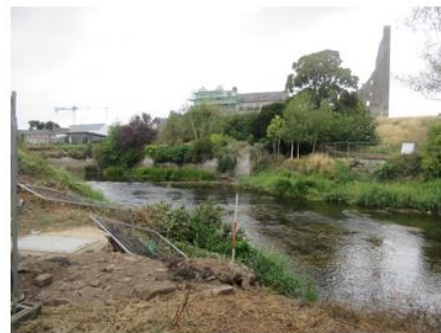
Photo 8

IMG_4814 Facing E to OPW works area

IMG_4815 Facing S showing minimal disturbance

IMG_4821 Facing W to OPW works area

IMG_4817 Facing NW

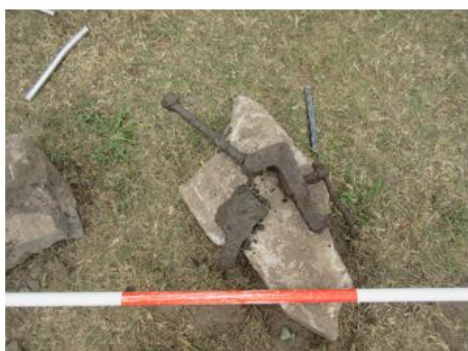
Photo 9

IMG_4828 OPW works metal items

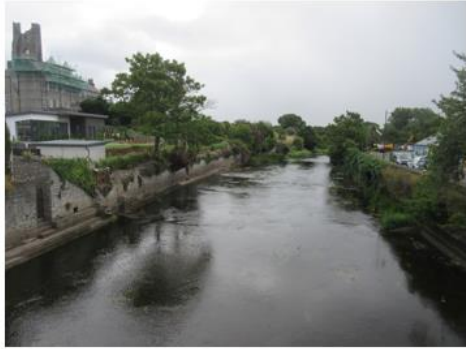
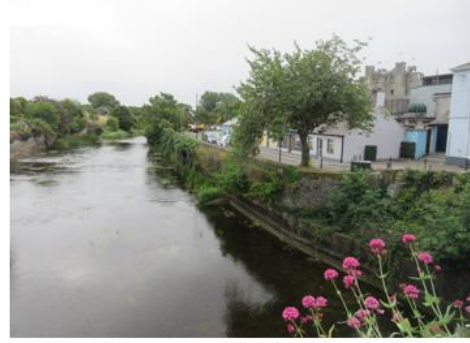
Photo 11

With the removal of the dangerous Millennium Bridge, the Boyne 'Blue way' can reopen in the area of the Castle. The views from the Old Bridge with Millennium Bridge removed are seen in Photo 11.

IMG_4845 Facing E from Old Bridge, Millennium Bridge removed

IMG_4846 Facing E from Old Bridge, Millennium Bridge removed

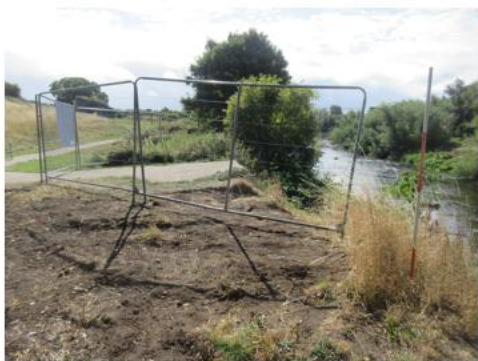
Photo 12

At the northern abutment a small area of turf had been cleared of grass (Photo 12) and so this area was examined, but only modern drink cans and cigarette lighters were noted.

IMG_4863 Facing E. Bridge removed

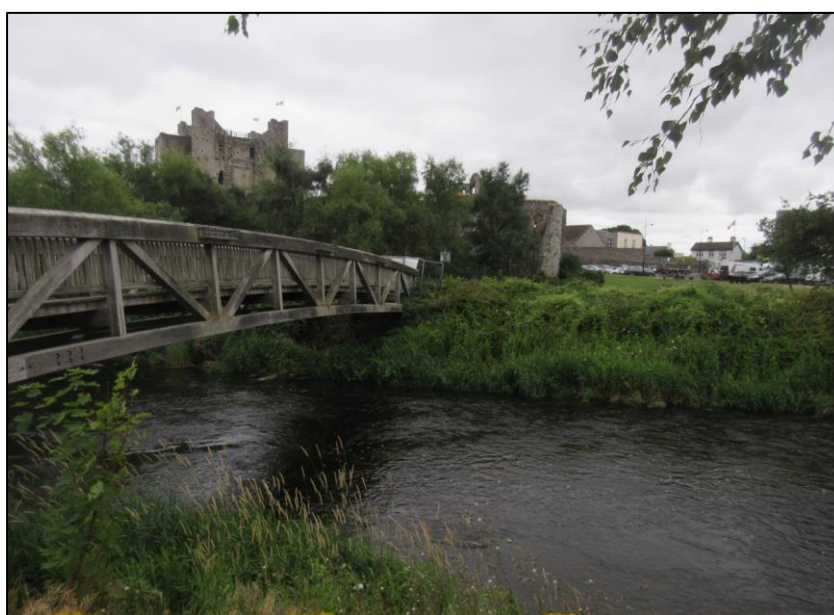
General view of Bridge from NW bank. The entire opposite riverbank is made of raised dumps.

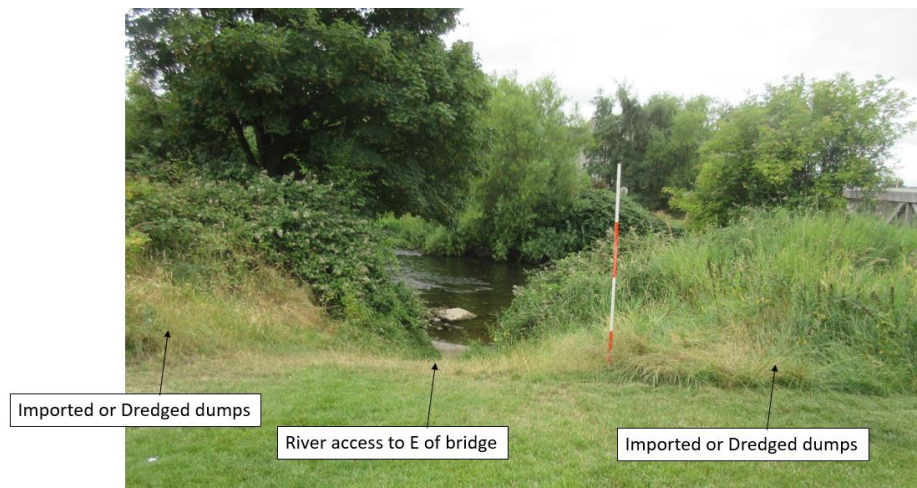
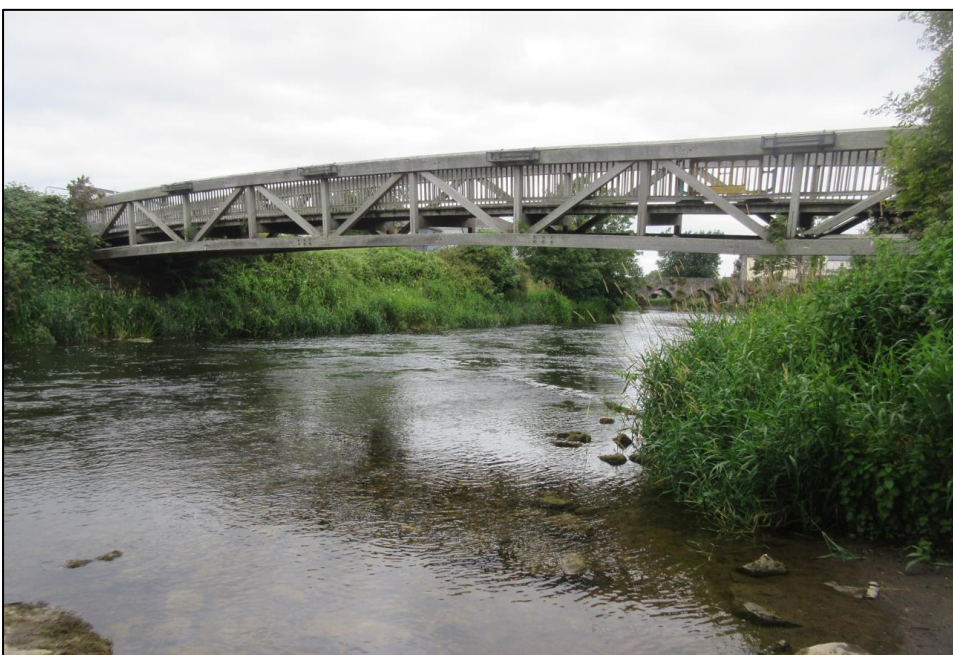
Facing S

Bridge E face. Riverbed is not very deep here, but the channel may be deeper elsewhere.

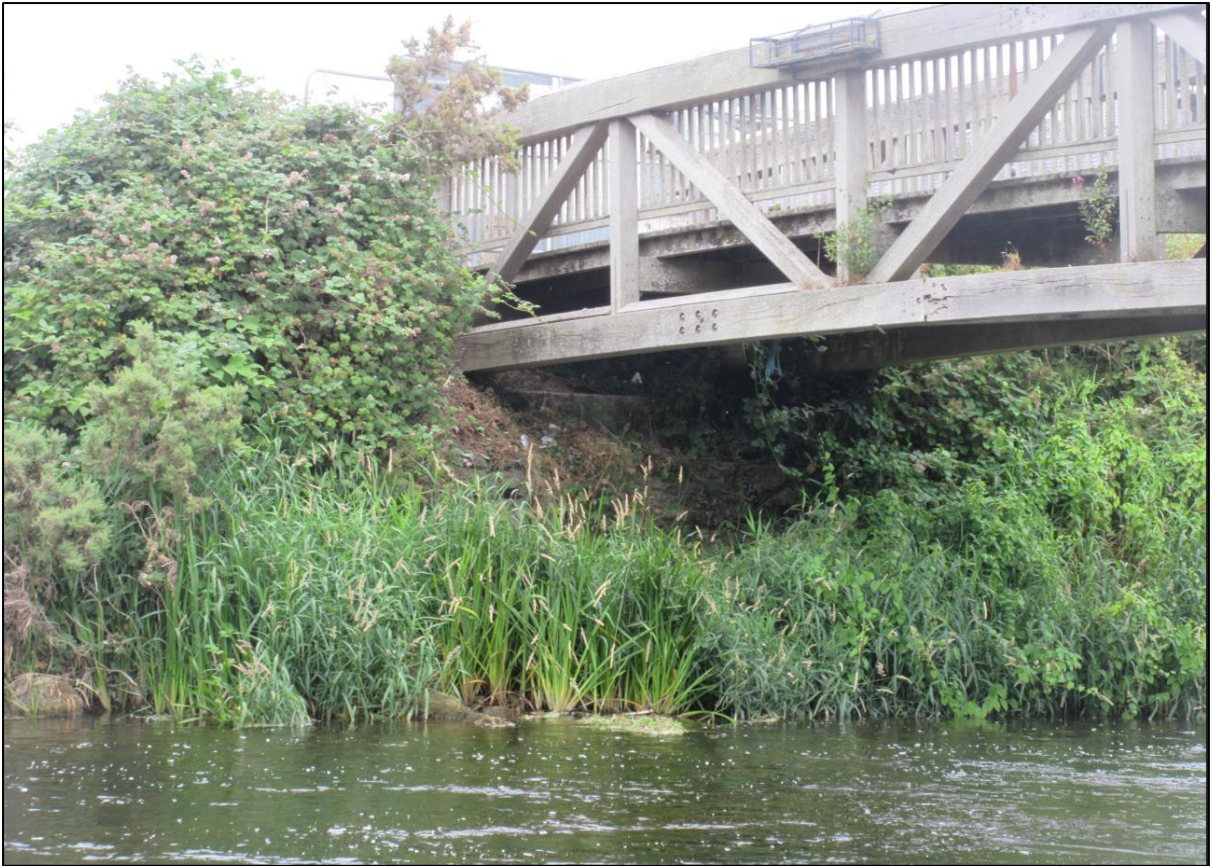
Northern abutment. Top of mass concrete block abutment may be visible.

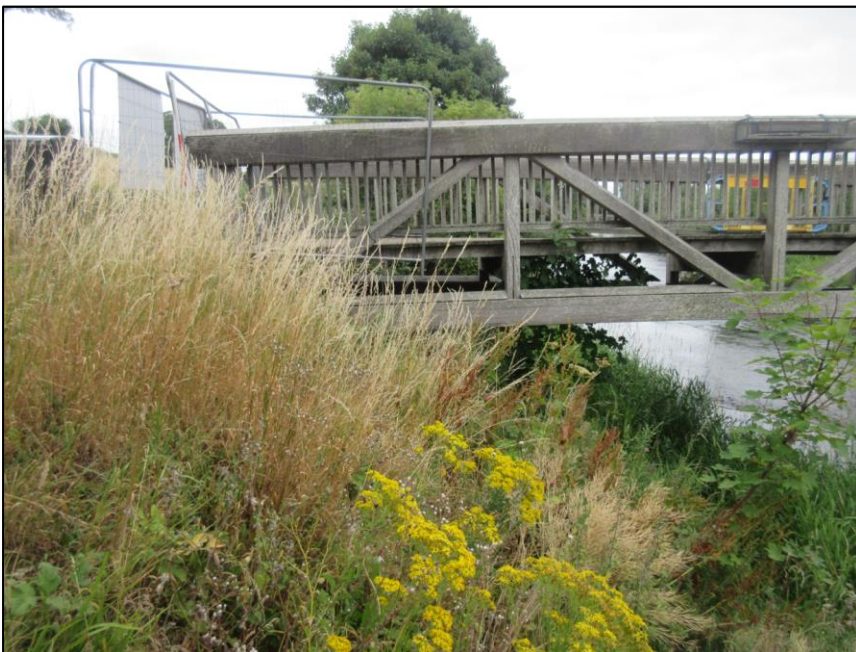
Northern abutment with ground raising dumps in foreground sloping down to the River. Facing E

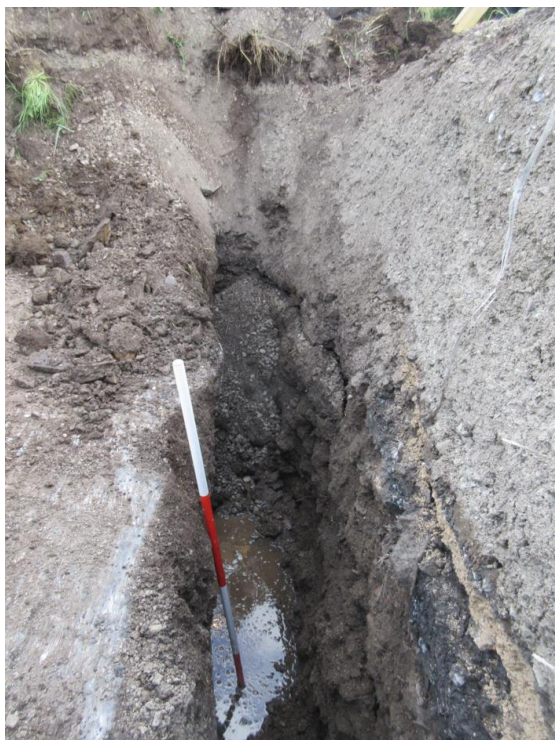
Sl.1 showing water ingress at 50.90m OD. This coincided with waterlain layers [16]

[16] Waterlain clays smelling of waterlogging and a suggestion of hydrogen sulphide gas. This deposit coincided with water ingress into the trench which caused a halt to the excavations. The top of this deposit is around 51.00m OD and previous 2001 work suggests a depth of around 0.20m deep. These clays indicate a slow-moving backwater that was perhaps flushed during floods but generally waterlogged so that river water level would have been perhaps around 51.30m OD or so.

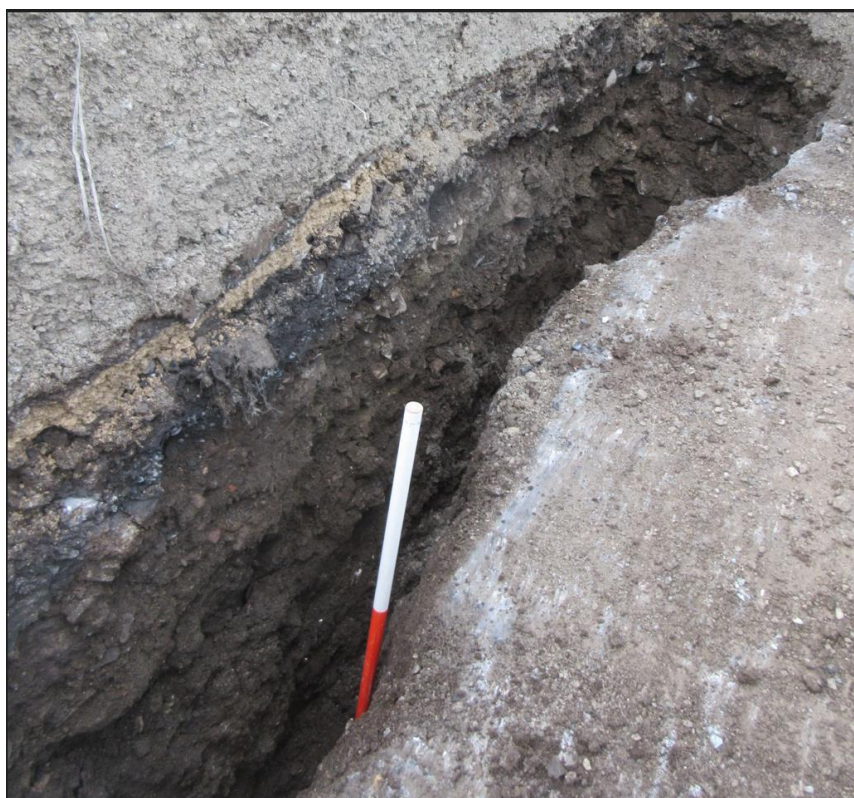
Sl.1 general section face. The abutment on right was exposed for 1.50m. The upper deposits on left are infill [12] with tip lines visible and the lower are probably the old floodplain [11]

[11] Brown floodplain deposit presumably post-dating the medieval period and in normally-above-water conditions. Top level at 51.50m OD.
