# Old Johnstown Village

## **Draft** Public Realm and Regeneration Plan

## Mrs Butterly's Condition Survey

The following pages outline the condition survey report on the Mrs Butterly's Building completed by Hall Black Douglas in July 2024.

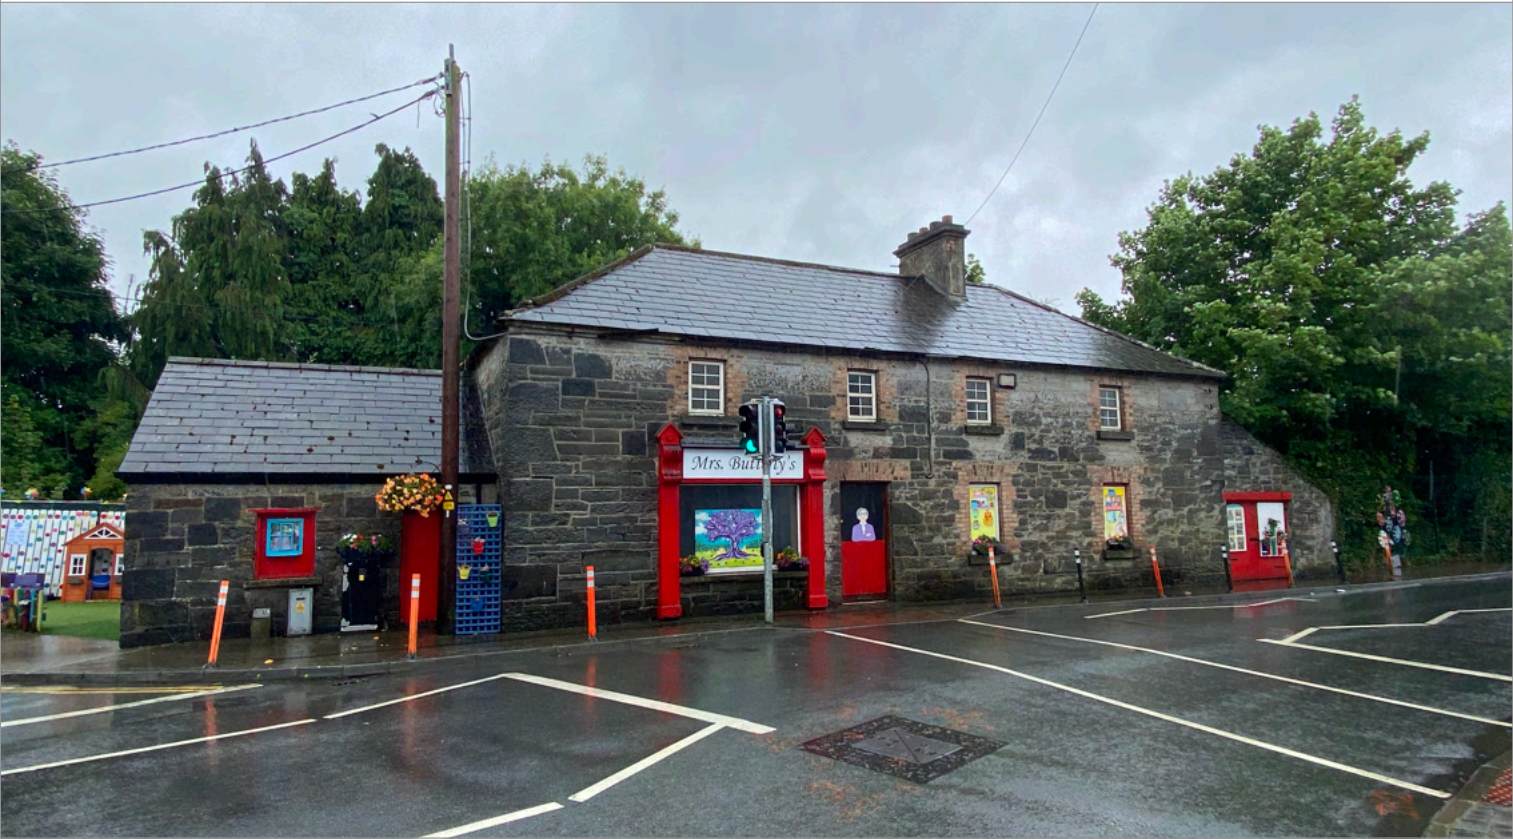
Ref:	Description	Photographs
001	<p><b>North Elevation</b></p> <p>The main two-story building is of coursed stone masonry construction with red brick details to window and door openings. The stonework is of quality construction and features large cornerstone blocks.</p> <ul style="list-style-type: none"><li>- The front elevation of the main two storey block features 8 openings in total including 4 smaller window openings to the first floor, 2 taller windows on the ground floor, a front door and large shop window opening. The current windows are modern PVC frames however older photographic imagery (<i>refer to black and white cover image</i>) depicts traditional timber framed, ‘6 over 3’ sash windows to the first floor and ‘6 over 6’ sash windows to the larger ground floor openings.</li><li>- The main roof is hipped in form, slated with a single chimney stack, constructed of brick with a rendered finish with 4no. ceramic chimney pots.</li></ul>

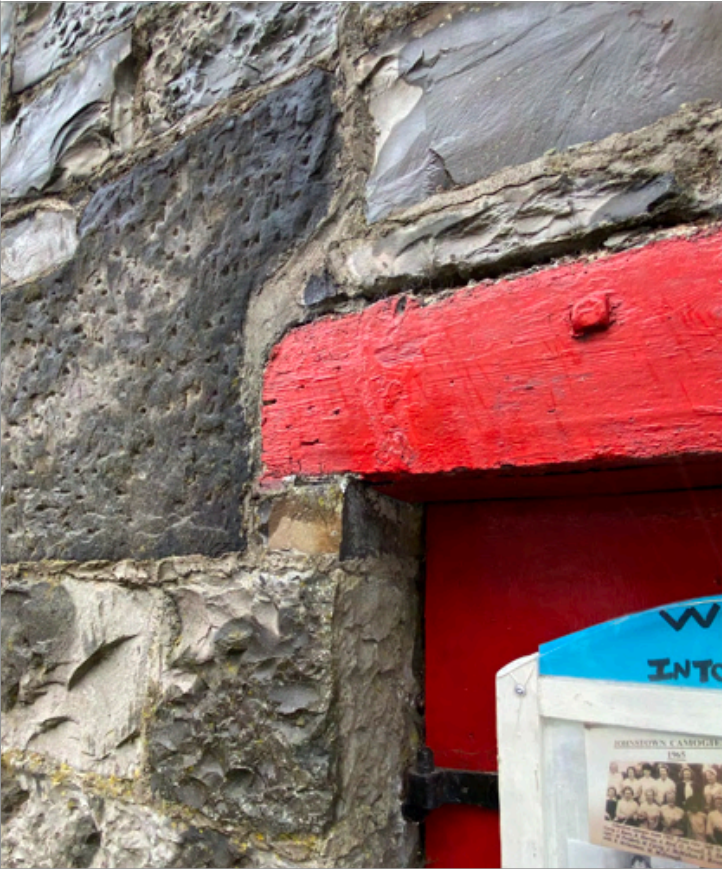
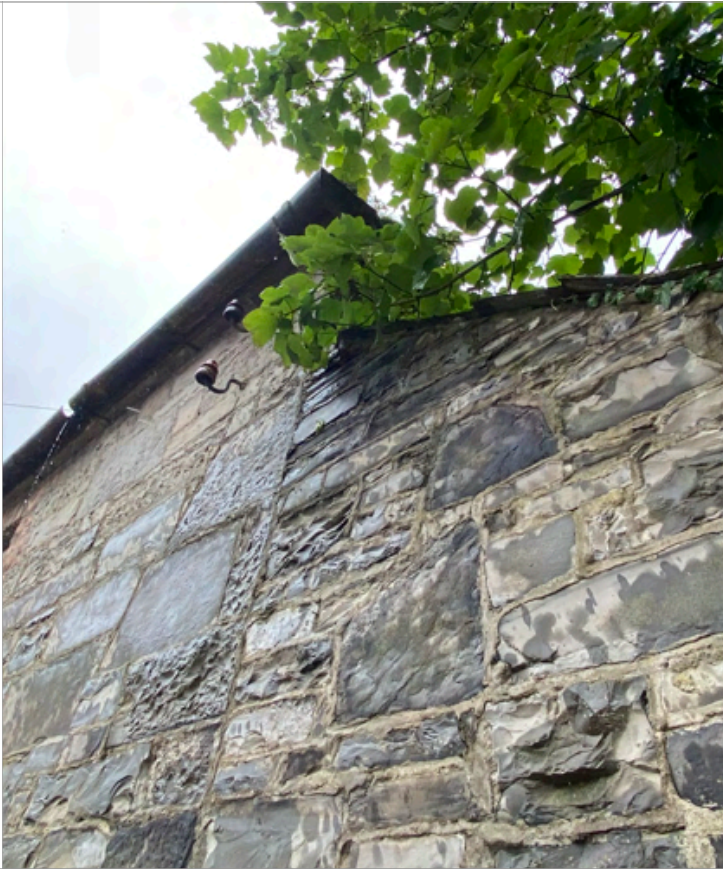
</div> <div><div>Fig. A</div><div>Fig. B</div></div>

015	<p><b>Lean-to Store (West)</b></p> <p><b>Fig. A</b> - Timber beam forming gate opening rests on corner stone of original 2 storey building. Significant ponding of water on footpath on day of survey which makes it's way into the building.</p> <p><b>Fig. B</b> - Visible separation of stone work coursing provides evidence for later construction of lean-to.</p>

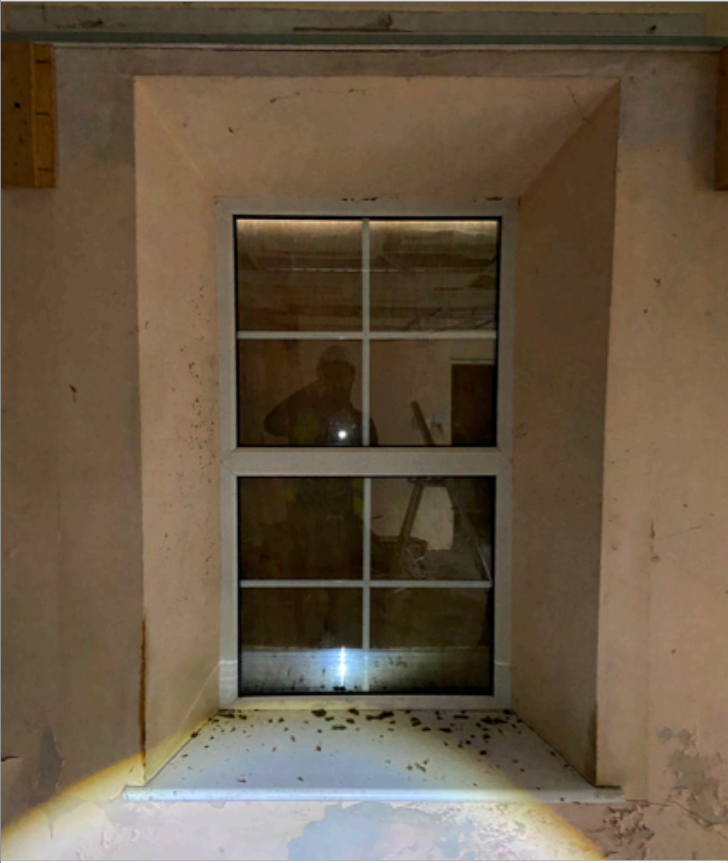
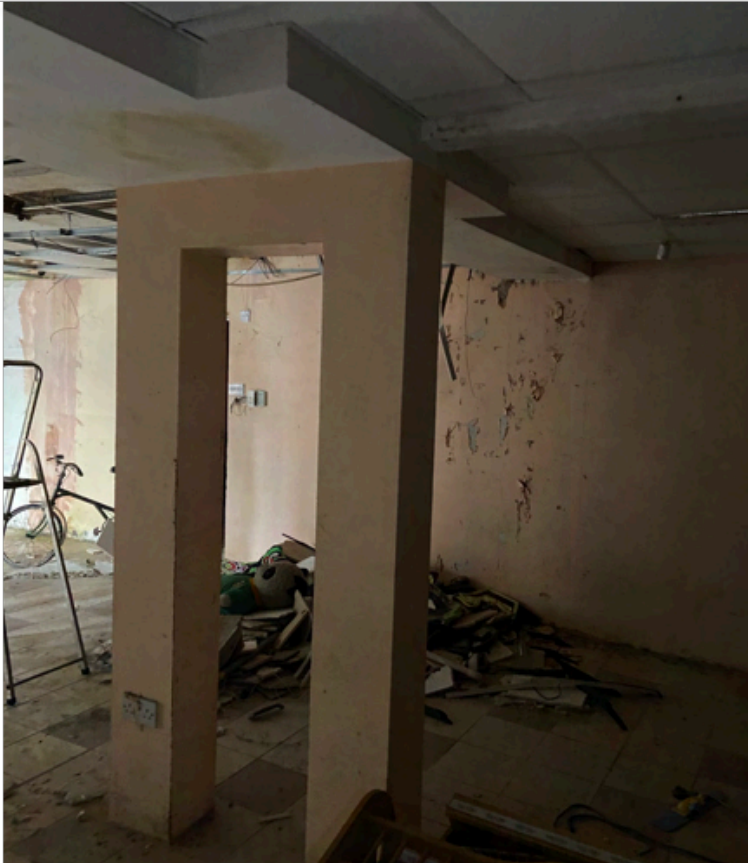
</div> <div><div>Fig. A</div><div>Fig. B</div></div>

020	<p><b>2 Storey Cottage - Interior - Ground Floor - Shop Floor</b></p> <p><b>Fig. A</b> -Traditional splayed reveal to ground floor window openings. PVC window frame.</p> <p><b>Fig. B</b> - Further detail of steel columns and beam structures supporting timber first floor above.</p>	<div>
