# Architect's Report

## Proposed Residential Development at Rathmolyon

Meath County Council

**Sheridan Woods**

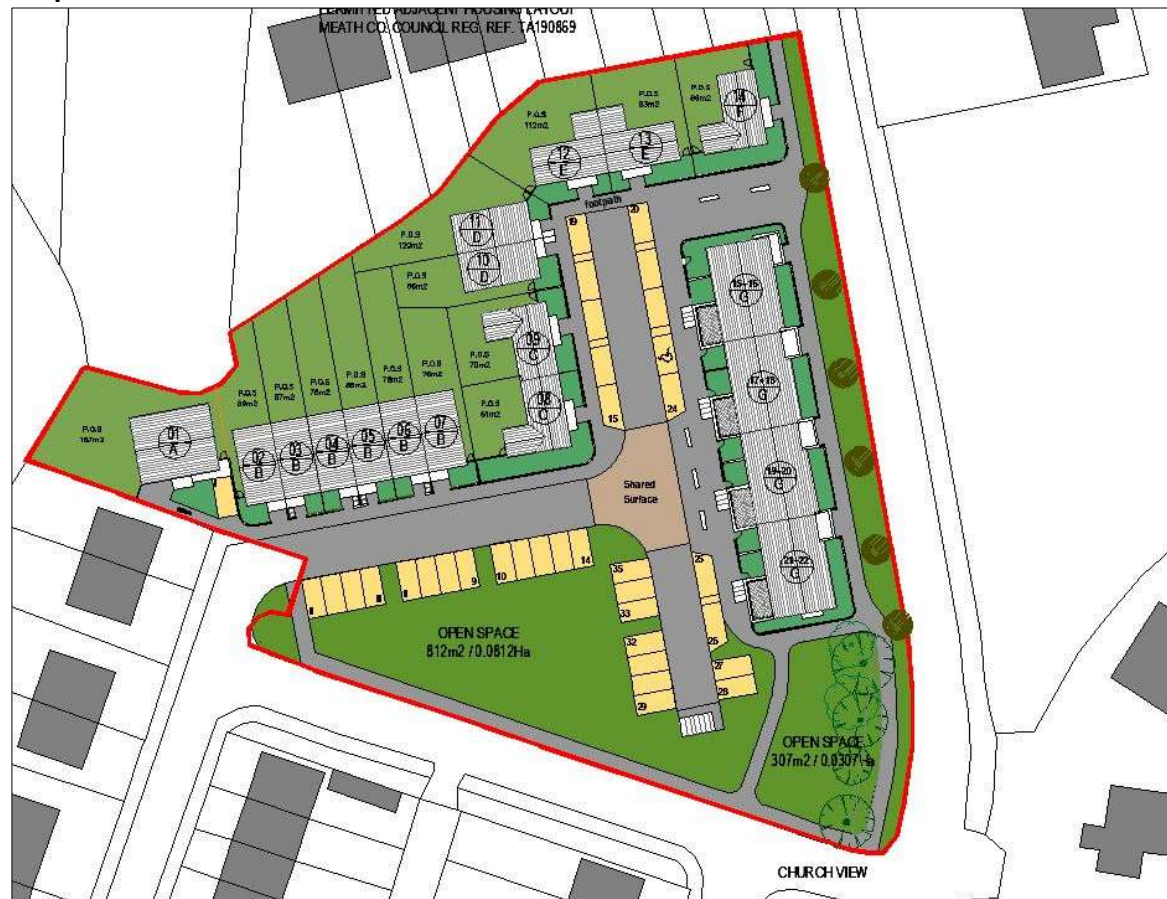
### Proposed Site Plan

The proposed dwellings are accessed off the Church View access road, and create a new street defined by the new dwellings to the north and north-east, extending to a pedestrian landscape space to the Enfield Road (R159). The single and two storey dwellings are located to the north and east of the new route, and the dwellings create a facade and define the street edge. Each of these dwellings comprise rear gardens and back onto the adjoining properties to the north. Separation distances ensure that there is no overlooking to adjoining sites or within the proposed development itself. The fronts of the dwellings include a privacy strip separating the living spaces from the proposed footpath.

The proposed G-Type apartments are positioned between the new route and the Enfield Road to the east of the site. Two pedestrian landscaped spaces are provided, one to the front of the proposed duplex dwellings, facing west and the second north of the apartment block. The proposed duplex dwellings comprise private ground and first floor open space. This block includes a privacy strip all around the block to protect its privacy at ground floor level. These units (G1 + G2 Types) are dual fronted 2 and 3 bedroom units with 4 No. 3-bedroom units accessed from the Enfield Road facade and 4 No. 2-bedroom units accessed from the new access road to the west
